AVIATION INVESTIGATION REPORT

A16W0092

Nose landing gear failure to extend

Beechcraft 1900D, C-GORF

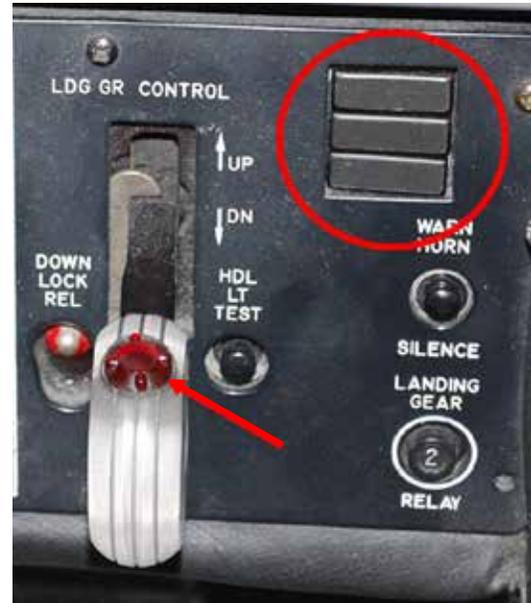
GGN7212 departed CYQL at 0531¹ and climbed to the flight-planned altitude of 11 000 feet above sea level (ASL). The flight progressed normally into CYYC until 0610, when the flight crew selected the landing gear down. When the landing gear began to extend, a grinding, banging noise was audible. When the landing gear extension sequence stopped, the flight crew observed 1 green down indicator light for each of the main landing gears, but no green indicator light for the nose landing gear. The in-transit light in the landing gear handle was extinguished (Figure 1).

Figure 1. Beechcraft 1900D gear-down indicator lights (circled in red) and landing gear control handle (arrow)

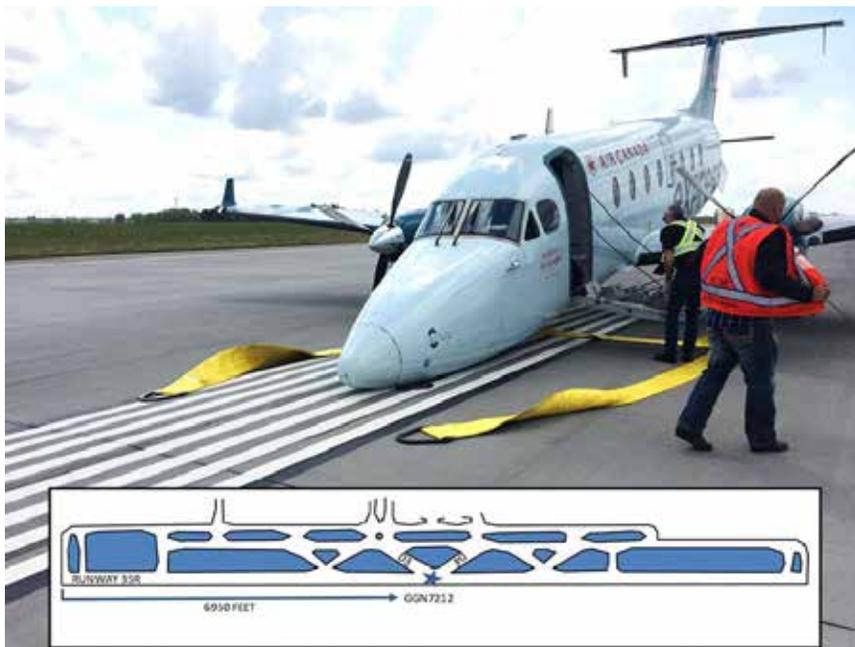
Figure 2. Resting position of C-GORF on Runway 35R (Source: Calgary Airport Authority)

Some smoke and fumes were present in the cabin due to the nose scraping along the runway, but there was no fire. The actions of the flight crew resulted in minimal damage to the aircraft and no injuries to the passengers.

Damage to the aircraft was limited to the nose landing gear components, the nose gear door and gear light, as well as 2 propeller tips on each side of the aircraft that contacted the runway.

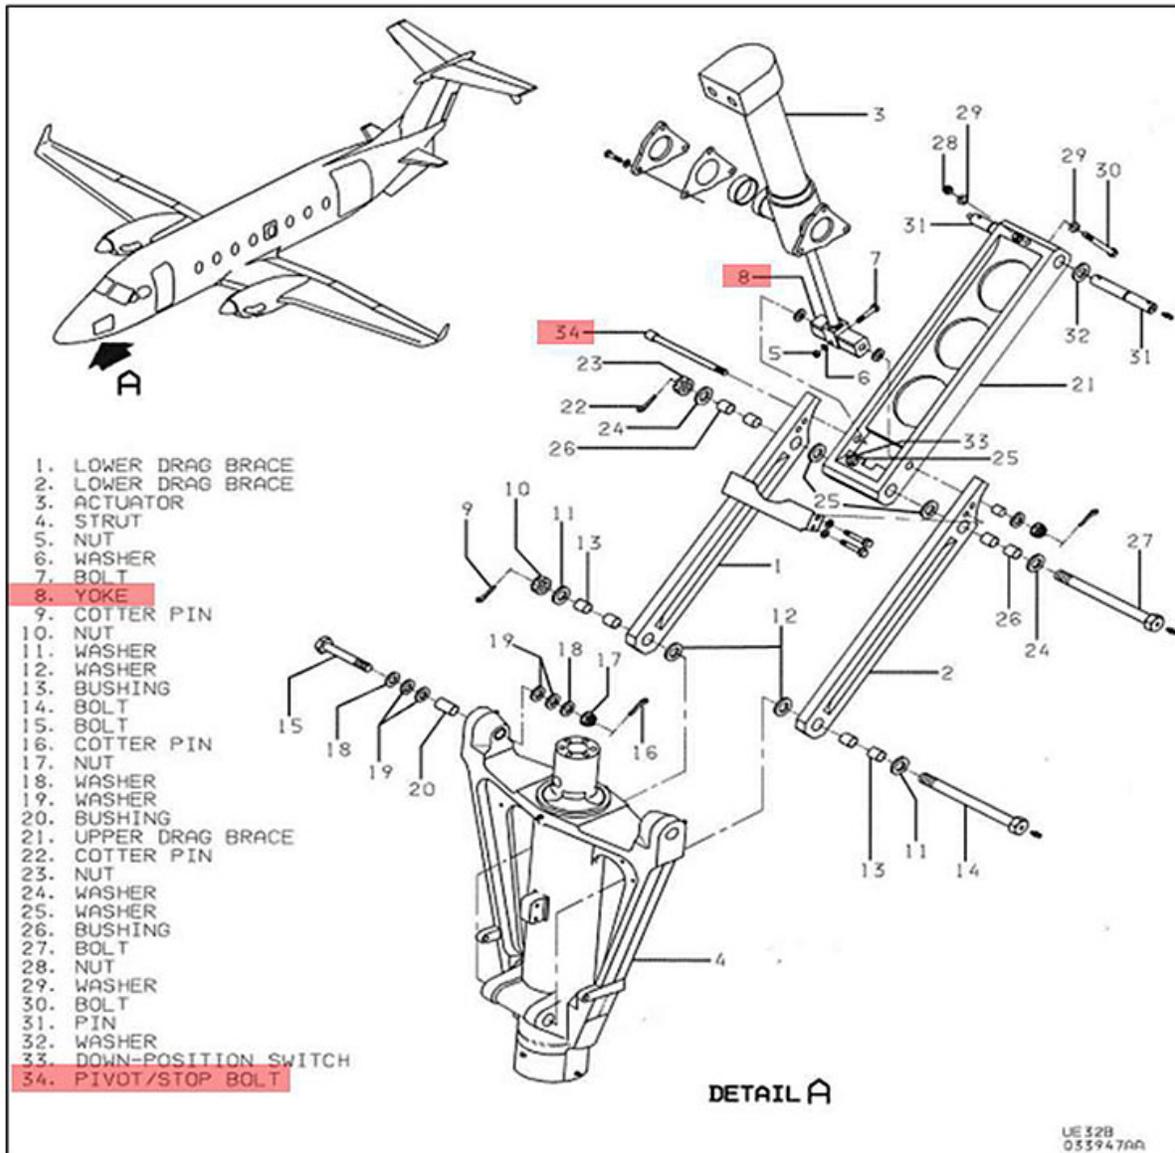
Figure 3. Beechcraft 1900D nose landing gear parts diagram (Source: Beechcraft Corporation, *Model 1900D Airliner Maintenance Manual*, 32-20-01, Figure 201 (sheet 1 of 2), p. 206 (01 November 2013))

The failure of the retract-and-extend mechanism of the nose landing gear was initiated by a yoke lubrication problem. The bolt with part number 114-820107-1 on the occurrence aircraft was not lubricated as required. The yoke should turn freely around the yoke's pivot/stop bolt; however, the occurrence yoke's pivot/stop bolt was seized in the yoke due to deteriorated grease and corrosion for 2 reasons: First, the deteriorated grease did not provide lubrication. Second, insufficient lubrication allowed the penetration of moisture between the bolt and the bore surface, causing corrosion on both surfaces. The bolt seizure resulted in abnormal loading on the yoke's pivot/stop bolt and the actuator clevis during retraction and extension of the nose landing gear. This led to fatigue cracking and failure of the yoke's pivot/stop bolt ends.

The failure of the retract-and-extend mechanism of the nose landing gear was initiated by a yoke lubrication problem. The lack of lubrication caused the pivot/stop bolt in the nose landing gear yoke to seize and break, which eventually prevented the nose landing gear from fully extending.
