**TRANSPORTATION SAFETY BOARD OF CANADA
BOARD CONCERN A06Q0188-D1-C1**

DATE ISSUED: 21 February 2007

SUBJECT: Bombardier CRJ Flap Failures

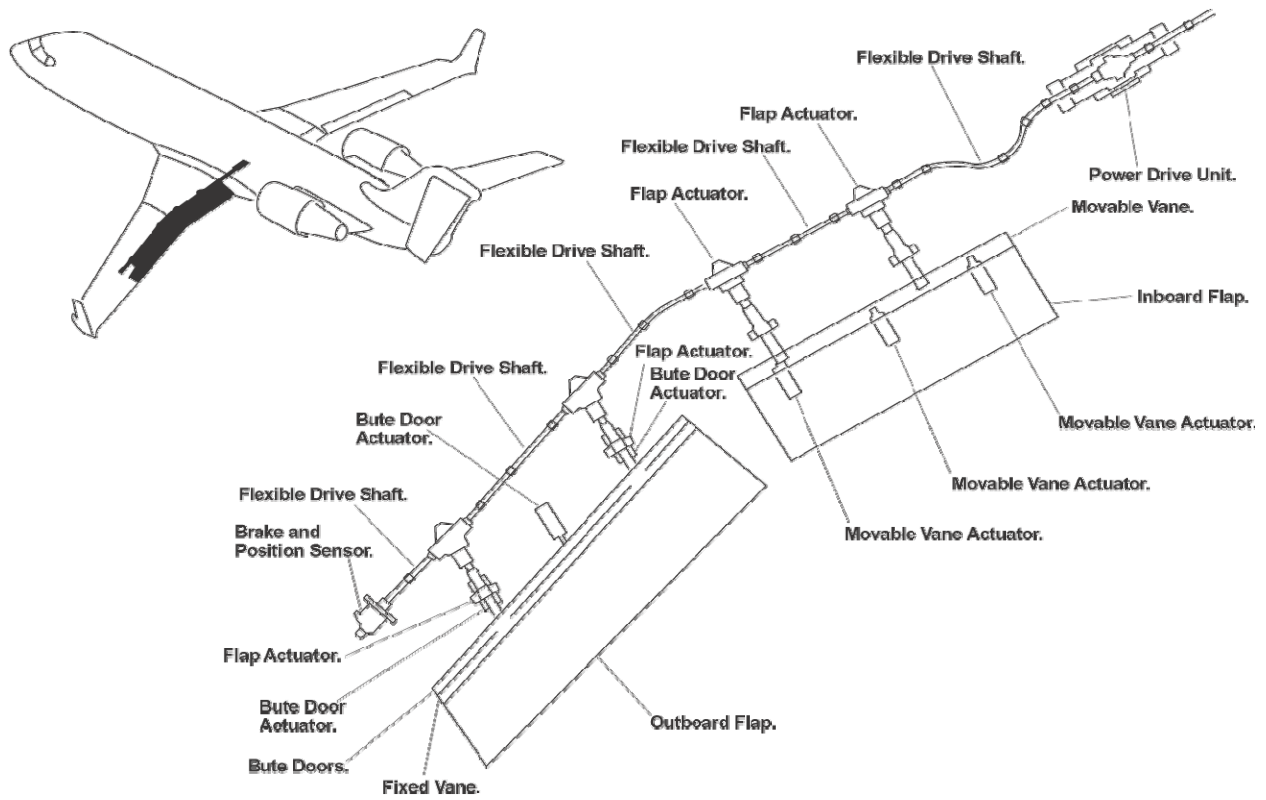
Appendix A - Flap Drive System

On the CRJ, flaps are extended or retracted by a series of drive units and flexible shafts connected to actuators (see Appendix A). A flap electronic control unit (FECU) supplies the commands and monitors the performance of the components and flap position as the flaps are extended and retracted. Flap selection is made by moving the flap control lever in the cockpit to one of the flap position detents. When a flap problem is detected by the FECU, a signal is sent that causes a disconnect relay to operate, the associated power drive unit to stop, and both flap brakes to engage. The flaps remain set at whatever position they were in when the problem was detected.
