**AVIATION OCCURRENCE REPORT**

**LOSS OF SEPARATION  
BETWEEN**

**CANADA 3000  
BOEING COMPANY 757 C-FOOH**

**AMERICAN AIRLINES INC.  
BOEING COMPANY 767 N322AA  
NATASHQUAN, QUEBEC  
16 SEPTEMBER 1995**

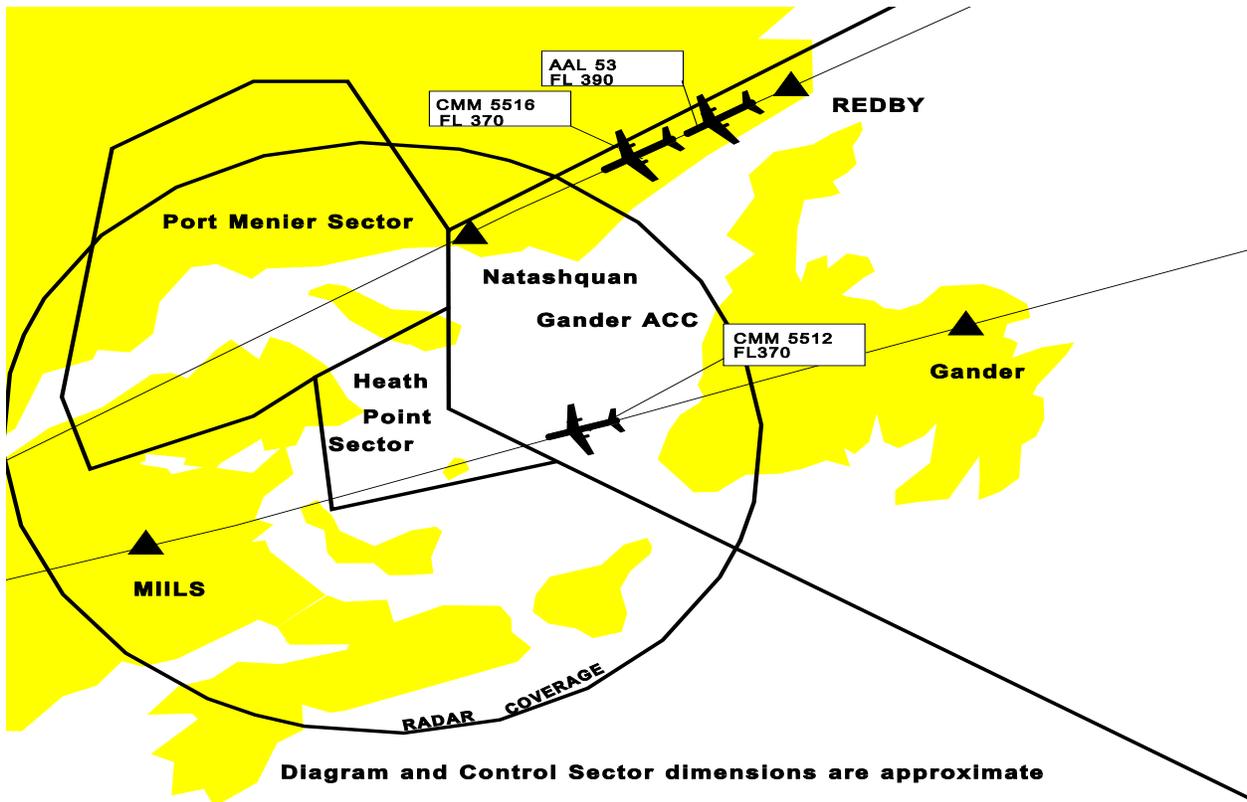
Canada 3000 (call sign Elite 5516), a Boeing 757, was westbound at flight level (FL) 370 from Denmark to Toronto via REDBY, Natashquan. American Airlines (AAL 53), a Boeing 767, was westbound at FL390 from Scotland to Chicago, also via REDBY, Natashquan. Canada 3000 (Elite 5512), a Boeing 757, was westbound from London to Montreal at FL370 via Gander, MIILS. (See figure 1.)
