TAIL STRIKE ON LANDING

BOEING 767-375 C-FOCA

HALIFAX, NOVA SCOTIA

REPORT NUMBER A96A0035

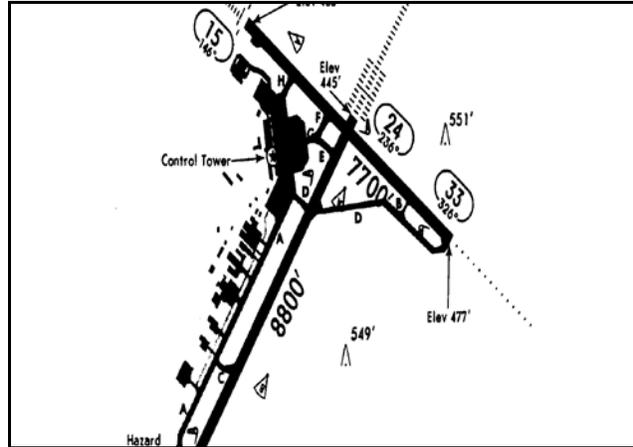
Runway 06/24, which is oriented 056/236° magnetic, measures 8,800 feet long by 200 feet wide. The first quarter of runway 06 has a 0.77% upslope. At taxiway Charlie, the runway begins to slope down by 0.5% to about the runway halfway point. The remainder of the runway is basically level. There is no information contained in the aviation publications about the overall slope for runway 06. The slope of a runway is published by the *Canada Air Pilot* (CAP) when the average slope is 0.3% or greater. For example, the average slope for runway 33 at Halifax is 0.55% down, which is significant enough to be noted on the CAP approach plates for that runway.

Runway 06 has an upslope of 0.77% in the first portion of the runway, which is close to the normal limit specified by TP312. The illusion created by the upslope is that the aircraft is higher than it should be, and a reaction to correct for this perceived problem causes the aircraft to deviate below the proper path. There was nothing on the approach chart to indicate that the first portion of the runway was sloped up. Also, there does not seem to be any way for the crew to have determined that runway 06 had an upslope in the first portion of the runway. Only average slope is provided if the average runway slope exceeds 0.3%. The visibility present during the landing would limit the amount of runway that could be seen, which would have made the first portion upslope more of a visual illusion problem. It appears that both pilots were unaware of, and affected by, the visual illusions presented by the runway and approach lights, causing them to believe that the aircraft was higher than it actually was. An absence of published information in the form of a cautionary note, or a slope indication on an approach chart, deprived the crew of a possible strategy in overcoming the runway illusions present. This could explain why the power was reduced to 50% N1 by the captain, leading to an unstabilized approach as the aircraft descended through 150 feet agl. A call of the 800 to 900 fpm descent rate, even though it was not required by company SOPs, might have been helpful to the captain. The lack of a call may indicate that the first officer was affected by the visual illusions and failed to appreciate the unfolding situation. The PAPI provided information that would have assisted the captain in maintaining the proper visual glide path to landing. However, he discounted these visual cues. Ignoring the PAPI is consistent with his preoccupation with the possibility of overrunning the runway, and contributed directly to the deviation below the desired glide path.

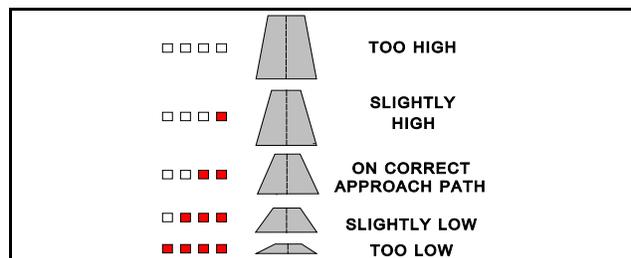
The runway is served by a type 3 PAPI, suitable for aircraft with an eye-to-wheel height of up to 45 feet (Boeing 747 and smaller). The PAPI consists of four light units in a wing bar, located on the left side of the runway, 1,307 feet from the threshold, and provides a 3° glide path to the touchdown zone. A pilot's on-slope indication is two white lights and two red lights visible. If four red lights are visible, the aircraft is too low.

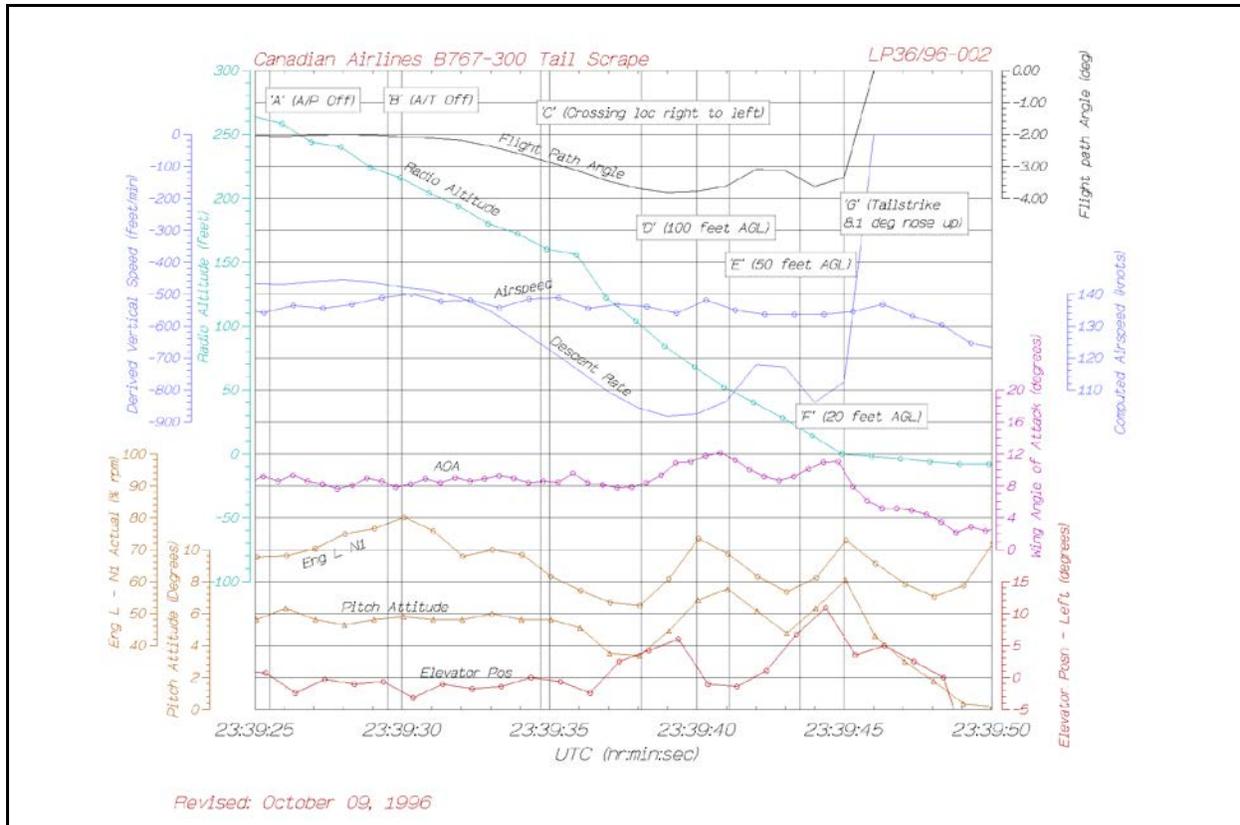
The aircraft crossed the runway threshold at approximately 20 feet agl, the engine power was increasing through 58% N1 (to 72% N1 at touchdown), body attitude was increasing through 5.8°, and the aircraft was

descending at 800 fpm. In the last 10 seconds before touchdown, the N1 averaged about 8% lower than the previous steady value during the approach, which equates to about 20% less thrust. Airspeed had decreased to 134 KIAS (V_{REF30}). The aircraft touched down, without slowing its descent, about 200 feet beyond the threshold, 40 feet left of the centre line, with a peak vertical acceleration of 2.2G (load factor) and peak pitch attitude of 8.1°.

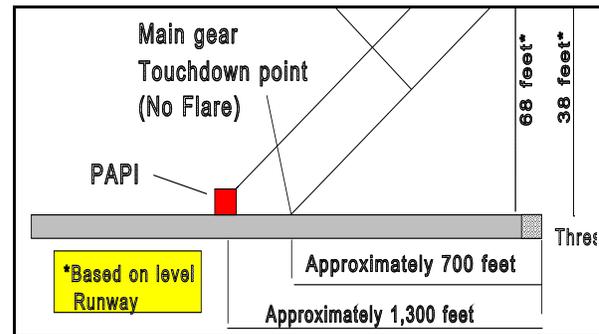
When using the location of the PAPI at runway 06 at Halifax, but not accounting for the runway upslope, the main gear touchdown point can be determined using the approximately 30-foot difference between eye-level path and gear path for the Boeing 767-300, as depicted in figure 4. Assuming no flare, the main wheels would contact the runway at about 700 feet. With normal flare and round out, a touchdown could be expected at about 1,000 feet.
