AVIATION INVESTIGATION REPORT

A98A0191

COLLISION WITH TREES

KNIGHTHAWK AIR EXPRESS LIMITED
DASSAULT-BREGUET FALCON 20D C-GTAK
ST. JOHN'S, NEWFOUNDLAND
30 DECEMBER 1998

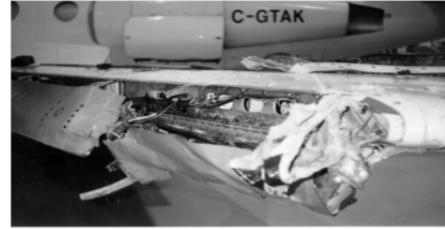
The left wing sustained the following damage: approximately three feet of the outboard droop leading edge was torn loose and curled under the wing; the outboard wing extension lower skin was twisted; and the aileron and outboard flap panel exhibited minor damage. The left wing inboard droop and fixed leading edges exhibited several substantial impact marks.
