AVIATION OCCURRENCE REPORT

RUNWAY OVERRUN

**RELIANT AIRLINES INC.
DASSAULT/SUD FAN JET FALCON N212R
PETERBOROUGH AIRPORT, ONTARIO
18 FEBRUARY 1998**

REPORT NUMBER A98O0034

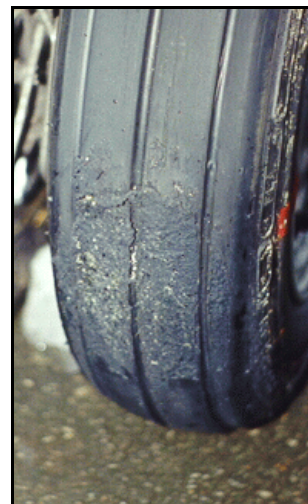
Figure 1

All four tires on the dual-wheeled aircraft main landing gear had an area of reverted rubber present (see Figure 1), indicative of hydroplaning. When hydroplaning occurs, the tires of the aircraft are completely separated from the actual runway surface and will continue to hydroplane until a reduction in speed permits the tire to regain contact with the runway surface. During total dynamic hydroplaning, the tire lifts off the runway and rides on the wedge of the water, causing such a complete loss of tire friction that wheel spin-up will not occur. On wet runways, where there is not enough water to cause dynamic hydroplaning, viscous hydroplaning can occur. This term describes the normal slipperiness or lubricating action of water. Viscous hydroplaning does not reduce the friction to such a low level that wheel spin-up will not occur. On the other hand, reverted rubber hydroplaning can occur when a locked tire is skidded along a very slippery water- or slush-contaminated runway, at any speed above about 20 knots, where the heat generated by friction produces steam and begins to revert the rubber, on a portion of the tire, back to its uncured state. The increase in stopping distance as a result of hydroplaning is impossible to predict accurately, but it has been estimated to increase by as much as 700 per cent. Performance graphs for the aircraft indicate that a landing distance of 4 400 feet was required for the aircraft at the calculated landing weight of 22 198 pounds. Landing distance was calculated for a bare, dry runway condition.

1. Precipitation changed from light rain to snow and rain at or near the time at which the flight crew commenced their approach to the airport.
2. The runway surface was contaminated with a thin layer of slush at the time the aircraft landed.
3. The aircraft main landing gear tires hydroplaned on landing roll, reducing the aircraft braking action.
4. The aircraft main landing gear wheels locked in a skid when braking was applied with the brake anti-skid system deactivated.
5. The drag chute, when deployed , did not remain attached to the aircraft.
6. The aircraft overran the end of the runway.

The aircraft hydroplaned and overran the runway, probably as a result of the anti-skid brake system being selected off and maximum brakes being applied. It was not determined whether having the anti-skid system selected would have prevented the overrun, but the distance to a full stop would have been reduced. Contributing to this occurrence was the lack of aerodynamic braking, a result of the drag chute becoming detached.
