AVIATION OCCURRENCE REPORT

A99A0046

INJURIES TO PERSON WHILE DEPLANING

BOEING 767-200, C-FBEM

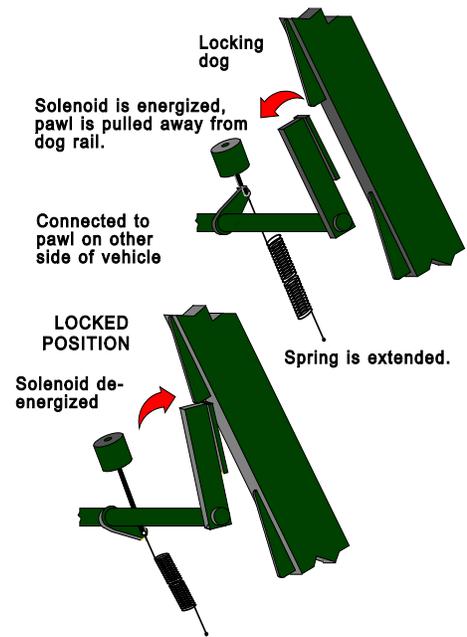
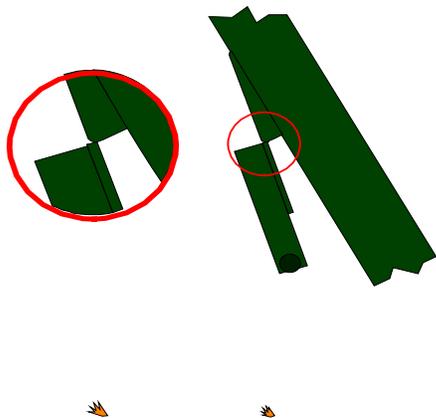
The passenger stand (Trailbec BMH series unit No.15) used for the deplaning of Air Canada Flight 861 is designed for use on various aircraft of different door sill heights. The stair height is adjusted by means of a moveable upper stair portion which is raised and lowered by an hydraulic cylinder. The upper stair portion is held in the raised position by a mechanical pawl and dog locking system. This pawl is normally held in the engaged (locked) position by a spring and it is disengaged by an electric solenoid which functions in opposition to the spring. The solenoid is energized by a “deadman”

(spring- loaded to the off position) button in the cab of the vehicle. The stair is raised a half step above the desired height and then lowered against the stop.

Several tests were carried out on the locking mechanism after the accident. In about half of these tests, the pawls failed to engage or only partially engaged. In tests where the pawl partially engaged the dog, the upper stair remained in place for a short period, then, as the pawl slipped off the dog, the stair descended. In tests where the pawl failed to engage the dog, the stairs began to descend immediately.

Visual verification that the locking mechanism was fully engaged was hampered by the pawl, the dog, and the background being painted a uniform dark green and by the fact that, on this vehicle, a small brace (which had been added to support the unit’s side panel) impeded the operator’s view of the pawl.

The locking mechanism used to hold the upper stairs in position is a fairly simple mechanical device. The pawl that prevents the stairs from descending is held in place against the dog rail by a spring and released by energizing a solenoid. In this occurrence, the pawl had only partially engaged the dog rail and, after several passengers had travelled over the stairs, it slipped off, allowing the upper stairs to descend away from the aircraft. Whether this was due to a weakness in the spring, a mechanical resistance in the mechanism, or a combination of both, the proper functioning of the locking mechanism was impeded.

- A comprehensive inspection was completed on all Air Canada passenger stands within 48 hours of the accident. All pawl mechanisms have been painted in contrasting colours to facilitate determination of the pawl position, and support braces have been relocated so as not to impede the operators' view of the pawl. All airstairs units have been put on a weekly follow-up to ensure all checks are completed on time.
- The company has disseminated details of the occurrence to the Air Transportation Association of Canada, the International Air Transportation Association, and the Air Transportation Association of America.
