## **AVIATION OCCURRENCE REPORT**

**A99A0046**

### **INJURIES TO PERSON WHILE DEPLANING**

**BOEING 767-200, C-FBEM**

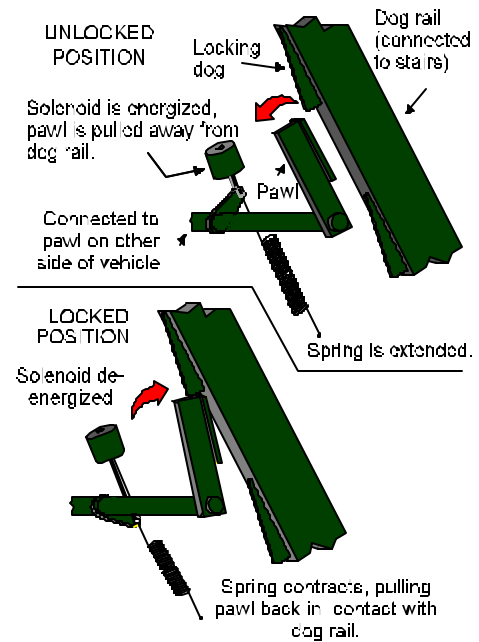
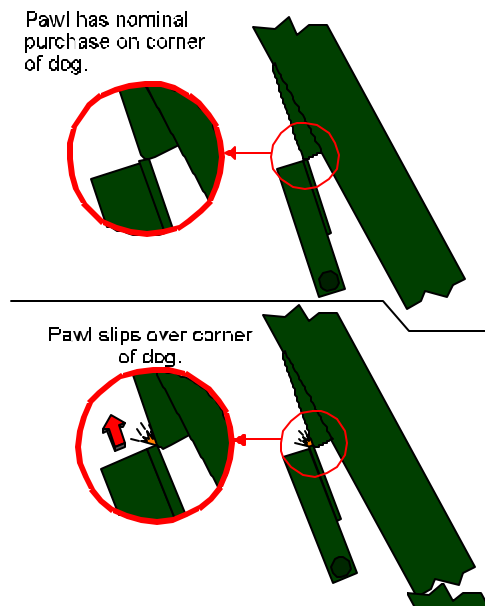
The passenger stand (Trailbec BMH series unit No.15) used for the deplaning of Air Canada Flight 861 is designed for use on various aircraft of different door sill heights. The stair height is adjusted by means of a moveable upper stair portion which is raised and lowered by an hydraulic cylinder. The upper stair portion is held in the raised position by a mechanical pawl and dog locking system. This pawl is normally held in the engaged (locked) position by a spring and it is disengaged by an electric solenoid which functions in opposition to the spring. The solenoid is energized by a “deadman”

(spring- loaded to the off position) button in the cab of the vehicle. The stair is raised a half step above the desired height and then lowered against the stop.

Several tests were carried out on the locking mechanism after the accident. In about half of these tests, the pawls failed to engage or only partially engaged. In tests where the pawl partially engaged the dog, the upper stair remained in place for a short period, then, as the pawl slipped off the dog, the stair descended. In tests where the pawl failed to engage the dog, the stairs began to descend immediately.

Visual verification that the locking mechanism was fully engaged was hampered by the pawl, the dog, and the background being painted a uniform dark green and by the fact that, on this

vehicle, a small brace (which had been added to support the unit's side panel) impeded the operator's view of the pawl.

The locking mechanism used to hold the upper stairs in position is a fairly simple mechanical device. The pawl that prevents the stairs from descending is held in place against the dog rail by a spring and released by energizing a solenoid. In this occurrence, the pawl had only partially engaged the dog rail and, after several passengers had travelled over the stairs, it slipped off, allowing the upper stairs to descend away from the aircraft. Whether this was due to a weakness in the spring, a mechanical resistance in the mechanism, or a combination of

both, the proper functioning of the locking mechanism was impeded. The company had procedures in place whereby periodic service checks and periodic operational/safety checks were to be carried out on all ground support equipment to ensure proper mechanical functioning. However, these procedures were not being followed and the passenger stand was 130 hours overdue for a service check.

- A comprehensive inspection was completed on all Air Canada passenger stands within 48 hours of the accident. All pawl mechanisms have been painted in contrasting colours to facilitate determination of the pawl position, and support braces have been relocated so as not to impede the operators' view of the pawl. All airstairs units have been put on a weekly follow-up to ensure all checks are completed on time.
- The company has disseminated details of the occurrence to the Air Transportation Association of Canada, the International Air Transportation Association, and the Air Transportation Association of America.
