AVIATION OCCURRENCE REPORT

A99H0002

LOSS OF CONTROL AFTER TAKE-OFF

THUNDER AIRLINES LIMITED
BEECH AIRCRAFT CORPORATION A100 C-GASW
THUNDER BAY AIRPORT, ONTARIO
14 JUNE 1999

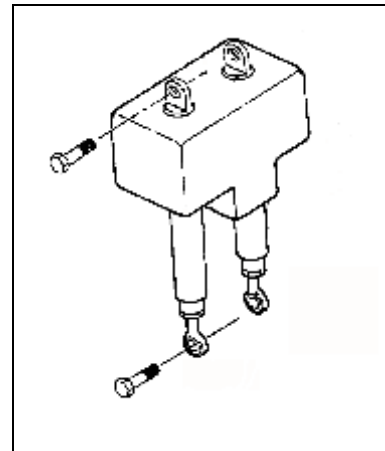
Figure 1 - Pitch trim actuators

Thunder Airlines Limited maintenance personnel had performed work on the elevator and rudder controls during the weekend preceding the flight. In order to remove the rudder, the primary and secondary pitch trim actuators, connected between the stabilizer and the airframe, had to be disconnected from the airframe. This bracket, in the form of a double U, with the primary and alternate trim motors located in the middle, is attached to the airframe and the leading edge of the stabilizer. Four bolts are routed through the holes at each end of the actuators for attachment to the airframe and the stabilizer. After the occurrence, investigators found that the top of the actuators was not attached to the airframe. The two bolts did not pass through the actuator holes when reinstalled, only through the attachment holes in the airframe. When the bolts were tightened during installation, they squeezed the ends of the actuators to the attachment points on the airframe. Without the actuators attached to the airframe, the stabilizer was free to rotate to a full up or down position on its own.

The AME did not use a mirror or other devices, such as a centring punch, to ensure the proper alignment of the bolts during the installation. After completing the maintenance work, the AME and the crew chief carried out a control check and the control surface behaved normally. During take-off, when the pilot pulled the control column aft for rotation, air loads on the stabilizer caused the improperly attached trim actuators to separate from the airframe, which made the noise heard by the co-pilot on take-off. The separation of the actuator from the airframe rendered normal control of aircraft pitch impossible, even though the control column was still properly attached to the elevators.

1. The pilots were certified and qualified in accordance with current regulations.
2. The AMEs were certified and qualified in accordance with current regulations.
3. Records show that the aircraft was certified, equipped, and maintained in accordance with existing regulations and approved procedures.
4. The stabilizer trim actuator's two upper mounts bolts, which attach the mounts to

airframe formers, were not properly installed by the AME.

The flight crew lost pitch control of the aircraft on take-off when the stabilizer trim actuators became disconnected because they had not been properly reinstalled by the AME during maintenance work conducted before the flight. The crew chief responsible for the inspection did not ensure correct assembly of the stabilizer trim actuators, which contributed to the accident.
