AVIATION INVESTIGATION REPORT

A99P0105

COLLISION WITH TERRAIN

A.A.L. AIR ALPS (GLACIER AIR)
EUROCOPTER AS350BA (HELICOPTER) C-GDWF
SQUAMISH, BRITISH COLUMBIA 3 NM W
15 AUGUST 1999

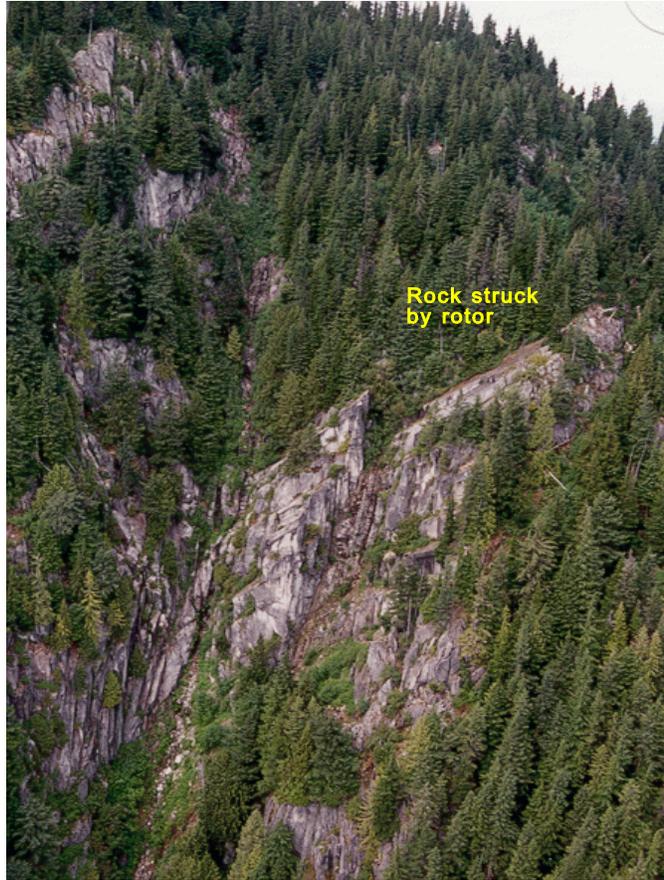
The ravine was off the track that joined the lake and the airport, and since there were no apparent tourist attractions in the ravine, it is likely that the pilot flew into the ravine because of low visibility. The pilot did not cross the ravine at its mouth, which would indicate that the visibility at the time was less than the distance that spans the mouth and was probably equal to or less than the distance that spans the ravine in the vicinity of the accident site. When flying up the ravine abeam the accident site, the distance from the pilot's seat to the site is about 75 feet; and, because the helicopter had gone this far up the ravine, it is likely that the flight visibility was 75 feet or less. In this reduced visibility, the pilot would probably have slowed the helicopter to a hover close to terrain and navigated with reference to ground features. When flying a path from the southwest side of the ravine to the northeast side and trying to fly down the ravine back into the valley, the rock formation that was struck, which blends into the background, could initially be disregarded as not obtrusive. This rock formation would be on the pilot's blind side, aft left, as he focussed on the next clump of trees below. It is possible that the pilot, flying this path, descended onto the aforementioned rock formation with little or no sense of how close it was.

It is possible that the pilot was not acutely aware of how much more room was needed to clear obstacles on his left side, since he had limited experience flying the AS350BA.
