AVIATION INVESTIGATION REPORT

A99W0061

IN-FLIGHT FIRE

AEROSPATIALE AS 355 F1 TWINSTAR (HELICOPTER)

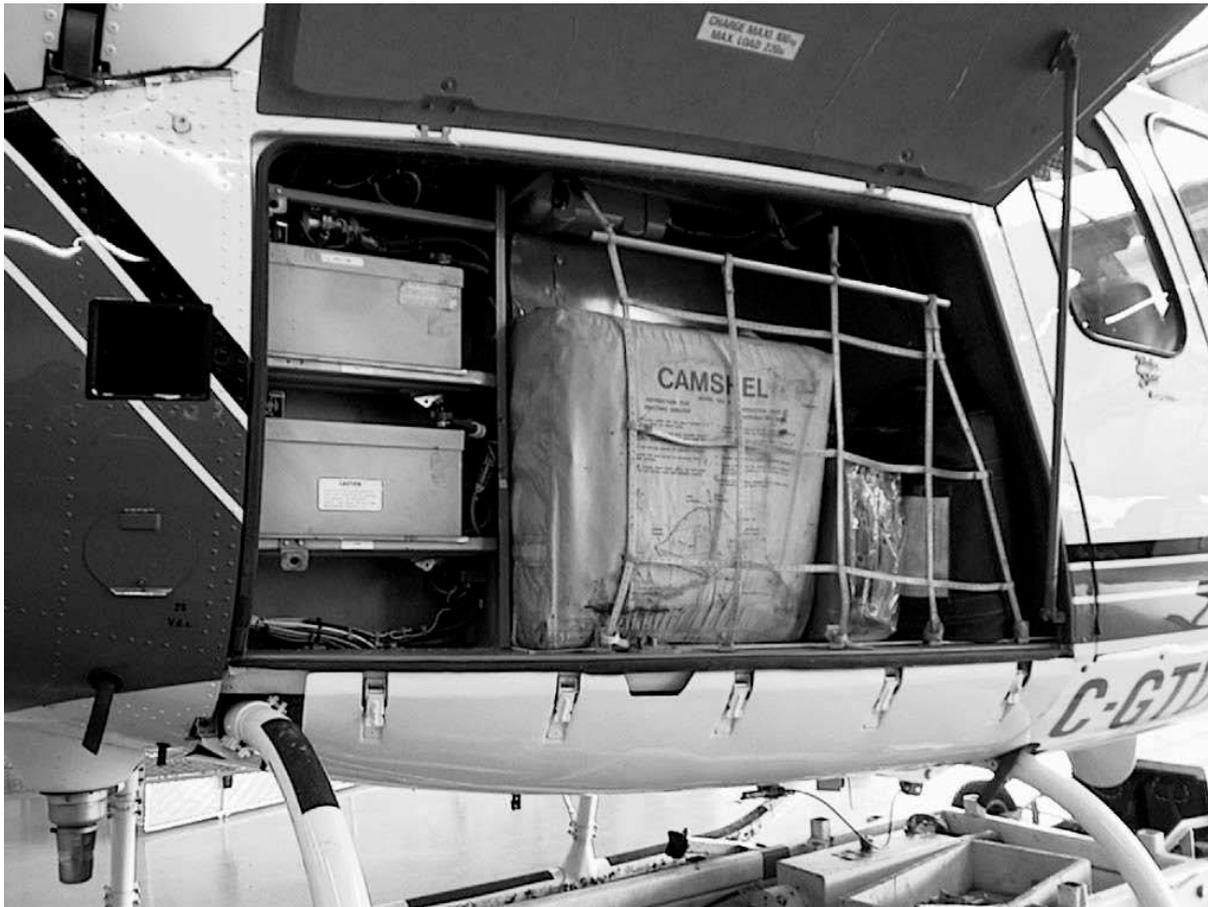
Appendix A - Battery and Baggage Compartment Configuration

The right baggage compartment is located immediately forward of the battery compartment on AS 355 helicopters (see Appendix A). The compartments are separated by a 0.050-inch-thick aluminum bulkhead. The company used the right baggage compartment in each of the four company helicopters for storage of the required survival and emergency equipment. The survival and emergency equipment included a five-person survival shelter and a survival kit that contained emergency flares. The bags that housed the survival shelter and the emergency kit were made of flammable nylon, and the survival shelter was also packaged in a waxed cardboard box. The bags were not required by regulation to be flame-resistant, and during testing, the packaging materials ignited quickly, melted, dripped and were totally destroyed by fire. The burning characteristics did not meet the requirements of any existing flame-resistant textile specifications. The survival kits contained two hand-held, marine-type, parachute flares and four day/night smoke flares. The emergency

Examination of the severely fire-damaged nicad batteries determined that the parallelling cable had been attached to the positive post of the auxiliary battery; however, it had not been attached to the positive post of the main battery. A short length of unattached battery cable was found near the batteries in the fire-damaged wreckage. Visual and laboratory examination of the cable identified that the copper end terminal was arc-damaged. Surface analysis and examination of micro sections of the end connector revealed areas where the copper had alloyed with aluminum. This indicated contact at sufficiently high temperature and of ample duration for the aluminum to have diffused into the copper tab. No additional pre-occurrence battery or electrical system discrepancies were identified. Examination of the 400-A fuse in the negative lead of the auxiliary battery determined that the fuse link had failed because of mechanical overload when the battery tray collapsed during the ground fire.

The AS 355 F1 helicopter sustained an in-flight fire that occurred as a result of the auxiliary-battery-to-main-battery parallelling cable not being attached to the positive post of the main battery. The maintenance error was not detected before the flight. Based on witness information, the battery compartment mock-up testing, and the TSB Engineering Laboratory examination of the recovered section of the arc-damaged battery cable, it was concluded that the unattached cable contacted an unpainted area of the battery compartment forward bulkhead, arced through the bulkhead, and ignited the survival gear in the adjacent baggage compartment.
