AVIATION INVESTIGATION REPORT

A00A0051

COLLISION WITH TREES

JETPORT INC.

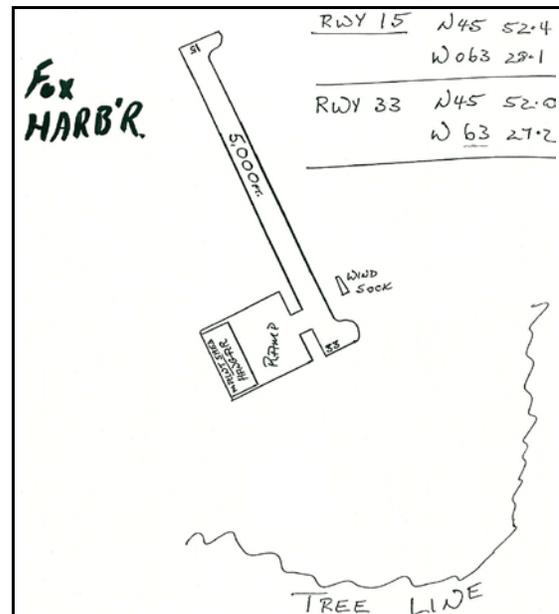
The aerodrome information available to the crew for the approach was a hand-drawn sketch of the aerodrome layout, with the latitude and longitude coordinates noted (Figure 1). The crew could not obtain current runway condition or wind information because the VHF radio at the aerodrome was not staffed.

- (a) The runway has been surveyed and centreline markings have been made in accordance with accepted standards.
- (b) A PAPI (precision approach path indicator) has been installed at both ends of the runway, and the calibration is confirmed weekly.
- (c) ARCAL (aircraft radio control of aerodrome lighting system) has been installed to control runway lighting and the PAPI.
- (d) The trees on the Runway 33 approach have been cut back to comply with the approach standards set out by Transport Canada.
