AVIATION INVESTIGATION REPORT

A00C0059

LOSS OF CONTROL ON GO-AROUND

DOUGLAS AIRCRAFT COMPANY DC-3 C-FNTF

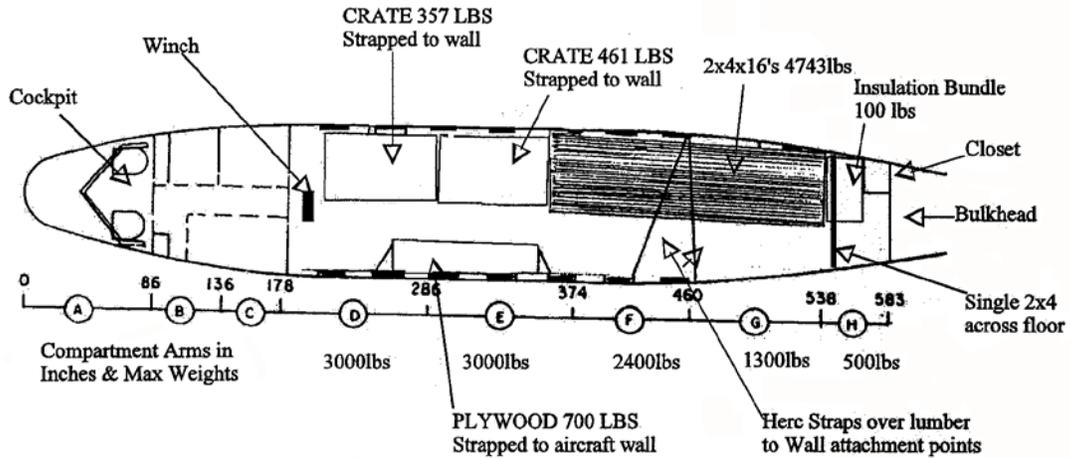
C-FNTF LOAD DISTRIBUTION

Wreckage examination confirmed the position of the loads in the aircraft and the method of tie-down as shown in Appendix A. The aircraft's nose and cockpit section were destroyed by impact forces. The fuselage failed in full-circumference just aft of the trailing edge of the wings. The two crates remained secured in this area. Several sheets of plywood also remained in place in front of the fuselage failure. The fuselage, aft of the wings, and the tail were twisted to the left and downwards. The remainder of the plywood sheets had dropped into the space in the fuselage opening aft of the wings. A second, almost full-circumference failure of the fuselage occurred in the vicinity of the forward portion of the vertical fin and ahead of both horizontal stabilizer attachments. All of the 2x4s were found in the rearmost section of the fuselage, with a large number found aft of the rear bulkhead.

5. The stack of 2x4 lumber was inadequately secured and may have shifted rearward during the go-around.
6. The crew did not recalculate the aircraft's weight and balance for the second flight.
7. Leaks in the heater shroud allowed carbon monoxide gas to contaminate cockpit and cabin air.
8. The captain's carboxyhaemoglobin level was 17.9 per cent, which may have adversely affected his performance, especially his decision making and his visual acuity.

1. First 2-3 rows of 2x4's extend beyond edge of rear crates.
2. Herc straps over lumber are attached to aircraft wall not floor points.
3. Insulation bundle extends beyond closet.
4. Weight of 2x4's exceeds combined weights of Compartments F & G
