AVIATION INVESTIGATION REPORT

A00C0260

COLLISION WITH TERRAIN

PIPER PA-31-350 CHIEFTAIN C-GZFK

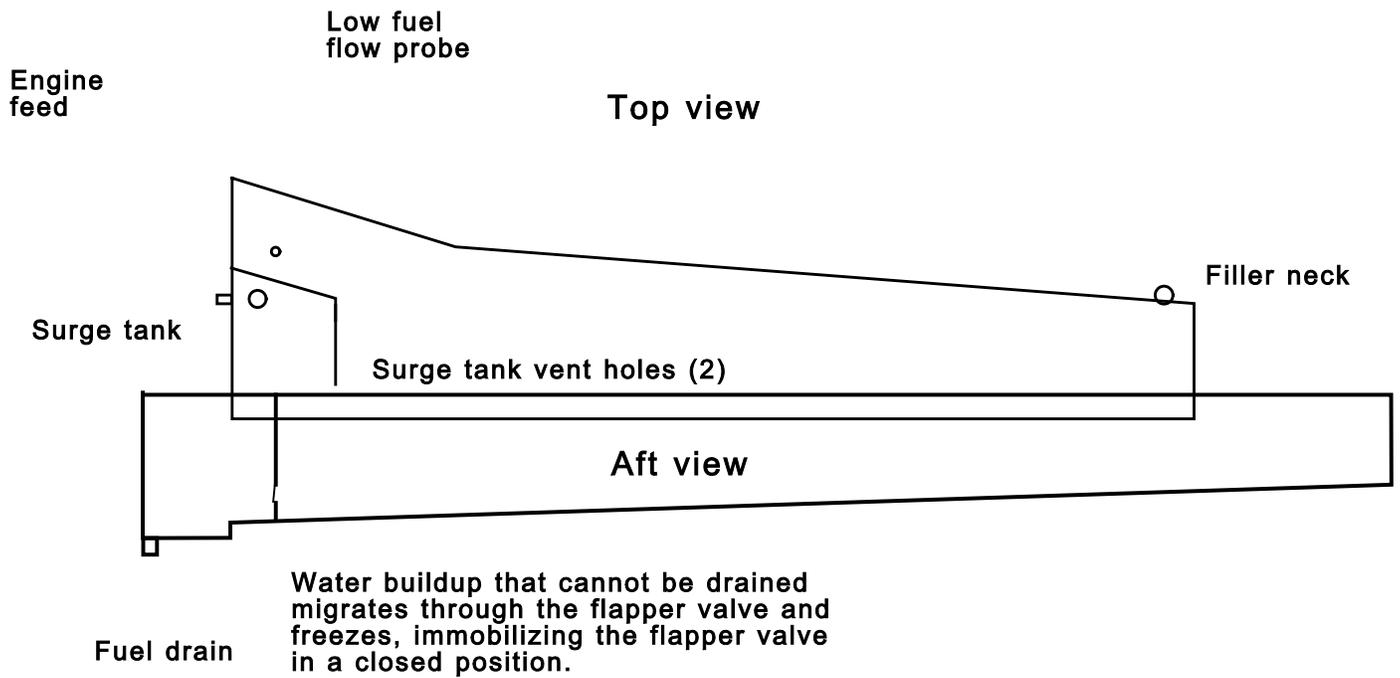
Appendix A—Fuel Cell Schematic

Each inboard fuel tank is partitioned into two segments (see Appendix A). The small segment, or surge tank, has a capacity of about four gallons and a purge (drain) valve; the engine draws fuel from this tank. A one-way flapper valve on the partition between the surge tank and the large segment allows fuel to flow into the surge tank. There is no purge valve in the large segment. A low-fuel sensor, installed in each surge tank, activates the respective fuel flow warning light in the cockpit when fuel starvation is imminent. Analysis of the cockpit warning lights indicated that the right fuel flow warning light was illuminated when the aircraft struck the ground. Examination of the inside of the large segment of the right inboard fuel tank bladder revealed a rust line up to the level of the flapper valve (see Appendix B). Fuel samples from the inboard fuel tanks were analyzed and found to be of normal quality.

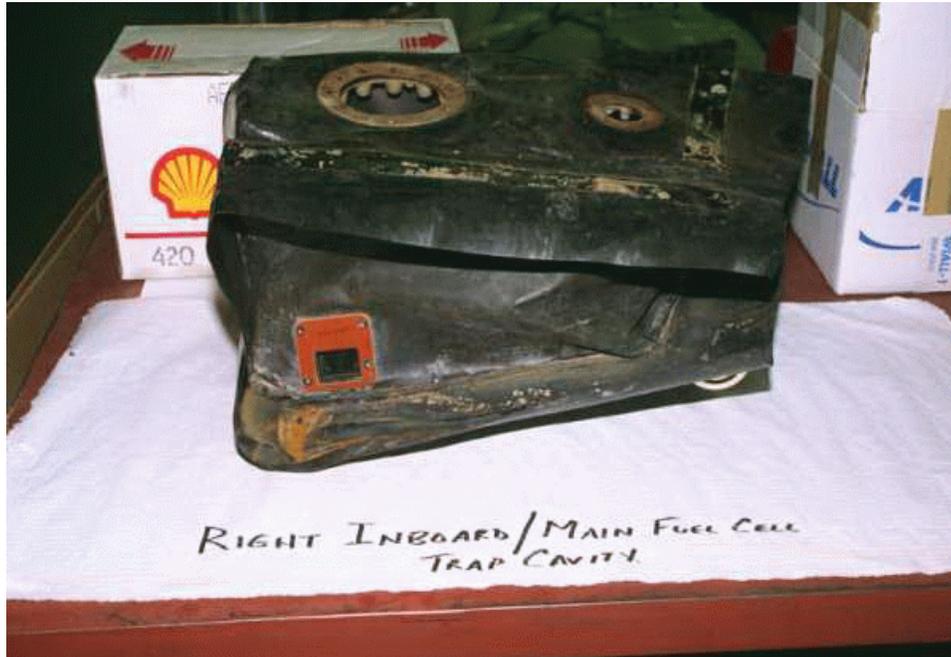
Appendix B—Fuel Cell Photographs

The aircraft came to rest upright, with the landing gear down and the flaps partially extended. The right inboard fuel cell was ruptured, but a considerable amount of aviation fuel remained trapped within the right surge tank. A large globule of ice (which when melted was approximately one cup of water) was removed from inside the right surge tank at the site. The left inboard fuel tank was approximately three-quarters full; some fuel had escaped from this tank, after the crash, through an impact-damaged fuel drain. The left and right outboard fuel tanks contained a small amount of fuel. The cockpit fuel selector switches were at the inboard position. All four fuel caps were securely fastened.

Illumination of the right fuel flow warning light and the serviceable condition of the right engine following the accident suggest that the right engine stopped because of fuel starvation. Rust in the surrounding segment of the right fuel tank indicates the presence of water up to the level of the flapper valve. This segment of the tank does not have a drain valve; water can therefore accumulate to the level of the flapper valve. Ice was found in the surge tank after the accident. It is probable that the water froze around the one-way flapper valve in the right inboard tank, obstructing the flow of fuel into the surge tank. When the inboard tanks were selected, the fuel in the surge tank was quickly depleted, the low-fuel sensor activated the right fuel flow warning light, and the right engine stopped because of fuel starvation. After the accident, the right surge tank refilled with fuel when the flapper valve began to move freely again as a result of either the ice melting or impact forces.

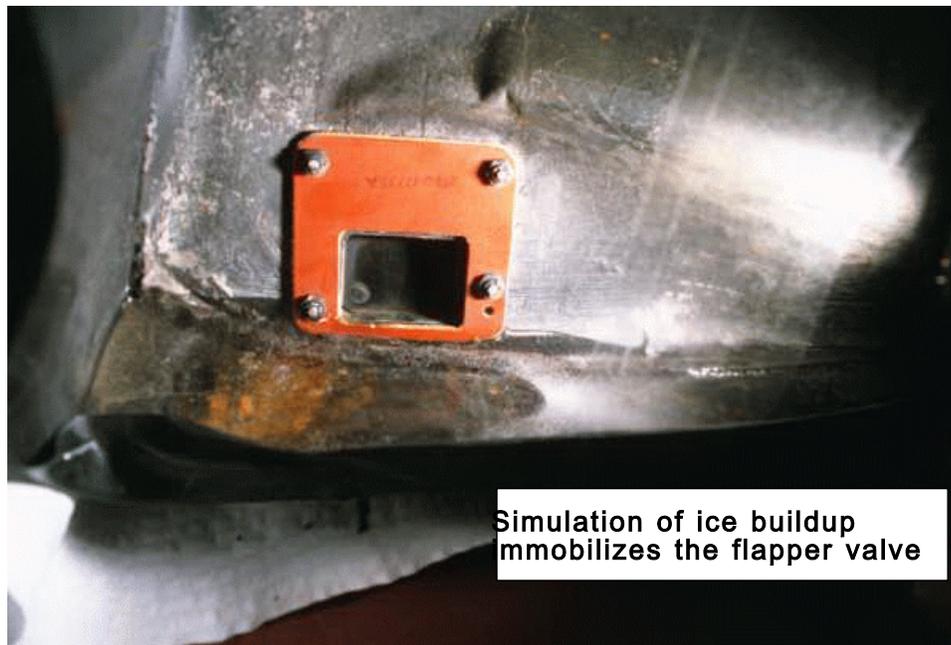
Tests were conducted at the regional Transportation Safety Board office to try to simulate water buildup and freezing of the flapper valve. The test was conducted in sub-zero temperatures. Water was allowed to collect outside the surge tank and adjacent to the flapper valve and spill over into the surge tank. The water froze and immobilized the flapper valve in the closed position (see Appendix B, Figure 2).

On 01 June 2001, the TSB issued two aviation safety advisories to Transport Canada (TC). Aviation Safety Advisory A010021 suggested that TC may wish to review the adequacy of the existing design certification of the PA-31's inboard fuel tank drains. The fuel tank drains do not allow water contamination to be removed from the larger section of the inboard fuel tank below the level of the flapper valve. Aviation Safety Advisory A010022 suggested that TC may wish to review the adequacy of the information, provided in the PA-31 pilot's operating handbook, on the fuel flow warning light and pilot response to illumination of this light.
