AVIATION INVESTIGATION REPORT

A01C0097

ENGINE POWER LOSS—COLLISION WITH TREES

PIPER PA-28-140 C-FXUF

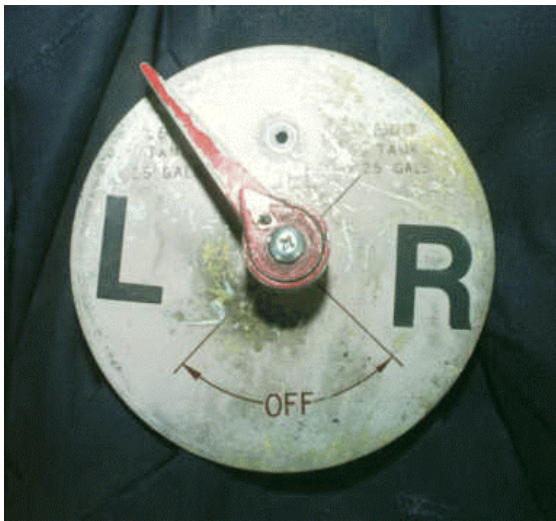
The fuel tank selector has left and right ON positions at 45° up from the horizontal and two OFF positions at 45° down from the horizontal (Figure 1). Two large letters, L and R, had been glued to the selector dial face between the OFF and ON detents on each side. The date at which these letters were installed was not determined. The fuel selector allows fuel to be drawn from either the left or right fuel cell and provides a means to shut the fuel off. Detents in the fuel selector

Figure 1 – Fuel selector in left detent

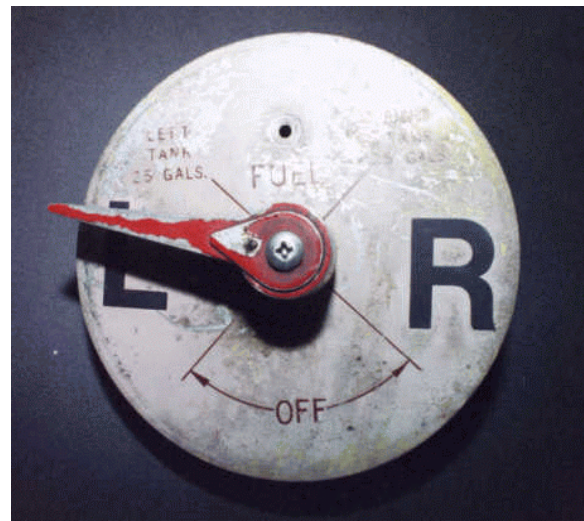
Figure 2 – Fuel selector over L, not in detent

When fuel selection was made to the left tank, the selector was most likely moved over the letter L and not engaged in the left tank detent. There was enough fuel flow to continually sustain idle power and the power settings for the run-up. When power was increased during the take-off roll, the required fuel flow was only available for a limited time. The reduced fuel flow was enough for the aircraft to become airborne; however, with the continued high-power setting, the engine required more fuel than the restricted selector would allow. As a result, the engine lost power.

1. The fuel selector was most likely set to the L and not in the detent, resulting in fuel flow less than that required to sustain high engine power.
2. The engine lost power after take-off because of fuel starvation.

1. The position of the letters L and R on the fuel selector dial face did not represent accurate left or right fuel tank selections.
2. The aircraft was not equipped with shoulder harnesses. The use of a shoulder harness would probably have reduced the pilot's injuries during the forced landing.
