AVIATION INVESTIGATION REPORT

A01C0152

COLLISION WITH POWER LINE

DE HAVILLAND DHC-2 BEAVER (SEAPLANE) C-FNFO

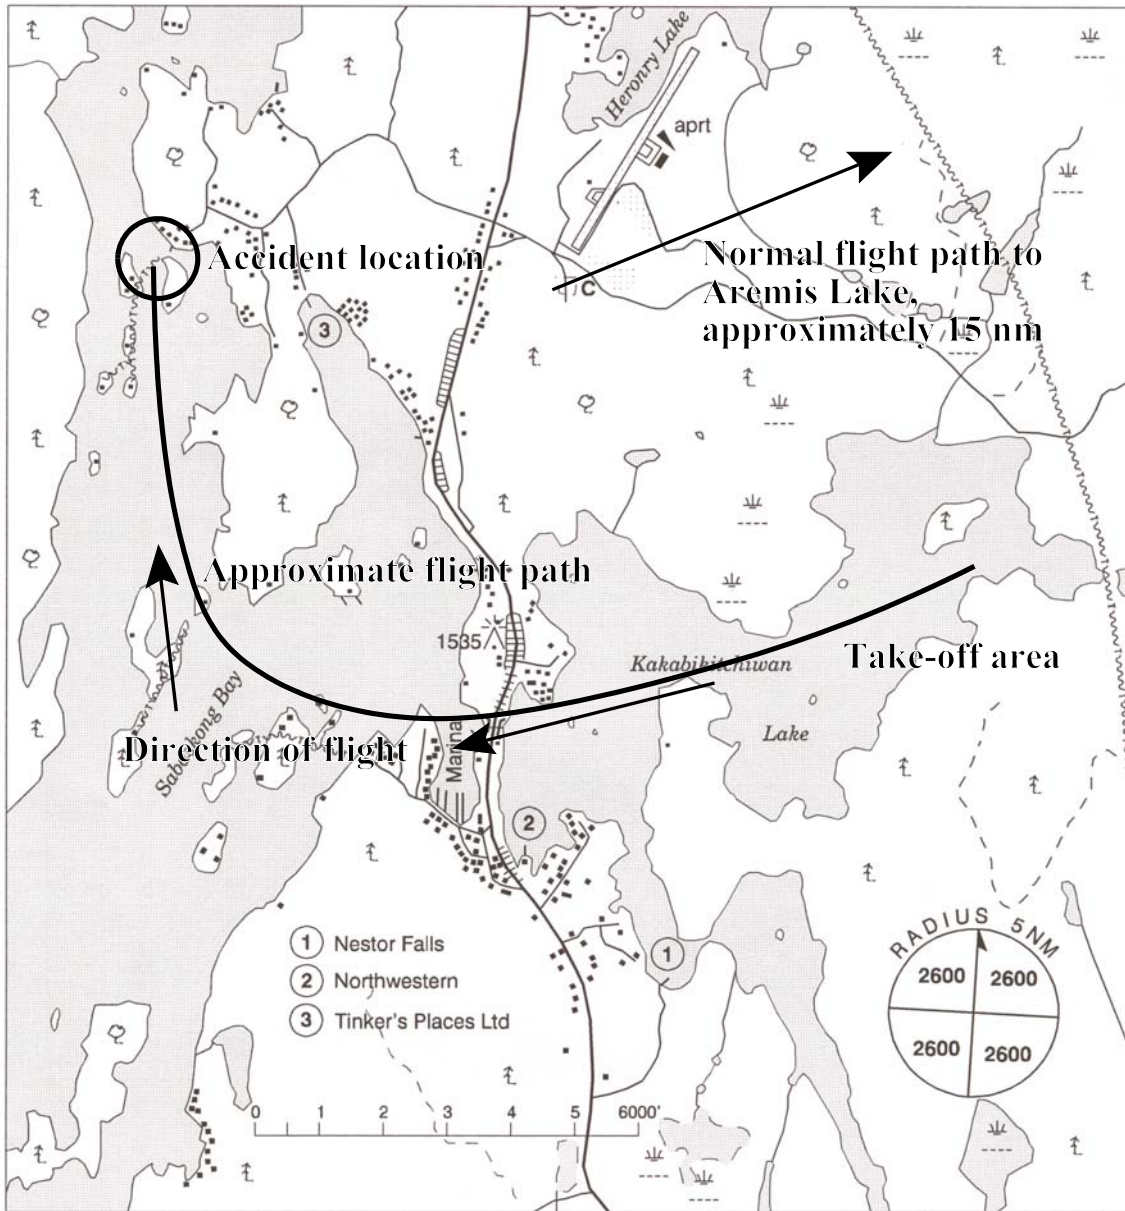
Appendix A—Nestor Falls Area Chart

The *Canada Water Aerodrome Supplement* (WAS) is a civil aeronautical information document published annually. It contains information on known water aerodromes and is used by pilots as a reference to plan and safely conduct air operations. The 22 March 2001 edition was the most current at the time of this accident. It contained a chart of the Nestor Falls / Sabaskong Bay area, depicting the power line struck by the aircraft. (See Appendix A.) Listings of operational information in the WAS for the two registered water aerodromes at Nestor Falls and Sabaskong Bay both cautioned "Numerous P-lines near ldg area". The pilot's company indoctrination training included briefings on the hazards of power lines and the general locations of wires in the company's area of operations. When pilots were dispatched, the company briefed them on the location of wires near their destinations and recommended specific areas for landing and take-off. However, no information was received as to whether the occurrence pilot had been briefed about the specific wire involved in this occurrence.

Although the power line was depicted on the chart in the WAS, and the pilot had been briefed about the hazard presented by power lines in the company's area of operations, it was not determined whether the pilot knew the location of this specific power line.
