AVIATION INVESTIGATION REPORT

A01O0157

ENGINE STOPPAGE ON TAKE-OFF

CESSNA 172N SKYHAWK C-GMHU

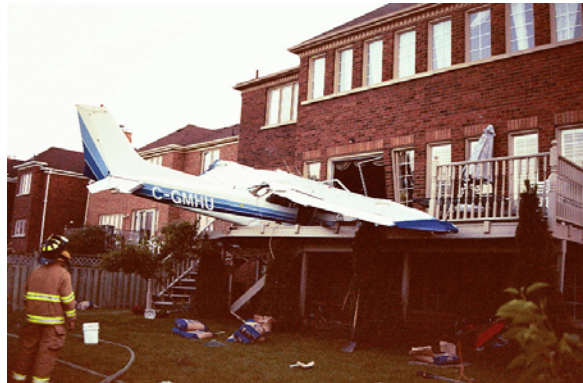
left toward a residential area and struck a house approximately 1.4 nautical miles west-northwest of the Toronto / Buttonville Municipal Airport, Ontario. After the aircraft came to rest on the back deck of the house (Figure 1), one of the occupants of the house assisted the pilot in exiting the aircraft. The aircraft windshield broke during the crash, and the pilot exited through the front of the aircraft. Numerous suitable forced landing sites were available off the departure end of Runway 33 had the aircraft continued straight ahead or altered course slightly to the right.

Figure 1 - Aircraft resting on deck
