## AVIATION INVESTIGATION REPORT

A01P0061

### MAIN-ROTOR BLADE FAILURE

MD HELICOPTERS 369D C-GHFL

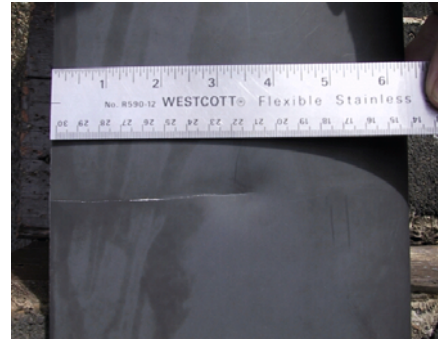
**Figure 1 - Cracked blade**

After the occurrence, company maintenance personnel inspected the blades and found that one of the five blades—part number 369D21100-523, serial number 009999-K077, the blade colour-coded yellow—had cracked at the upper and lower skins, from the trailing edge to the spar.

A nick or inclusion, in the radius of a lightening hole on the C-channel, was introduced at manufacture and compromised the structural integrity of the main rotor blade. This nick caused a stress riser and was the origin of a crack that propagated to the blade's lower skin, trailing edge, and onto the top skin perpendicular to the span of the blade, where the crack stopped near the blade spar. A recent inspection of the blade by company maintenance failed to detect any damage or crack; this suggests that crack propagation may develop rapidly and be difficult to detect.

1. The main-rotor blade failed because its structural integrity was compromised by a manufacturing defect at the edge of a lightening hole in the C-channel, internal to the blade, located about three inches inboard of the data plate.
2. The defect at the lightening hole resulted in a fatigue crack that propagated to the lower skin, rearward to the trailing edge, and around to the top skin going forward in the direction of the blade spar.

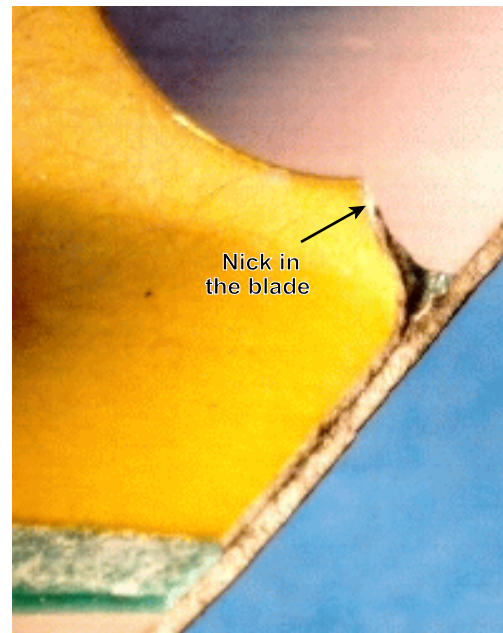
**Figure 2 - Lightening hole**

The failed blade was examined visually and using X-rays, photography, scanning electron microscope, and optical microscope. The examination revealed a fatigue failure and crack that started from a nick or rough radius on the edge of a lightening hole on the C-channel structure of the blade, about three inches inboard of the data plate. The fracture propagated to the top and bottom skins of the blade and subsequently across the cord of the blade, causing a separation at the trailing edge. The fractures stopped at or near the 'D' spar structure near the leading edge of the blade.

MDHI no longer manufactures main-rotor blades for 500-series helicopters. Under parts manufacturing approval, Helicopter Technologies Corporation (HTC) now assures the supply of these blades. HTC has incorporated an ultrasonic inspection as part of its manufacturing process to check for subsurface defects, voids, and cracks that, if undetected, may affect the structural integrity of the blades.
