AVIATION INVESTIGATION REPORT

A02C0079

RISK OF COLLISION

Winnipeg Area Control Centre - Prince Albert Sector

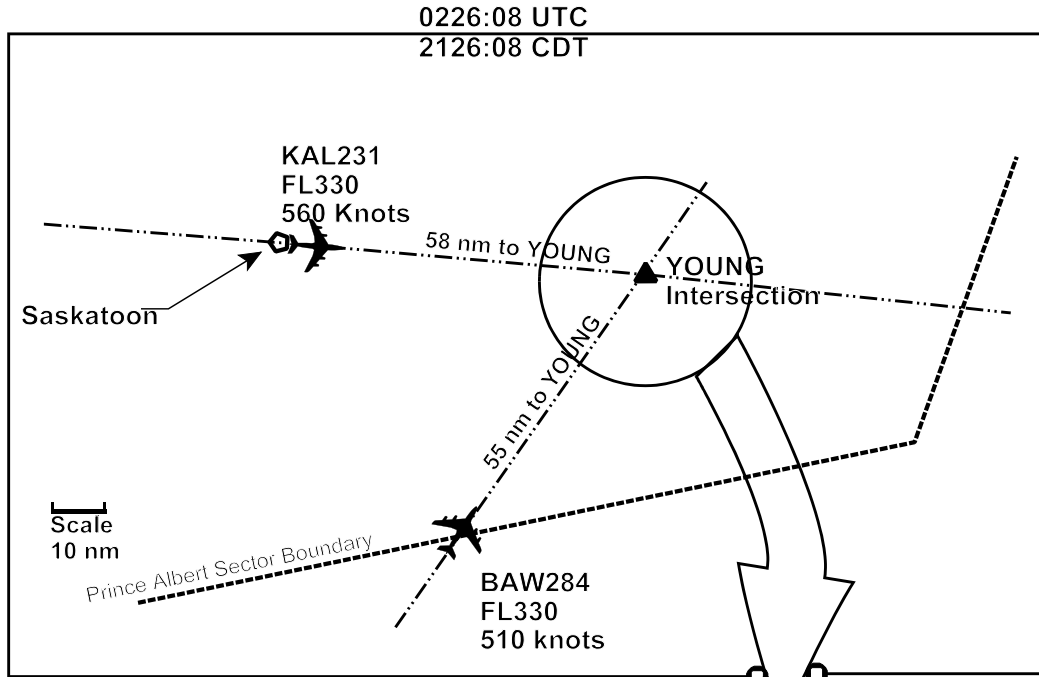
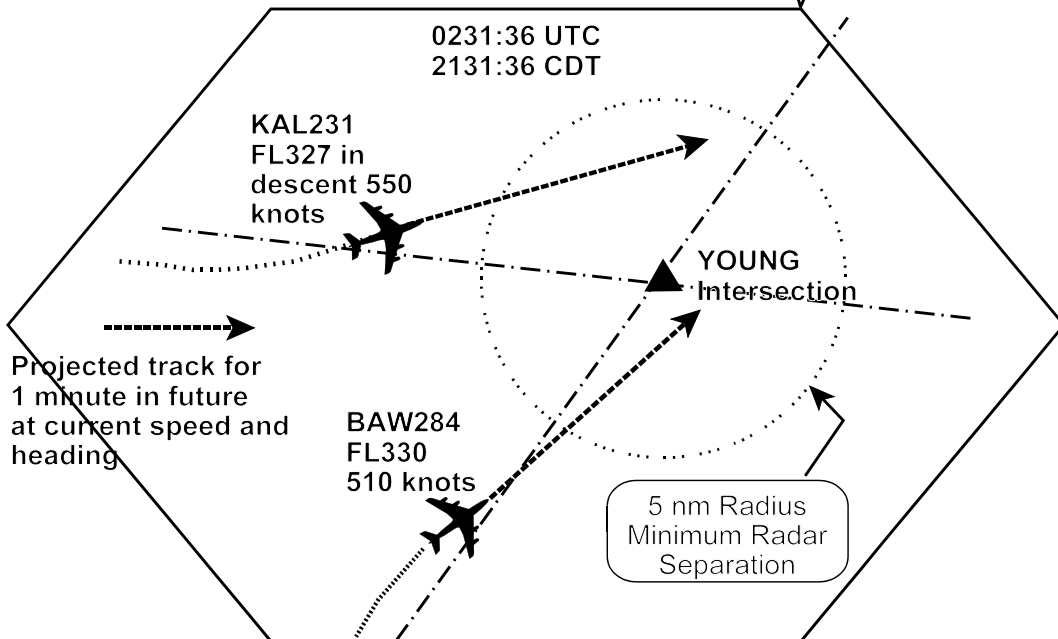
Appendix A - Route of Flight

At 2126, KAL231 passed the Saskatoon fix (see Appendix A). The PA sector controller calculated that KAL231 would cross the Yorkton fix at 2144 and then performed tasks involving three other aircraft. He did not check for conflicts between KAL231 and other aircraft.
