**AVIATION INVESTIGATION REPORT
A02O0105**

LOSS OF CONTROL AND COLLISION WITH TERRAIN

**SILVERLINE HELICOPTERS INC.
SCHWEIZER 269C (300C) C-GGUV
SU34 HARE FIELD, ONTARIO
18 APRIL 2002**

Report Number A02O0105

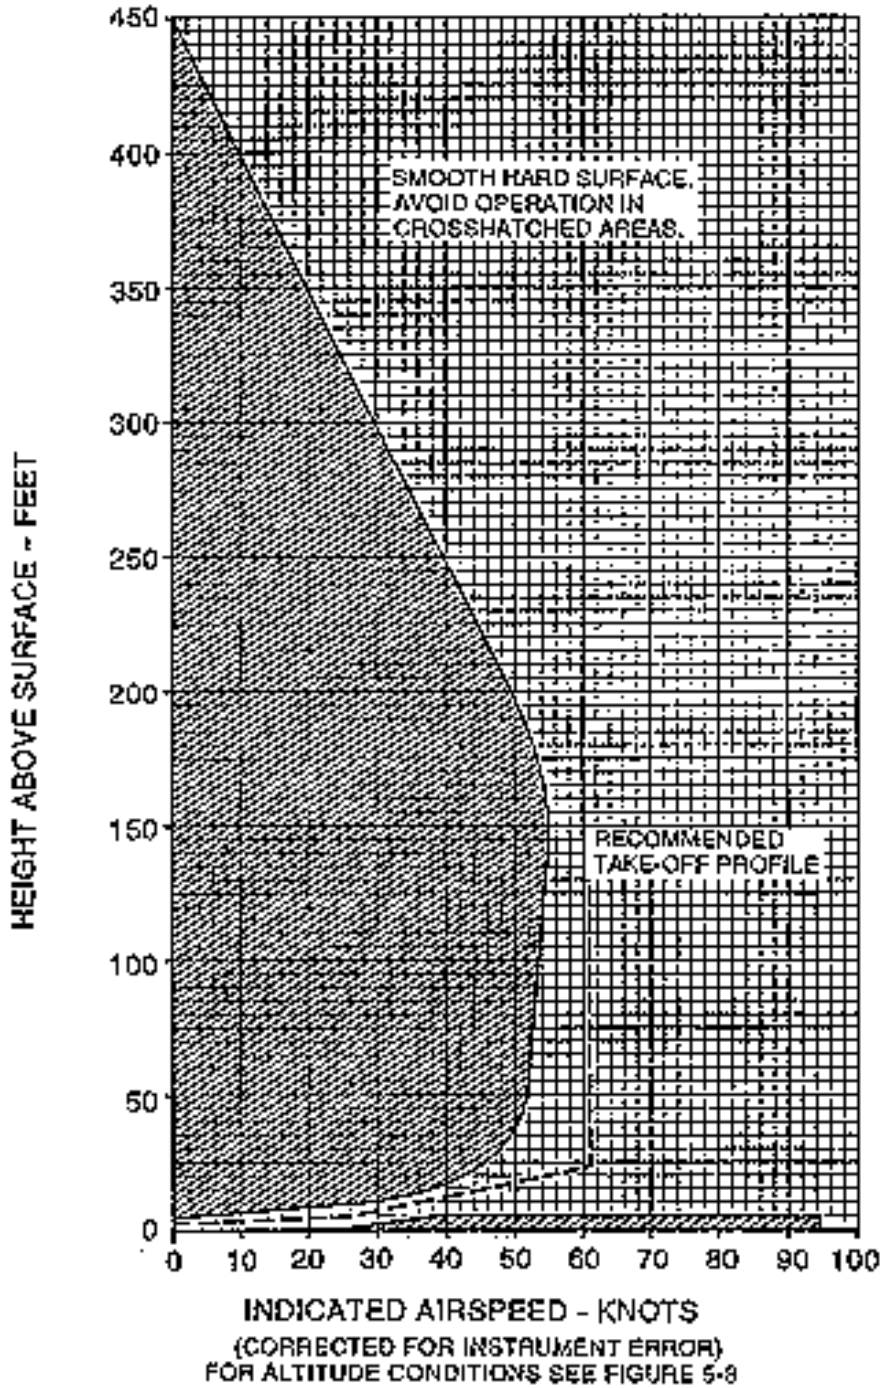
Figure 5-2. Height Velocity Diagram at Sea Level

4. The instructor allowed the helicopter’s speed and height to reach a state from which, according to the height-velocity chart, a safe autorotative landing was unlikely.

2. Transport Canada reference material is ambiguous and incomplete in its treatment of the height-velocity chart. The *Helicopter Flight Training Manual* does not explain the significance of the height-velocity chart nor identify it as a risk that needs to be managed. The *Flight Instructor Guide – Helicopter* refers to the height-velocity chart without an explanation of why.
