AVIATION INVESTIGATION REPORT

A02P0007

AIR PROXIMITY - RISK OF COLLISION

CAMPBELL RIVER, BRITISH COLUMBIA

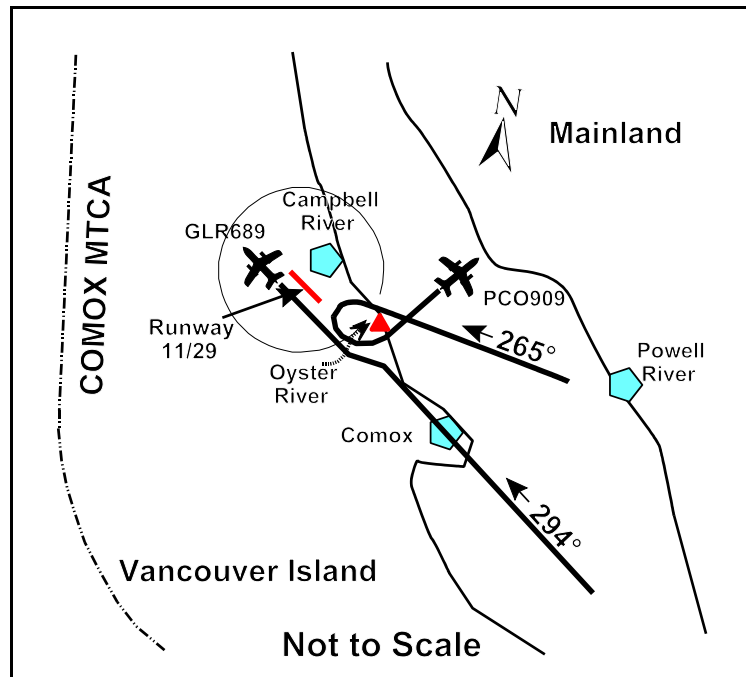
GLR689 had descended into cloud and was within 5 nm of the airport when the crew responded to the TCAS resolution advisory (RA). During these manoeuvres, the crew of each aircraft established visual contact with the other. Both aircraft climbed through 1300 feet asl at the same time, in opposite directions, with spacing between the two aircraft increasing through 0.6 nm. The cloud tops at the time were at about 1200 feet asl.

Figure 1 - Flight paths for PCO909 and GLR689
