## AVIATION INVESTIGATION REPORT

A02P0021

### IN-FLIGHT ENGINE NOSE DOME DETACHMENT

BOEING 737-200 C-FAWJ

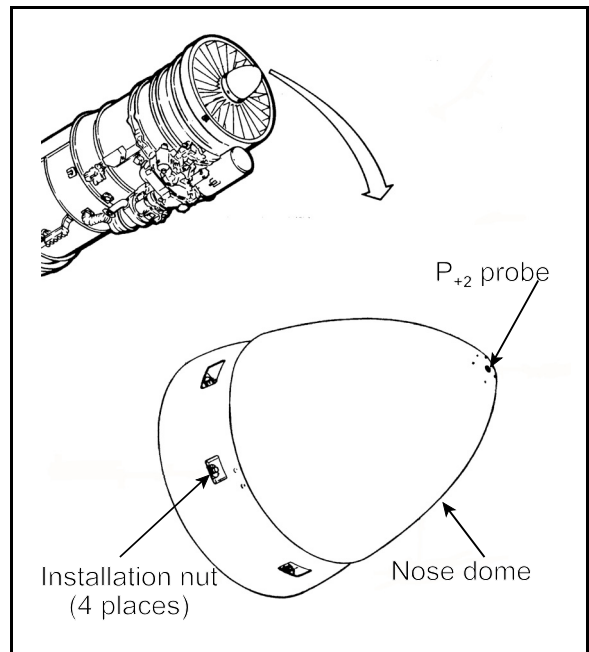
After the engines were shut down, maintenance personnel found that the extended nose dome assembly (see Figure 1) of the No. 2 engine had detached and jammed into the engine inlet guide vanes. The nose dome had broken away from the magnesium engine accessory support to which it is normally attached with four nuts. The nuts are threaded onto steel studs on the accessory support. Examination found that the four nuts had remained attached to the studs, but that the studs had pulled out from the accessory support, and a section of the support near the number-three stud was missing. The nose dome showed secondary impact damage and deformation as a result of contact with the inlet guide vanes. This damage included deformation of the tip, separation of one of the acoustic panels and partial delamination of another, and deformation of the aft edge of the nose dome.

**Figure 1.** Nose cone installation
