AVIATION INVESTIGATION REPORT

A02P0096

LOSS OF CONTROL AND COLLISION WITH TERRAIN

NORTHERN AIR SUPPORT LTD.
BELL 206L4 C-FVEF (HELICOPTER)
THREE VALLEY GAP, BRITISH COLUMBIA
20 MAY 2002

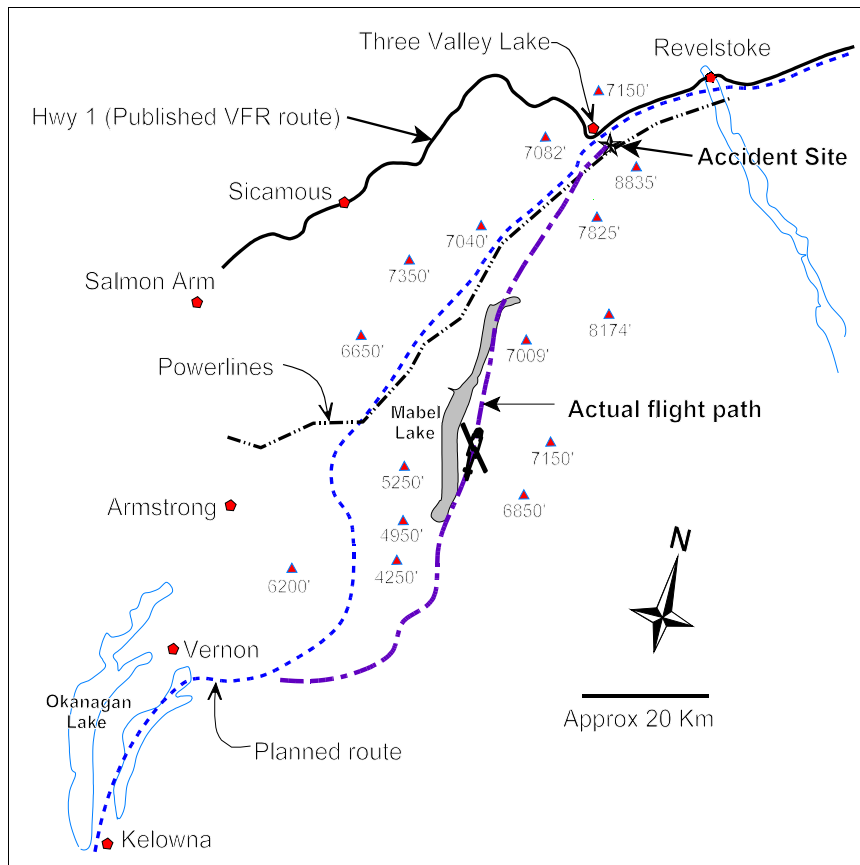
Figure 1. C-FVEF—Planned route and actual flight path

An analysis of the on-board navigation system data reveals that the last recorded track was 046° magnetic at 1749 Pacific daylight time¹ on the day of the accident, at an altitude of 3730 feet above sea level. Furthermore, the data show that Revelstoke airport had been selected as the next (or destination) waypoint, and that it was 10.5 nautical miles (19 km) from the last recorded position. The Revelstoke airport is 053° magnetic and 10.5 nautical miles directly from the accident site.

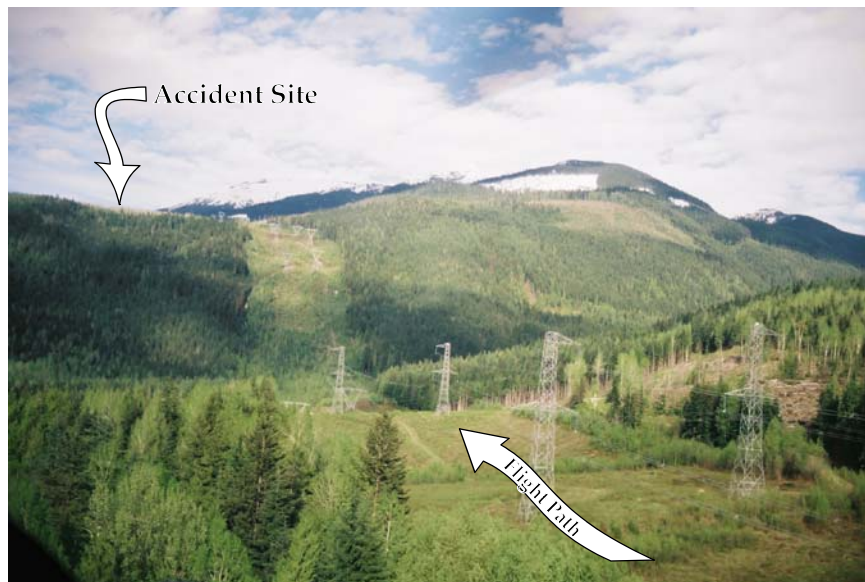
As a result, the pilot of C-FAHS abandoned the direct route along the powerlines to Revelstoke and followed the visual flight rules route along the road that passed through Three Valley Gap without further difficulty. The accident site was on the route segment that followed the powerlines upslope, and was about 100 metres west from the powerlines; in that area, the powerlines follow a path of about 040/220° magnetic (see Figure 2). The pilot of C-FAHS did not encounter any form of precipitation or icing conditions in the Three Valley Gap area. The pilot did observe that the ground in the higher elevations near the powerlines was partially covered with snow but that there was no freshly-fallen snow.

Figure 2. Powerlines leading to the accident site

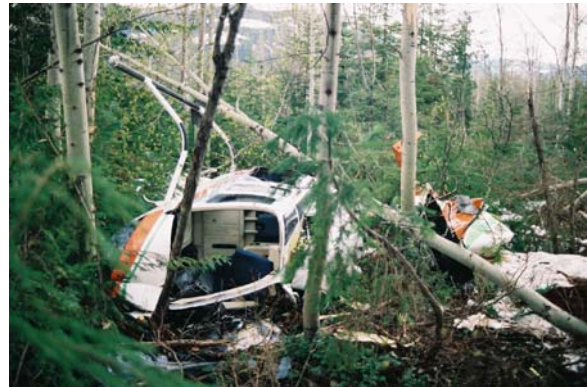
Although the wreckage was extensively damaged by impact forces, all helicopter and rotor system components were found at the accident site. The airframe had broken into three main sections: the main fuselage up to the cargo compartment bulkhead; the cargo compartment section; and the tail boom. No indication of either main or tail rotor blade contact with the airframe was found. In summary, no indication of any pre-existing airframe defect, engine malfunction, or system deficiency was found. The wreckage exhibited damage patterns characteristic of impact with trees and terrain while the helicopter was in a left-side-down attitude in the order of 60° to 70° angle of bank (see Figure 3).

Figure 3. Helicopter wreckage

The characteristics of the damage to the helicopter and the damage found to the trees and terrain, at and around the accident site, indicate that the helicopter was in a steep, left-bank, and slightly nose-down attitude as it passed through the trees and struck the terrain. Such an extreme attitude is not consistent with controlled flight and indicates that the pilot had lost control of the helicopter before impact with the trees.

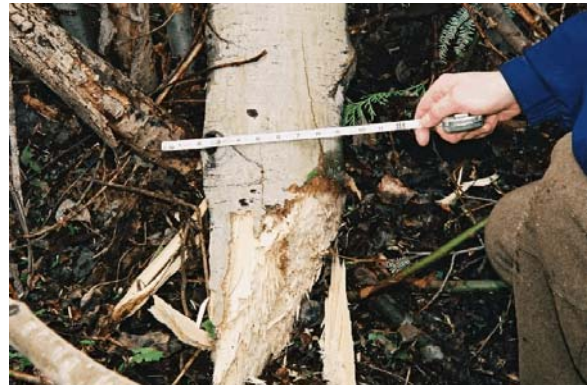
The main rotor blades were badly damaged and broken, and the damage indicates that rotor blades were coned upwards and at a high pitch angle when they broke. Many trees, ranging from a couple of inches to about 10 inches in diameter, were cleanly cut by the main rotor blades (see Figure 4 – many were cut on acute angles, and several trees were cut twice). The tree damage and blade damage indicate that main rotor rpm and energy was significant when the helicopter first entered the trees. The damage to the tail rotor blades and vertical fin is less, and characteristic of lower tail rotor rpm and energy. No indication of rotational scoring was found on any of the tail rotor drive shaft components, signifying that the damage to the tail rotor system occurred when the tail rotor blades were almost stopped.

Figure 4. 7 1/2" diameter tree cut by main rotor blade

The helicopter entered the trees with enough rotor/engine energy to cleanly cut through some fairly large-diameter trees; however, it cannot be stated with any certainty what the rotor rpm was at the time of the initial tree strikes. The damage to the rotor blades was consistent with high coning angle and high blade pitch angle at the time the damage was made. In level flight, these would be an indication of low rotor rpm; however, as the helicopter entered the trees at a bank angle of about 60°, the rotor blades contacting the ground immediately before impact would also result in coning and high blade pitch angle. Although no definite value of the rotor rpm could be ascertained, the transmission low oil pressure light being on indicates that the rotor rpm, at or immediately before impact, was likely below 50%. The tail rotor damage indicates that the tail rotor rpm was fairly low at ground contact, although there are indications that it was higher during initial contact with the trees.
