## AVIATION INVESTIGATION REPORT

A02P0168

### ENGINE POWER LOSS

**TRANSWEST HELICOPTERS LTD.  
BELL 214B-1 (HELICOPTER) C-GTWH  
SMITHERS, BRITISH COLUMBIA, 10 NM S  
07 AUGUST 2002**

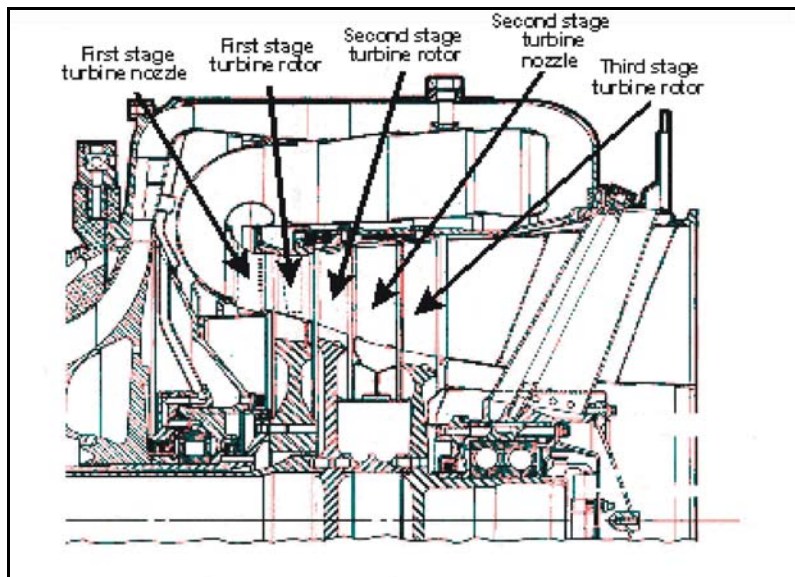
**Figure 1.** Turbine cross section

A post-accident teardown revealed extensive internal damage to the combustion section of the engine. The turbine housing was heavily dented outwards in a band coincident with the third turbine

(part number 2-140-050-36) blade path, and included at least one puncture. The exhaust diffuser showed heavy impact damage to the struts, and tearing and folding of the outer ring. No remarkable damage was noted to the bearings or bearing housing.

The gas flow through the engine downstream of the combustion chamber is through the first-stage nozzle, the first and second-stage turbines, the second-stage nozzle, and the third-stage turbine (see figures 1 and 2). The first-stage nozzle and first-stage turbine had no significant damage. The second-stage turbine (part number 2-140-040-45), which is coupled to the third-stage turbine via the power turbine disc inner spacer, showed tears and dents on the trailing edges of the blades, mostly toward the blade tips. Four of the blades had tip shrouds missing. The second-stage nozzle (part number 2-140-240-01) had largely disintegrated. A cluster of nine vanes remained attached; the vanes of that cluster were torn and dented from the trailing edge side, with the outboard half being the most affected. The third-stage turbine blading was completely destroyed; only blade roots and stubs remained in the disc.

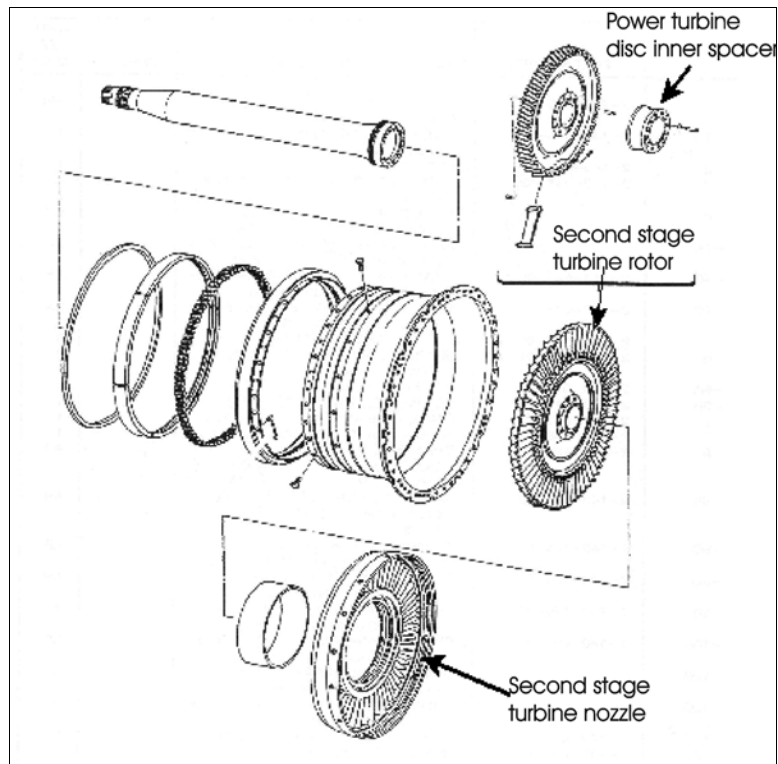
Figure 2. Second stage turbine and nozzle

Although the second-stage nozzle had largely disintegrated, a detailed examination of the remaining structure was conducted. The aft portion of the inner vane support was substantially worn away from being in contact with the forward side of the rotating third turbine. A sample of cracked aft inner support sheet metal was removed and an examination of the fracture surfaces was conducted revealing that the prevailing fracture topography was an oxidized intergranular surface with evidence of multiple secondary cracking. The second-stage nozzle is a brazed assembly. Examination of the remaining seams revealed that the braze between the aft seal and the inner shroud was not uniform and that several areas were nearly devoid of braze. Also, the second-stage nozzle had an unauthorised "window patch" weld repair on the outer ring, and the nozzle serial number appeared to have been altered.

Damage to the second-stage nozzle and third-stage turbine indicate that the two components contacted each other while the engine was operating at significant rpm. The damage pattern suggests that the failure sequence was initiated by a loss of integrity of the second-stage nozzle, possibly due to extensive cracking or separation of a braze joint. Such damage is likely to have caused a remarkable loss in delivered engine power, yet insufficient to cause the engine to stop.

1. The engine failed as the result of the second-stage nozzle failing and coming into contact with the third-stage turbine.
2. The second-stage nozzle failed, possibly due to extensive cracking or separation of a braze joint.
3. The second-stage nozzle failed non-destructive testing and was not subsequently repaired or certified airworthy; however, it was installed in the engine.
