AVIATION INVESTIGATION REPORT

A02P0320

LOSS OF ENGINE POWER / COLLISION WITH TREE

HAYES HELICOPTER SERVICES LIMITED
SIKORSKY S-61N (SHORTSKY) HELICOPTER C-FHHD

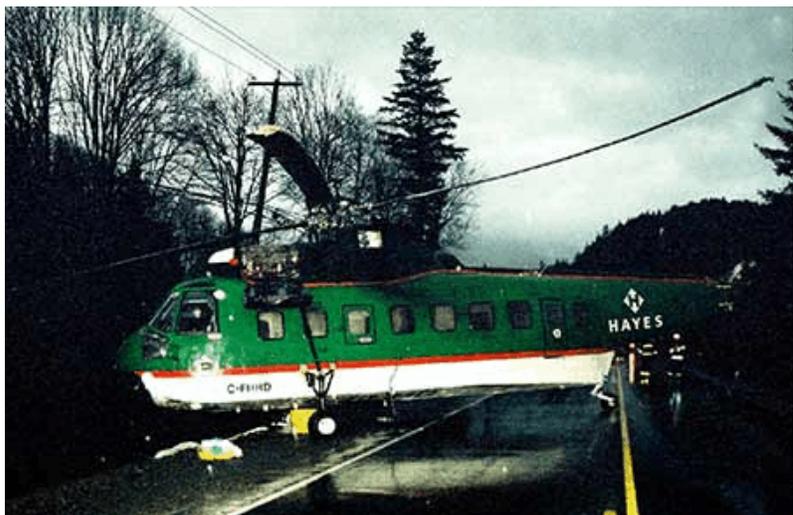
C-FHHD was owned and operated by Hayes Helicopter Services Limited of Duncan, British Columbia (B.C.), and was principally engaged in heli-logging activities in B.C. The helicopter was originally manufactured by Sikorsky Aircraft in 1971, and was later modified by Heli-Pro Corporation in March 1996 to the shorter, civilian

Shortsky model, similar in size to the military SH-3 “Sea King” helicopter. Sikorsky Aircraft Design Engineering was not involved in the modification, and Hel-Pro Corporation was not Sikorsky-approved. The modification was not approved by Sikorsky; however, it was approved by Transport Canada (TC). The helicopter is equipped with two General Electric Aircraft Engines (GEAE) model CT58-140-1 gas-turbine engines. At the time of the accident, the helicopter had accumulated about 30 323 hours total flight time as both original and modified airframes.

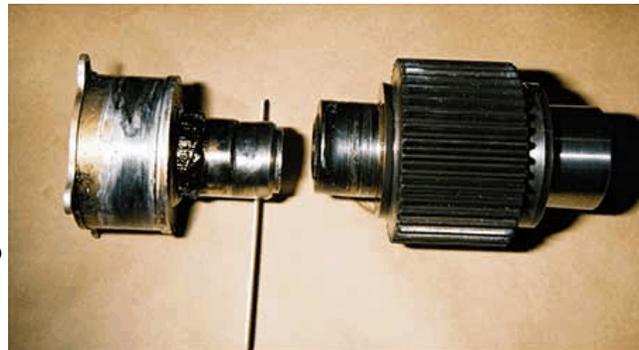
The MGB attachment fittings on the fuselage were intact. The MGB was undamaged, with the exception of the Number 1 (left)¹ input pinion gear (Photo 2) which had fractured just forward of the forward bearing journal, and its associated forward plain bearing (located in the MGB cover) which had mostly disintegrated. The splined coupling showed severe rub on the gimbal ring.

Once the number 1 plain bearing began to fail, the adjacent carbon seal broke down, allowing oil to spray out from the MGB. Without sufficient lubricant, the number 1 pinion rapidly overheated and weakened, leading to thermal distress, distortion, and subsequent fracture. The pinion fracture surface exhibits equiaxed ductile dimples, indicating tensile or bending overload, rather than torsional overload. Accordingly, the torque on the pinion was low when it broke. While components adjacent to the fracture were covered with soot, oil, and grease, the fracture surface itself was free of contamination, which may indicate that the break occurred after the grease and oil sprayed from the damaged bearing and coupling, and after the fire.

Structural analyses of the stresses present at the fracture site revealed that the initial effect of lubricant loss was severe and rapid friction wear between the pinion gear and the bearing. As the wear progressed, the gear radially displaced from the centerline of rotation, allowing the entire shaft assembly to orbit, creating a centrifugal load imbalance that would have been manifest as a high-frequency vibration. The imbalance would have also created a remarkable bending load on the components, forming the highest stress at the fracture point on the pinion. Calculations showed that such centrifugal forces can create bending loads that exceed the ultimate tensile strength of the pinion with about three degrees of coupling misalignment. Since the pinion was subjected to thermal distress as well, the ultimate tensile strength would have been reduced, and the misalignment required to fail the component would have been proportionally less. Given this situation, it could be said that the misalignment could have occurred with intact engine mounts; although a possibility, there is insufficient information to be conclusive.
