AVIATION INVESTIGATION REPORT

A02Q0005

COLLISION WITH TERRAIN

PIPER PA28-161 C-GBQY

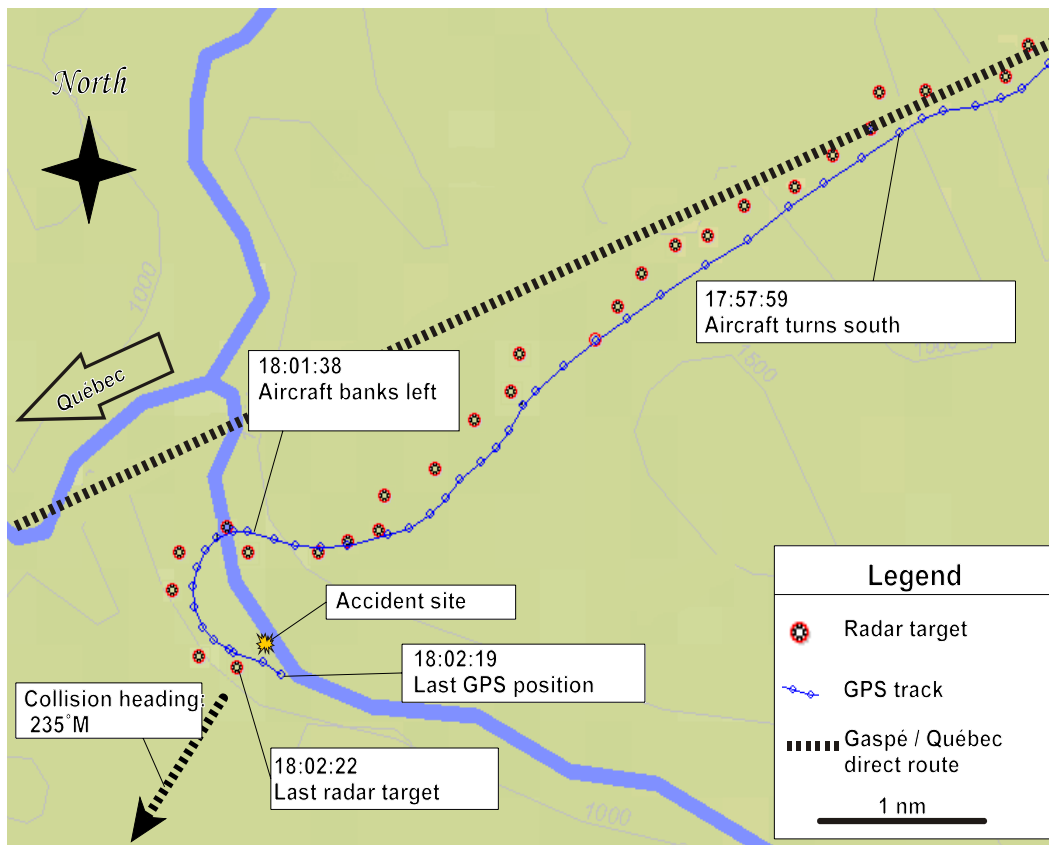
The aircraft followed a direct path between Gaspé and Québec, staying within about 100 feet of an altitude of 5000 feet, with a relatively steady ground speed of 95 knots. At 1758, at 130 nm from Gaspé and 170 nm from Québec, the aircraft turned slightly south of its path. One minute later, the aircraft turned its heading even more to the south. It then banked right on a heading to return to the direct path to Québec. At 1801, the aircraft initiated a banked left turn of about 20°. During the turn, the aircraft's altitude went from 5000 feet asl to 4600 feet asl, and the ground speed increased from 93 knots to 159 knots in 30 seconds. Ten seconds later, the GPS stopped recording the aircraft's track at an altitude of 4739 feet and at a heading of 138° M. At the same moment, the radar stopped receiving the transponder signals, and the aircraft's echo (secondary and primary) disappeared from the screen. The last recorded position was less than 200 metres from the crash site (see Figure 1).

Figure 1. Radar and GPS data for the last four minutes of flight
