AVIATION INVESTIGATION REPORT

A02Q0021

IN-FLIGHT ENGAGEMENT OF COLLECTIVE LEVER LOCK

EUROCOPTER AS 350 BA C-FPOO

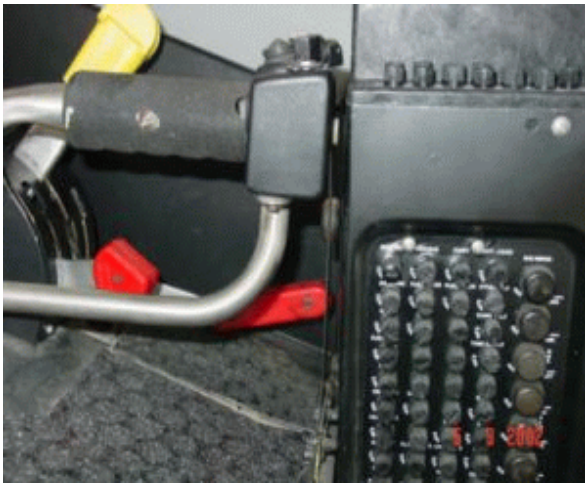
TSB investigator. But the space between the end of the collective lever and the electrical console was about 5 mm (see Figure 1), which is 11 mm less than the Eurocopter specification (16 mm \pm 0.5 mm) (see Figure 2).

Figure 1. Space for locking plate: 5 mm

Examination of the occurrence helicopter also revealed that some work had not been completed by the AMO. The stop screw was in an inverted position, and the connecting rods were shorter than those prescribed by the manufacturer, which allowed the collective control to overtravel down. This condition, combined with the down setting of the collective lever and the collective locking plate setting, contributed to the locking of the collective control by reducing the space between the electrical console and the collective lever.

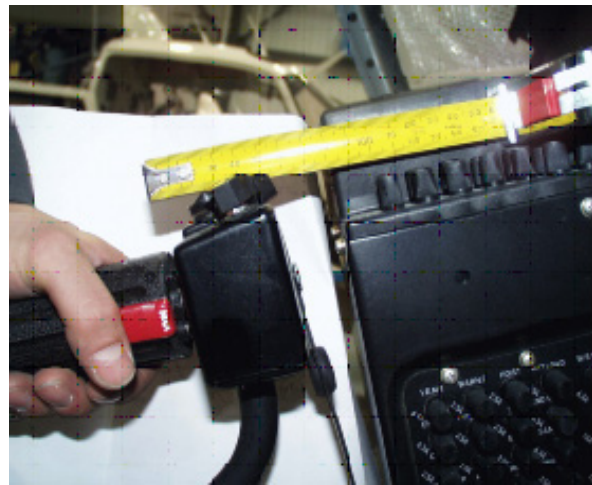
Figure 2. Normal position with space of 16 mm
