AVIATION INVESTIGATION REPORT

A02W0115

LOSS OF SEPARATION

NAV CANADA
EDMONTON AREA CONTROL CENTRE
EDMONTON, ALBERTA 60 NM S
27 JUNE 2002

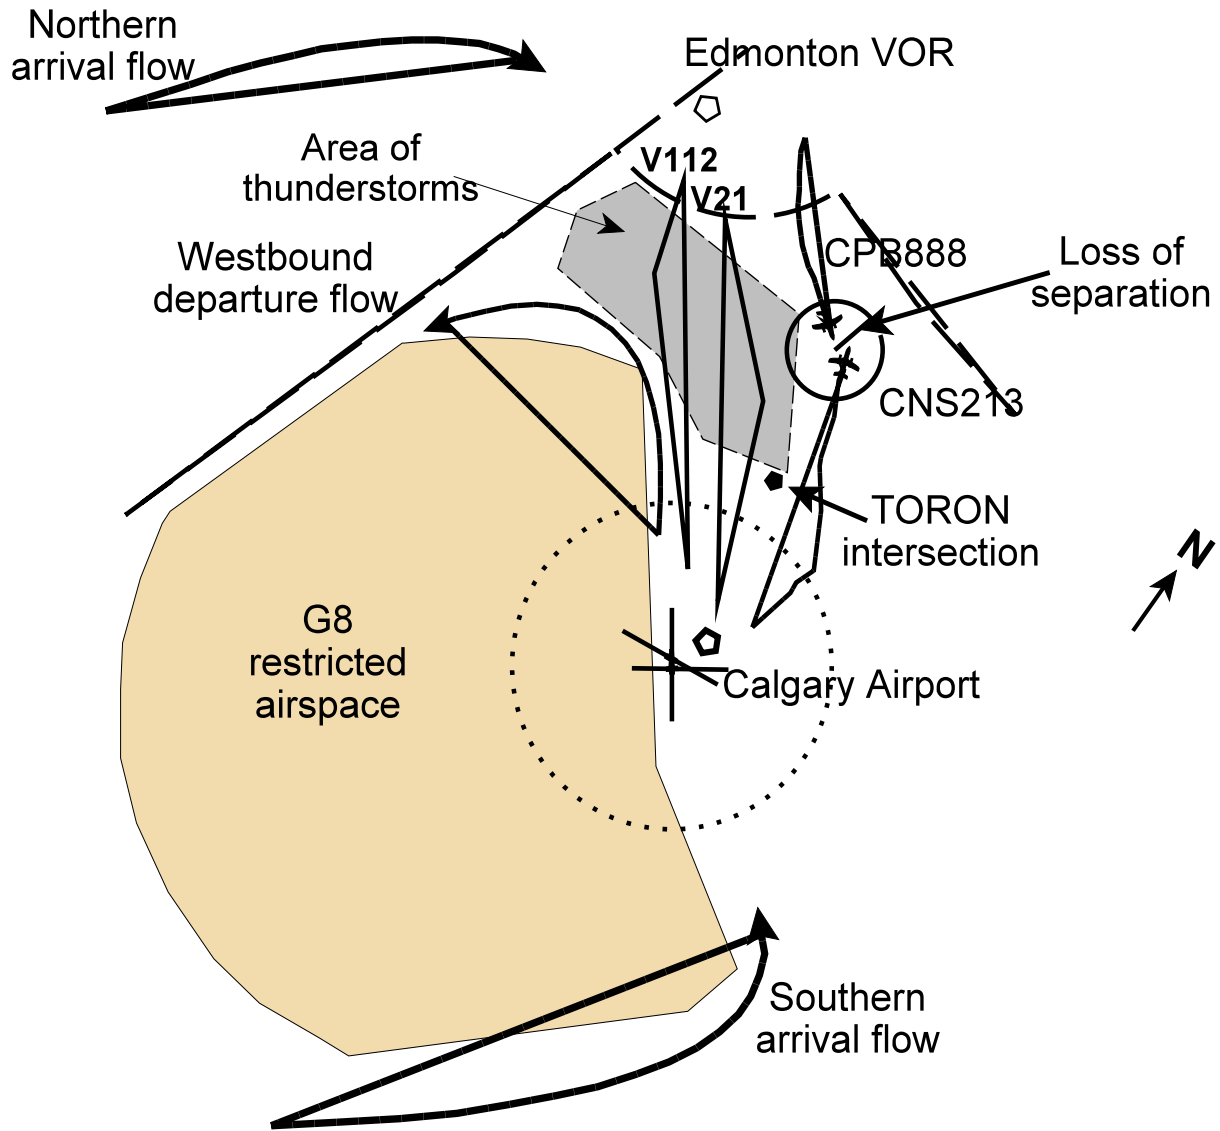
Appendix A - Occurrence Diagram

For the three-day duration of the G-8 Conference at Kananaskis, Class F restricted airspace (CYR255) was established to prevent unauthorized aircraft from entering the area. CYR255 was an irregularly shaped area with an approximate 80 nautical mile radius around the conference site. (See Appendix A - Occurrence Diagram). Aircraft travelling west from Calgary had to be routed around the northeast corner of CYR255 in the Red Deer en route sector before proceeding west. Civilian flights were only to be allowed into the restricted area in emergency situations, and unauthorized aircraft penetrating the restricted area were at risk of being intercepted by military fighters.
