**AVIATION INVESTIGATION REPORT
A03P0244**

RISK OF COLLISION

**NAV CANADA
VANCOUVER AREA CONTROL CENTRE – WEST SPECIALTY
PORT HARDY, BRITISH COLUMBIA, 26 NM W
11 AUGUST 2003**

Report Number A03P0244

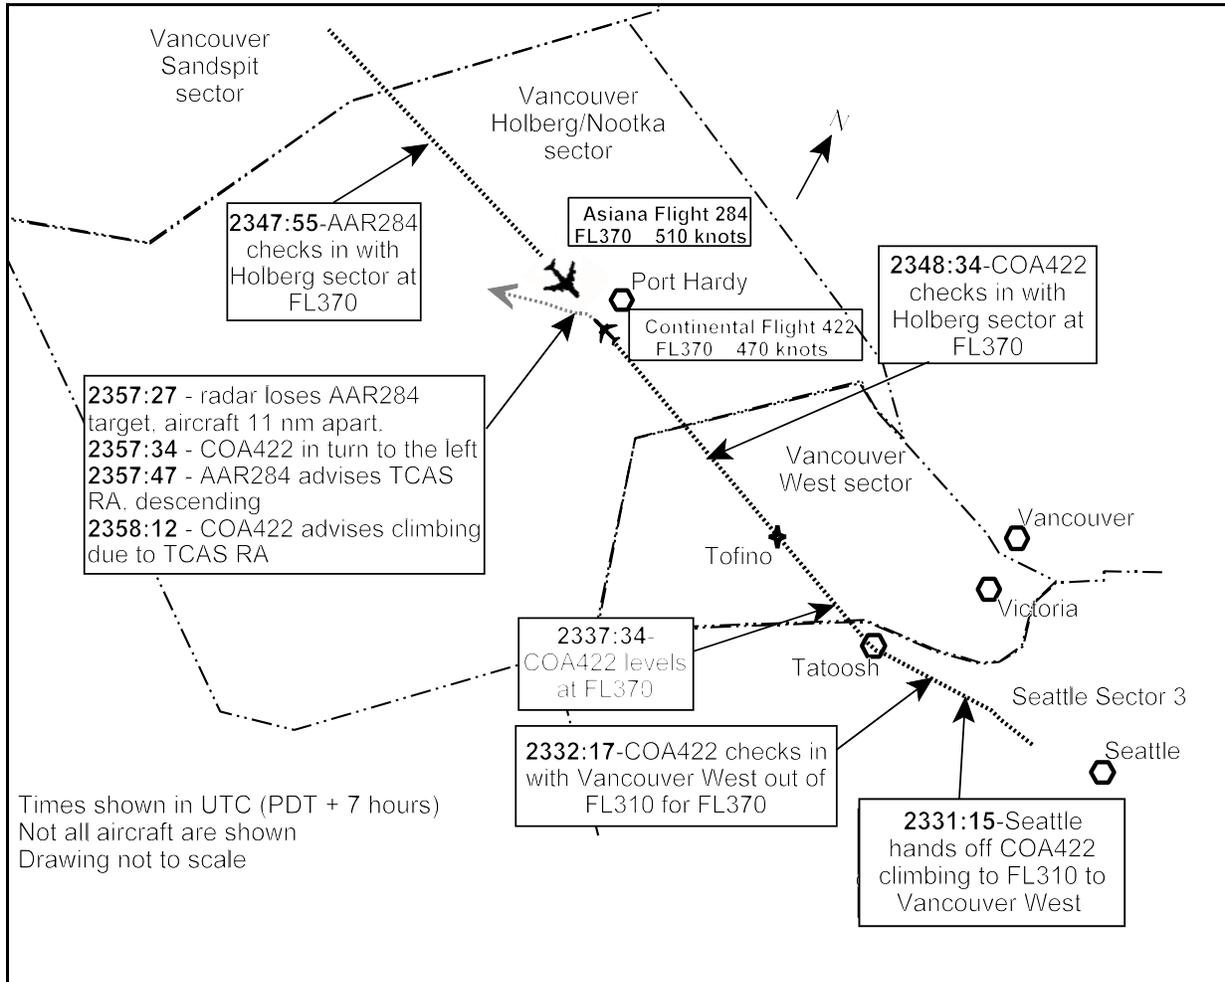
Appendix A – Sequence of Events

At 1632:17 Pacific daylight time,¹ COA422 contacted the West controller and reported passing FL310 for FL370 (see Appendix A). The West controller acknowledged with the word “roger” and, in the same transmission, asked the pilot to change the transponder code. No annotation to indicate reported FL was entered on the flight data strip. The West controller did not observe the change in FL as COA422 continued the climb above FL310 and did not notice that COA422 was at FL370 for the 10 minutes prior to the handover to the Holberg/Nootka sector.
