AVIATION INVESTIGATION REPORT

A05O0142

DIFFICULTY TO CONTROL

BELL 204B C-GRGY

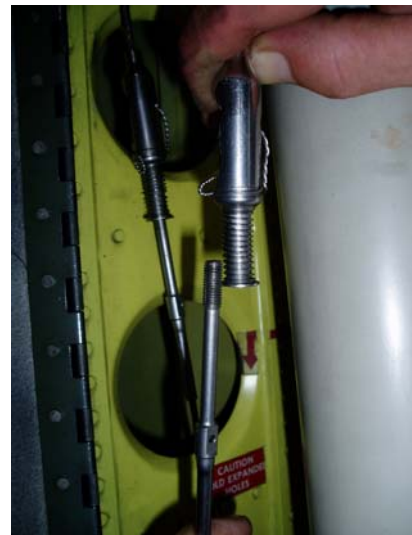
On checking the helicopter after the flight, it was discovered that a cable to the tail rotor pitch change mechanism had come undone. Investigation by the company showed that the cable had come undone at one of the two speed rigs,² and that the threaded end of the speed rig had not been lock wired. Additionally, it was found that the threaded end of the other speed rig had also not been lock wired (see Photo 1).

Photo 1. Speed rig and cables as found

The investigation found that, following the initial tail-boom installation, the AME followed the procedures in the maintenance manual, but only lock wired the quick disconnect and not the threaded portion of the speed rig. The last part of the instructions states, "Lockwire the speed rigs as shown in figure 7-32. Check complete tail rotor pitch control system for security, safetying and freedom of operation." The maintenance manual instructions were reviewed and found to provide adequate guidance for the task. A properly lock-wired speed rig will have one piece of lock wire securing the quick-disconnect ball end and another piece securing the threaded end (see Photo 2). The error made in lock wiring was duplicated in the subsequent Part A inspections. As well, the investigation found that the hole where the lock wire goes through the speed rig on the threaded end was small and partially hidden by a spring.

1. The tail rotor pitch change cable speed rigs were not lock wired in accordance with approved methods. As a result, one cable speed rig came undone, and tail rotor authority was lost.
2. The independent control inspection was not carried out in accordance with the standards described in the *Canadian Aviation Regulations* or relevant Airworthiness Notification, and the missing lock wire was not detected.

Following the occurrence, the operator conducted a training program for maintenance and operations personnel. The aim of the program was to refresh all personnel in the proper locking of turnbuckles and aircraft components in general, and to educate all personnel on what to look for when conducting an independent inspection on each aircraft operated by the company. The aircraft maintenance engineer (AME) who was involved in this occurrence developed and delivered the program to employees.
