**AVIATION INVESTIGATION REPORT  
A05P0189**

**COLLISION WITH TERRAIN**

**NORTHERN THUNDERBIRD AIR  
RAYTHEON BEEHCRAFT KING AIR 200 C-FCGL  
SHOVELNOSE CREEK, BRITISH COLUMBIA  
28 JULY 2005**

Report Number A05P0189

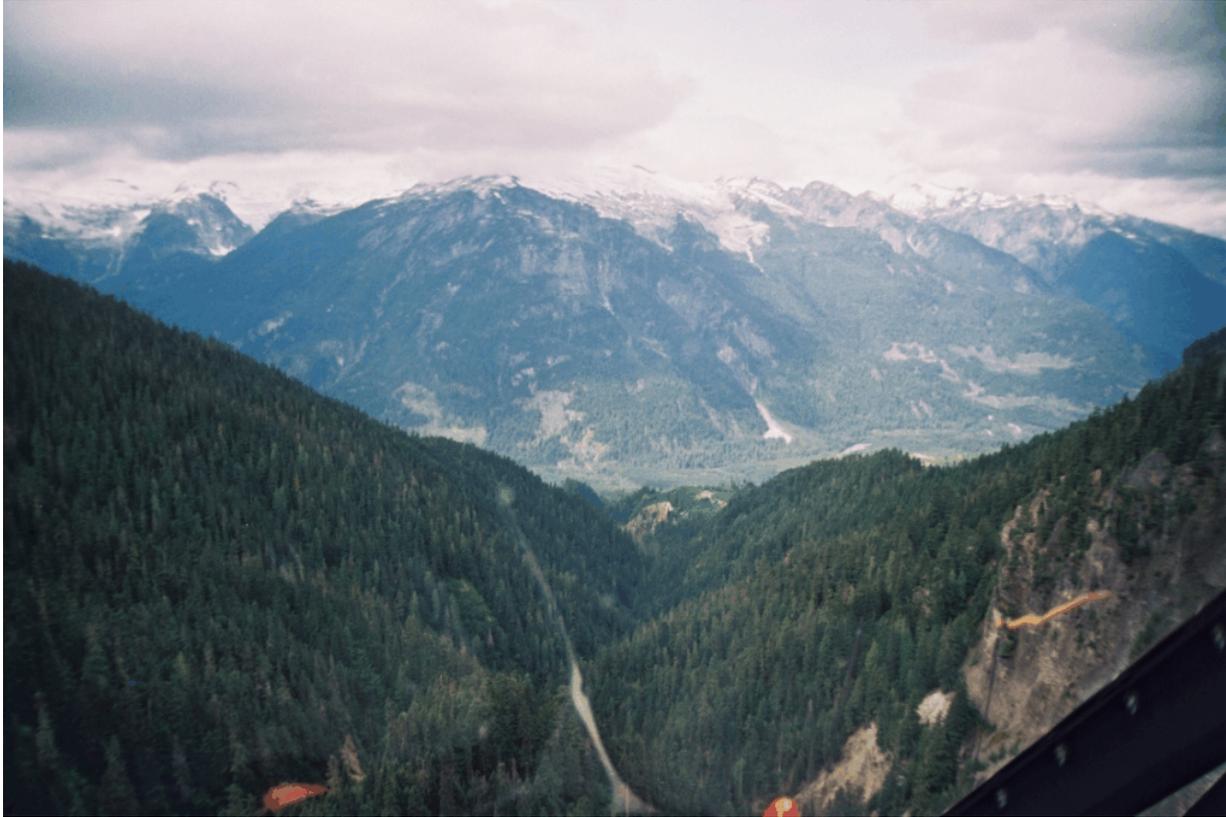
*Appendix A – View Down the Valley from Above the Accident Site*

The wreckage was found in the Shovelnose Creek valley at an elevation of 3900 feet asl. The aircraft had clipped the tops of two trees before contacting the 33° slope at about a 33° pitch angle. Measurements of the angle and direction between the two clipped tree tops indicate that the aircraft was climbing at an angle of about 12 or 13° when it struck the two trees, and was flying on a track of 038° M. The average slope was 11°, but it was much steeper at the accident site.

It could not be determined why the pilots turned northeast and flew up Shovelnose Creek at a low altitude. It is possible that this was a navigational error. This canyon narrows quickly, the terrain rises very steeply, and the slope exceeds the climb capability of the aircraft. The pilots' attention was probably focused outside of the aircraft and, by the time they realized they were reaching the aircraft performance limits, there was not enough room to reverse course and their only option was to out climb the terrain. Information from the aircraft manufacturer indicates that the aircraft, with specification performance, would be able to climb at an angle of 13°; however, this was insufficient to clear the steeply rising terrain.
