AVIATION INVESTIGATION REPORT

A05W0176

CONTROLLED FLIGHT INTO TERRAIN

**CESSNA 180H C-FYIX
MOUNT BURNS, ALBERTA
22 AUGUST 2005**

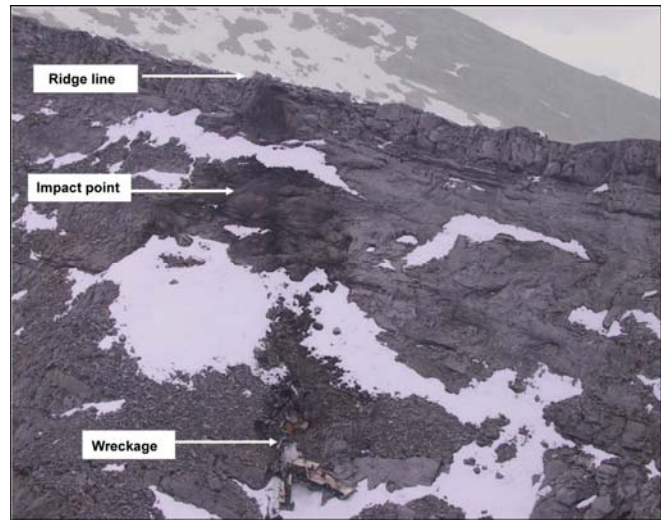
The aircraft contacted a near vertical cliff on the northeast face of a 9000-foot ridge. The point of impact was about 50 feet from the top of the ridge, which was oriented southeast to northwest. Damage to the aircraft indicated that it was in straight and level flight at the time of impact.

Most of the wreckage came to rest on a steep scree slope about 100 feet below the point of impact. Small pieces of wreckage were found on the other side of the ridge. A fuel-fed, post-impact fire consumed most of the aircraft. The pilot was found with the wreckage, and the passenger was found about 500 feet below. The propeller was not found; however, examination of the engine crankshaft indicated that the engine was delivering some power at impact. Higher terrain existed within one mile on an extension of the aircraft's track past the ridge (see Photo 1).

Photo 1. View of accident site

The occurrence fits the definition of CFIT. Since it does not appear that significant, timely evasive manoeuvres were attempted to avoid impact with the mountain, it is likely that the pilot did not have visual contact with the mountain top. The flight profile obtained from air traffic control (ATC) radar data and wreckage trail analysis suggests that, at the time of impact, the aircraft was under control and the engine was developing power. Since the aircraft struck the ridge at a relatively stable airspeed and heading (straight and level flight), it is likely that the pilot’s vision was obscured by cloud immediately before impact. It is also possible that, in attempting to cross the ridge, the aircraft entered a downdraft and was unable to out-climb the terrain. Had the aircraft successfully crossed the 9000-foot ridge, its track would have intercepted significantly higher terrain within one mile.

1. The aircraft was likely flown into cloud, which prevented the pilot from seeing and avoiding the high mountainous terrain.
