Transportation Safety Board
of Canada

**AVIATION INVESTIGATION REPORT
A06P0224**

LOSS OF VISUAL REFERENCE - COLLISION WITH TERRAIN

**VIH HELICOPTERS LTD.
BELL 206B (HELICOPTER) C-GWUF
KNIGHT INLET, BRITISH COLUMBIA
25 OCTOBER 2006**

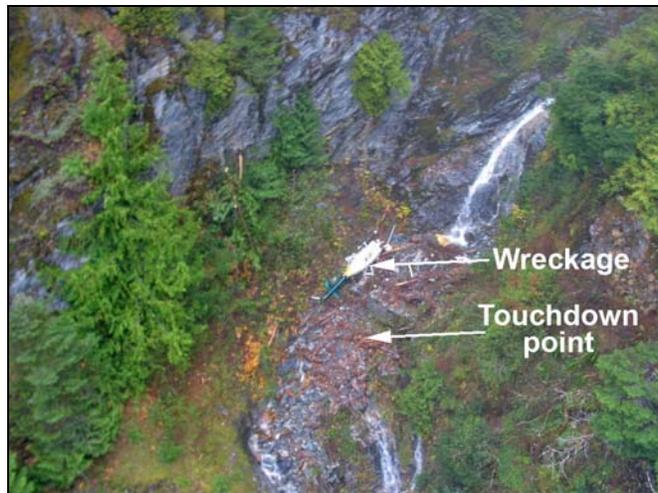
The landing site was a terraced ledge, about 40 feet wide, in a steep gorge on the west face of the mountain, and adjacent to a rapidly flowing waterfall. The site was surrounded by tall trees and almost-vertical rock faces, and the landing surface consisted mainly of loose rock and forest debris, constantly wet from the waterfall flow. The distance from the touchdown point to the waterfall rock face was about 50 feet, and the helicopter ended up about 20 feet away from the waterfall (see Photo 1).

Photo 1. View of touchdown area

1. The selected touchdown area was significantly sloped and the surface consisted of loose rock and debris, which allowed the skids to slip rearwards when the rear passenger climbed onto the left skid.
2. Saturated air, low temperature, rain, and mist from the waterfall caused significant water droplet accumulation on the outside surfaces of the helicopter windshields, impairing the ability of the pilot to maintain visual reference.
3. The air in the cockpit quickly became saturated when the first passenger entered the cockpit, causing the rapid formation of heavy condensation on the inside surfaces of the helicopter windshields and front door windows.

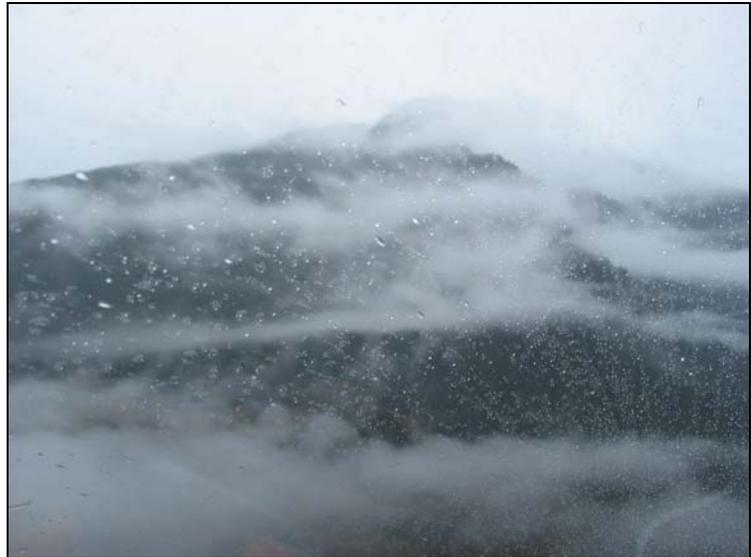
The weather conditions on the following day were reported by site personnel as quite similar to the day of the accident, and Photo 2 shows the weather conditions likely faced by the accident pilot.

Photo 2. View through windshield of likely weather conditions

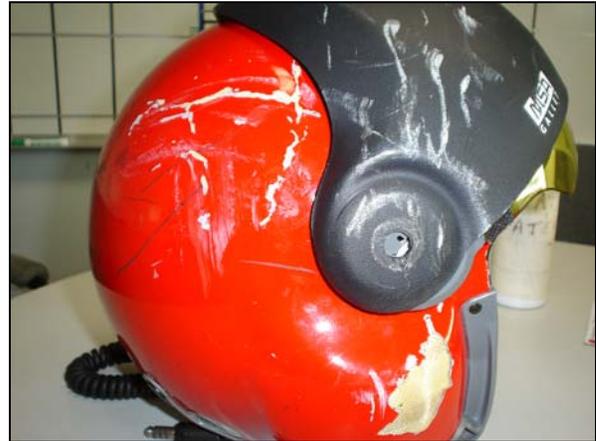
The injuries to the passenger in the left front seat and the pilot were caused by impact forces when the helicopter rolled over and struck the terrain. The passenger outside the helicopter received minor injuries when he dropped from the skid before the helicopter crashed. Medical information and injury patterns indicate that the pilot and passenger in the cockpit were wearing full seat restraints, and the pilot was wearing a flight helmet (see Photo 3). Both these factors contributed to their survival of the impact and the lessening of their injuries.

Photo 3. Damage to pilot's helmet

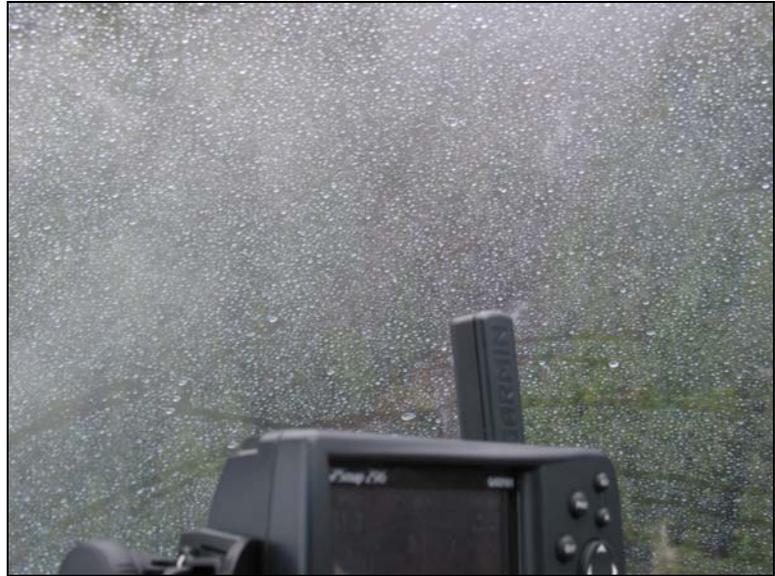
An additional restriction to vision for a Bell 206 pilot occurs in rain because the helicopter is not equipped with windshield wipers. When the helicopter is in forward flight, rain on the windshield runs off with a small amount of beading. However, at low forward speeds, and particularly in the hover, the airflow over the windshield is reduced and water can accumulate and cause significant restriction to visibility. Photo 4 shows the forward visibility from a Bell 206 cockpit at low forward speed in moderate rain.

Photo 4. Forward visibility in moderate rain
