AVIATION INVESTIGATION REPORT
A06W0002

IN-FLIGHT ENGINE FIRE

BUFFALO AIRWAYS LIMITED
DOUGLAS C-54G-DC (DC-4) C-GXKN
NORMAN WELLS, NORTHWEST TERRITORIES (CYVQ)
05 JANUARY 2006

Report Number A06W0002

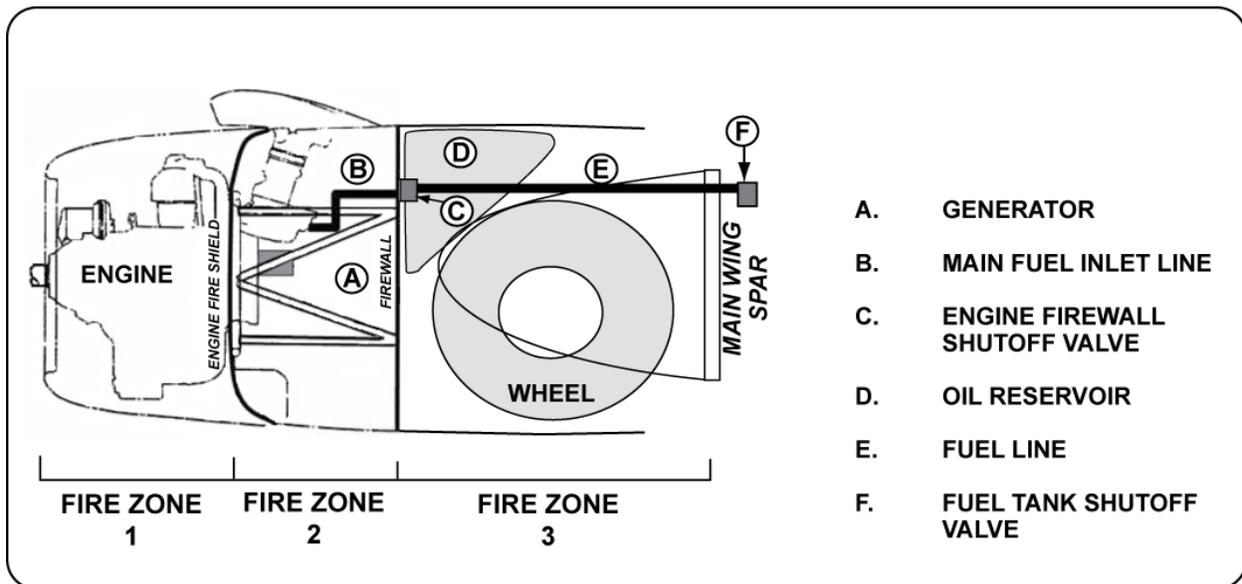
The Engine Fire Checklist procedures (see Appendix A) contained steps to shut down the engine, close the firewall shutoff valves to stop the flow of fuel, oil and hydraulic fluids to the engine, and discharge the CO₂ fire extinguishers into zones 2 (engine accessory section) and 3 (nacelle section). Closing the firewall shutoff valve had no effect on the flow of fuel into Zone 3 because the fire had compromised the fuel line between the tank and shutoff valve (see Figure 1).

Figure 1. Number 2 engine nacelle diagram

A vital action with an in-flight fire is to remove the source of fuel immediately. Closing the firewall shutoff valve in accordance with the Engine Fire Checklist did not cut off the flow of fuel to the fire area. When the fuel selector was closed as per the subsequent Engine Securing Checklist, the fuel flow stopped. If the fuel selector had been turned off as part of the initial Engine Fire Checklist, the fire would have been extinguished earlier.

The operator has amended the Engine Fire Checklist and the standard operating procedures for Engine Fire in the Air, with the addition of “Fuel Selectors Off “immediately after “Mixtures to Idle Cut Off.”

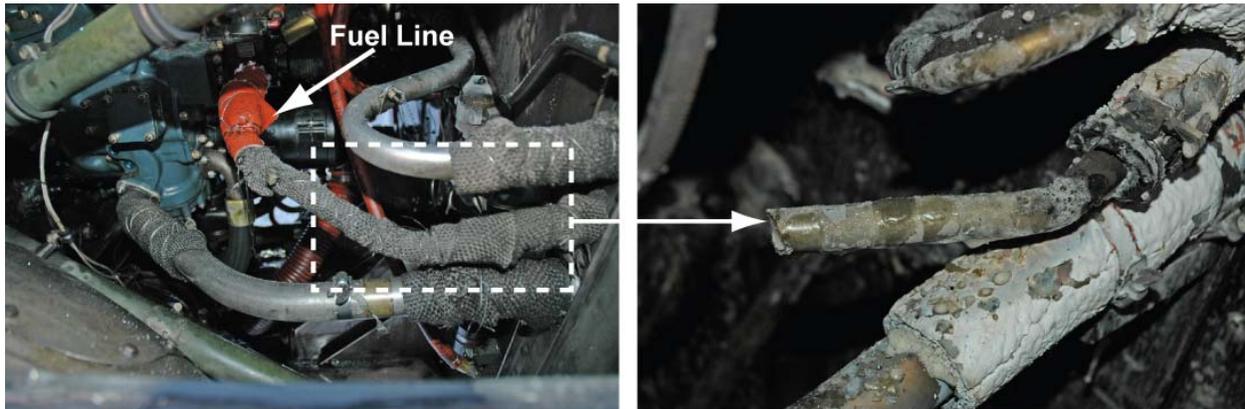
Examination of the number 2 engine area (Pratt & Whitney USA, R-2000) indicated that the fire originated in the lower left-hand accessory section (Zone 2). The intensity of the fire was consistent with a fuel-fed fire accelerated by engine oil and hydraulic fluid. The fuel source was the main fuel inlet line assembly, which is routed from the outboard firewall area to the engine-driven fuel pump. The line assembly consisted of a rigid tubular aluminum line connected with rubber hose couplings at the firewall and fuel pump fittings secured with hose clamps. There was no record of when the rubber couplings were last replaced, or their time in service. This assembly (see Figure 2) was wrapped and water-glassed from the firewall to the pump fitting. A fire shield sleeve was installed over the connector and fitting at the fuel pump. No special inspection criteria or schedule for this assembly is specified except for a leakage test at engine change. In June 1948, Douglas Aircraft issued Service Bulletin (SB) DC-4 No. 66 regarding engine fire prevention on aircraft specified by *Civil Air Regulations* amendments 41-3, 42-2, and 61-2. The SB specified a replacement flexible hose assembly to eliminate the aluminum line/rubber couplings/hose clamp assembly. An Airworthiness Directive (AD 48-12-01) was subsequently issued mandating the implementation of SB DC-4 No. 66 for aircraft used for air carrier operations. The modification had not been incorporated on C-GXKN.

Figure 2. Typical installation of the Zone 2 fuel line compared to the compromised fuel line.

The fuel line assembly of metal tubing, rubber hose couplings, and hose clamps increased the possibility of leaks due to the different expansion rates of materials. The sealing characteristics would be more critical when subjected to drastic in-service temperature changes, rubber hose aging, and heat deterioration. The wrapping and fire sleeve would conceal any evidence of minor seepage until the leakage had progressed substantially. The SB and AD that mandated the replacement of the fuel line had not been implemented on C-GXKN.

1. Airworthiness Directive AD 48-12-01 mandates the replacement of the potentially hazardous fuel line, but the line had not been replaced on this aircraft.
2. A fuel leak from the main fuel inlet line in the engine compartment of this cargo DC-4 caused an in-flight fire that spread into the nacelle and wing.
3. The fuel-fed fire burned for an extended period of time because turning the fuel selector off is not required as part of the primary Engine Fire Checklist.
