**AVIATION INVESTIGATION REPORT
A07C0151**

HARD LANDING - FUEL LEAK AND FIRE

**SUNDANCE BALLOONS INTERNATIONAL
FIREFLY 12B (HOT AIR BALLOON) C-FNVM
WINNIPEG, MANITOBA, 15 nm NE
11 AUGUST 2007**

Report Number A07C0151

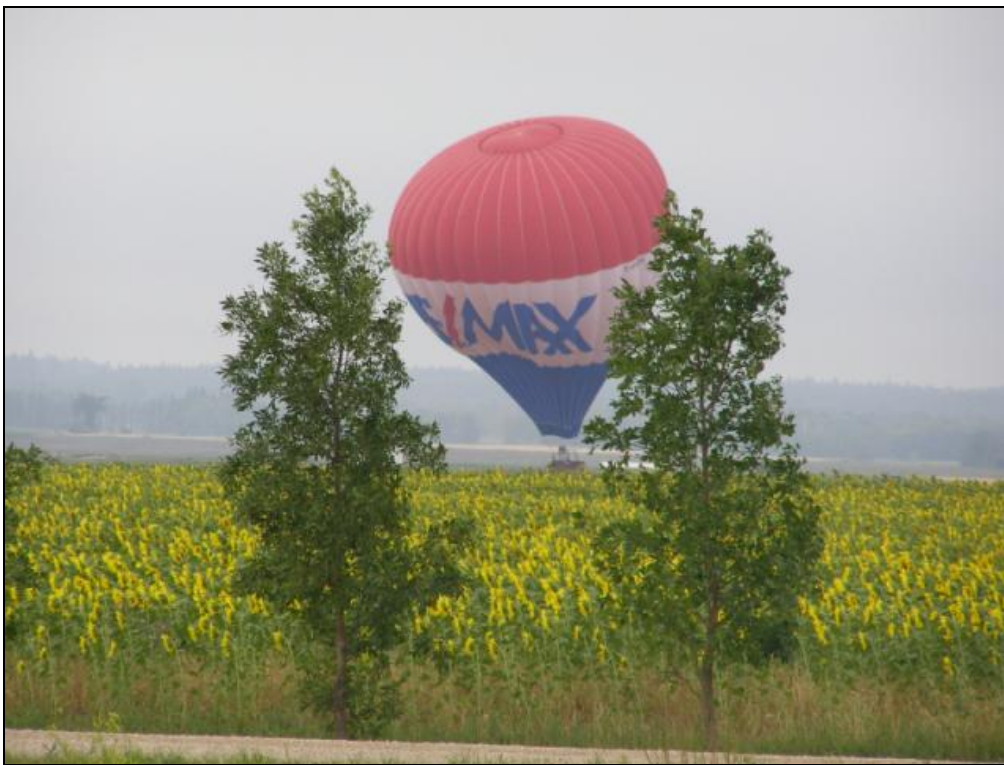
Photo 1. C-FNVM landing with parachute valve closed

The rigging of C-FNVM was examined and no failures were found. Information provided indicated that the parachute valve of the FireFly 12B balloon envelope does not dump the air quickly after a landing in high winds, increasing the likelihood of a dragged landing.

The pilot attempted to deflate the balloon envelope quickly and was unable to do so effectively even though the rigging was functional, resulting in a dragged landing of some 700 feet. The extended drag distance increased the risk of injury to the passengers and damage to the basket. The wind speed at the accident site could not be measured, but was likely between the wind speed of 15 knots recorded at the Winnipeg Airport and the 19-knot wind speed that was recorded near the accident site. Therefore, the company operations manual wind speed of 15 knots was too high to ensure a short drag distance while deflating the envelope after landing.

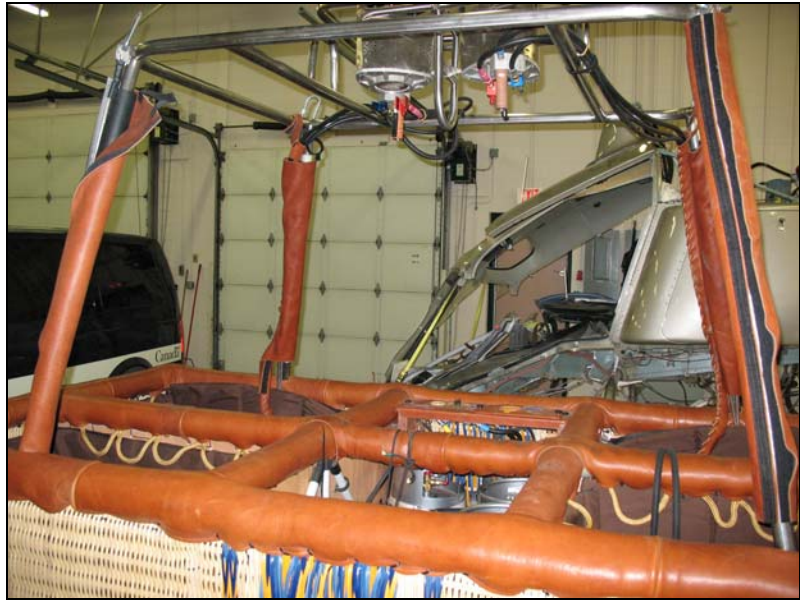
Photo 2. Example of basket and burner frame assembly

During the examination of a similar balloon basket, it was observed that passengers can reach fuel manifold lines and fuel lines running overhead to the burners, as well as suspension lines. The sole restraint devices provided are loops of rope in each compartment that can be held while the basket is dragged across the terrain. The company operations manual includes the propane tank rims as a suitable point to hold onto during landing. Neither the company operations manual nor the FireFly 12B BFM includes the requirement for protective helmets or gloves in case of dragged landings nor were any required by regulation.
