**AVIATION INVESTIGATION REPORT**  
**A07O0273**

**COLLISION WITH TREES ON APPROACH**

**UKRAINIAN CARGO AIRWAYS (UKS 702)**

**ILYUSHIN 76TD, UR-UCT**

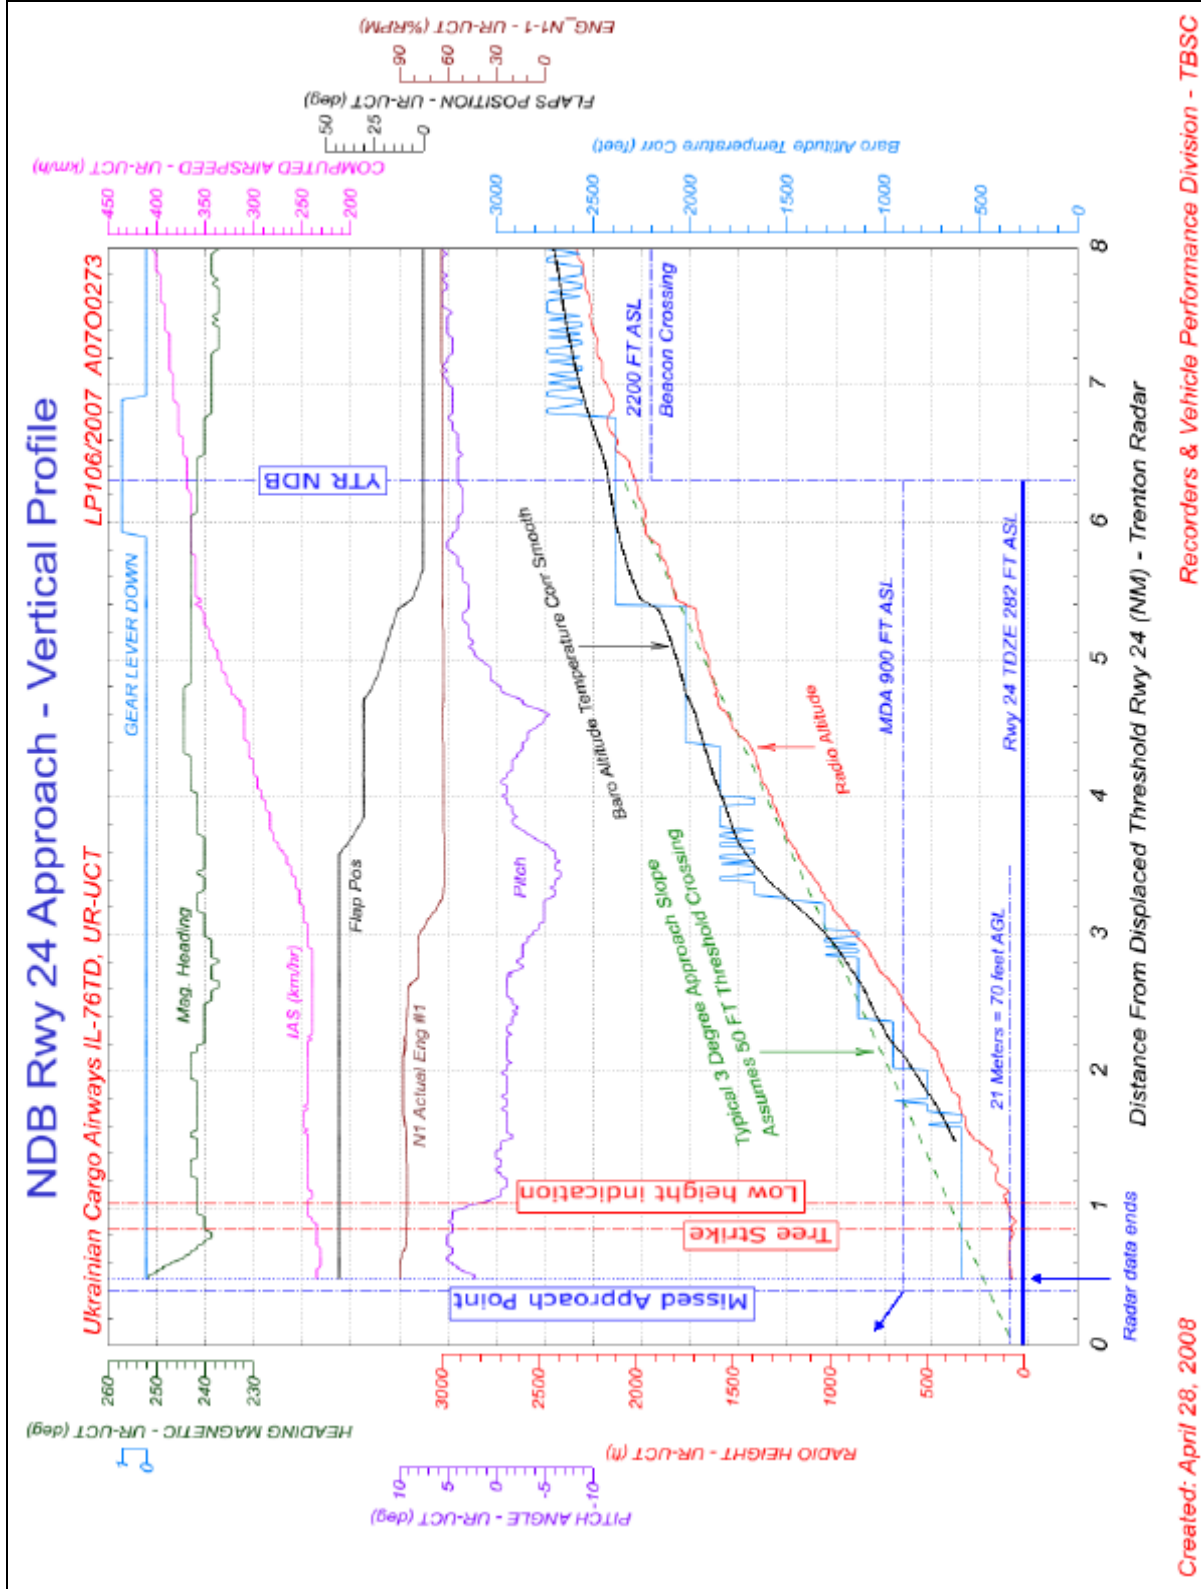
# Appendix A - NDB Runway 24 Approach - Vertical Profile

The aircraft's descent profile resembled a 3.0-degree glide slope during the descent and initial stages of the approach. The 3.0-degree glide slope intersected the top of the fog bank at approximately 0.5 nm from the displaced threshold for Runway 24. In the latter stages of the approach, the aircraft deviated below the 3.0-degree slope, which caused the aircraft to be at a lower altitude prior to entering the fog. It could not be determined why the flight crew deviated from the 3.0-degree glide slope.
