AVIATION INVESTIGATION REPORT

A07Q0063

LOSS OF CONTROL AND COLLISION WITH TERRAIN

PIPER PA31-350 C-FTIW

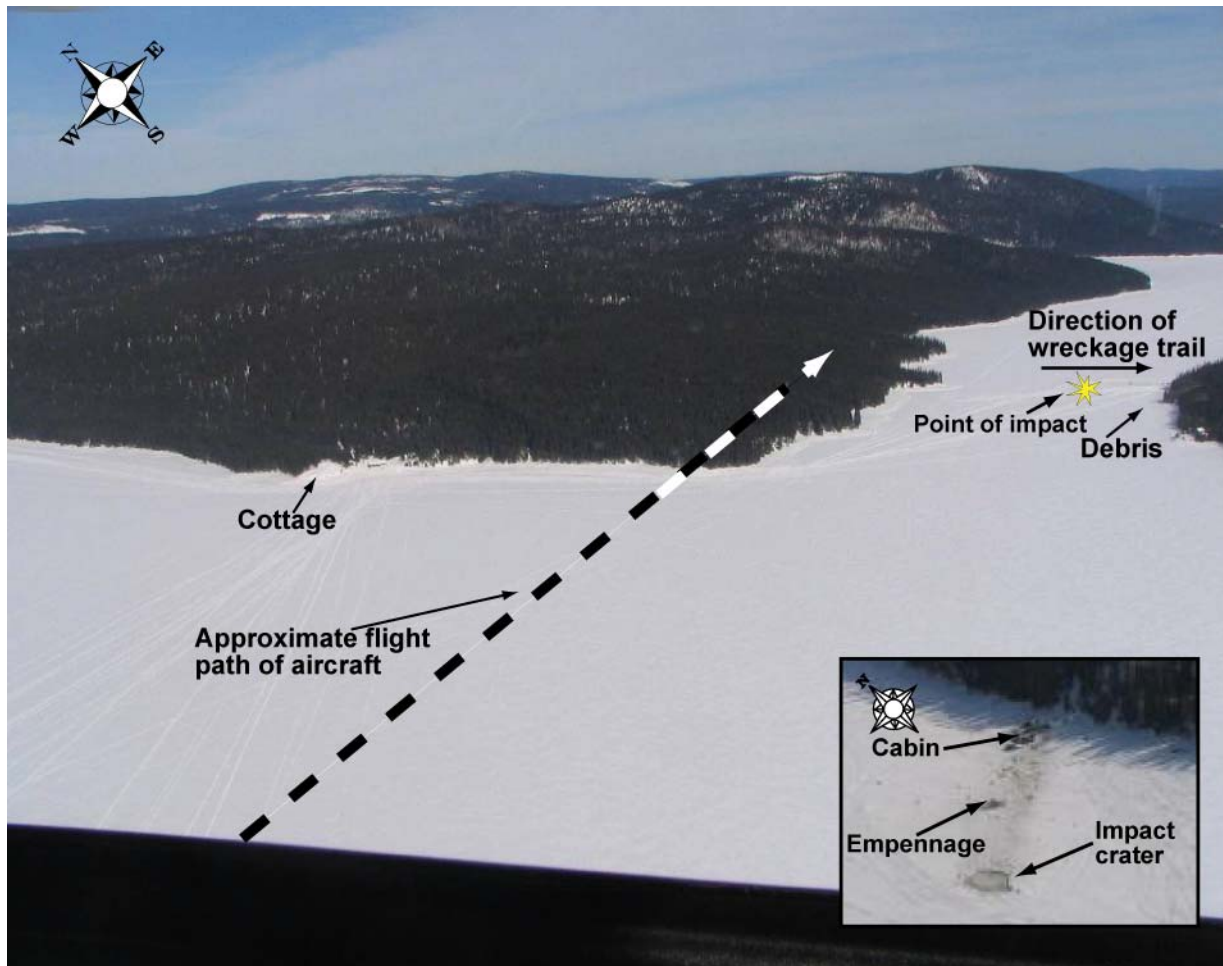
The accident occurred on the frozen surface of the southeast bay of Grand lac Germain, at an elevation of 1780 feet ASL. The aircraft struck the frozen surface of the lake 525 feet east of the shoreline it was flying over and 275 feet west of an island in the middle of the bay. The aircraft crashed approximately 2300 feet northeast of the cottage and 1600 feet after disappearing behind the trees. The aircraft broke through the top layer of ice, which was about two inches thick, then bounced off the second layer of ice. The impact produced a crater 30 feet in circumference.

Figure 1. Aerial view of accident site

The aircraft heading was 117°M at the time of impact, which is 14° off the breakup trajectory. Photogrammetric analysis of the crater established that the aircraft struck the ice surface in a low right bank attitude with the nose slightly up. The slope of the flight path was approximately 18° downward.

The wreckage was examined to the extent possible. The aircraft broke into several pieces. The breakup trajectory was on a heading of 103°M. The wreckage trail was approximately 250 feet long and an average 40 feet wide. The wing tips were found 50 feet from the point of impact. The cabin roof was completely torn off. The cockpit and cabin were so damaged by impact forces that the occupant space was almost completely reduced. The accident was not survivable.

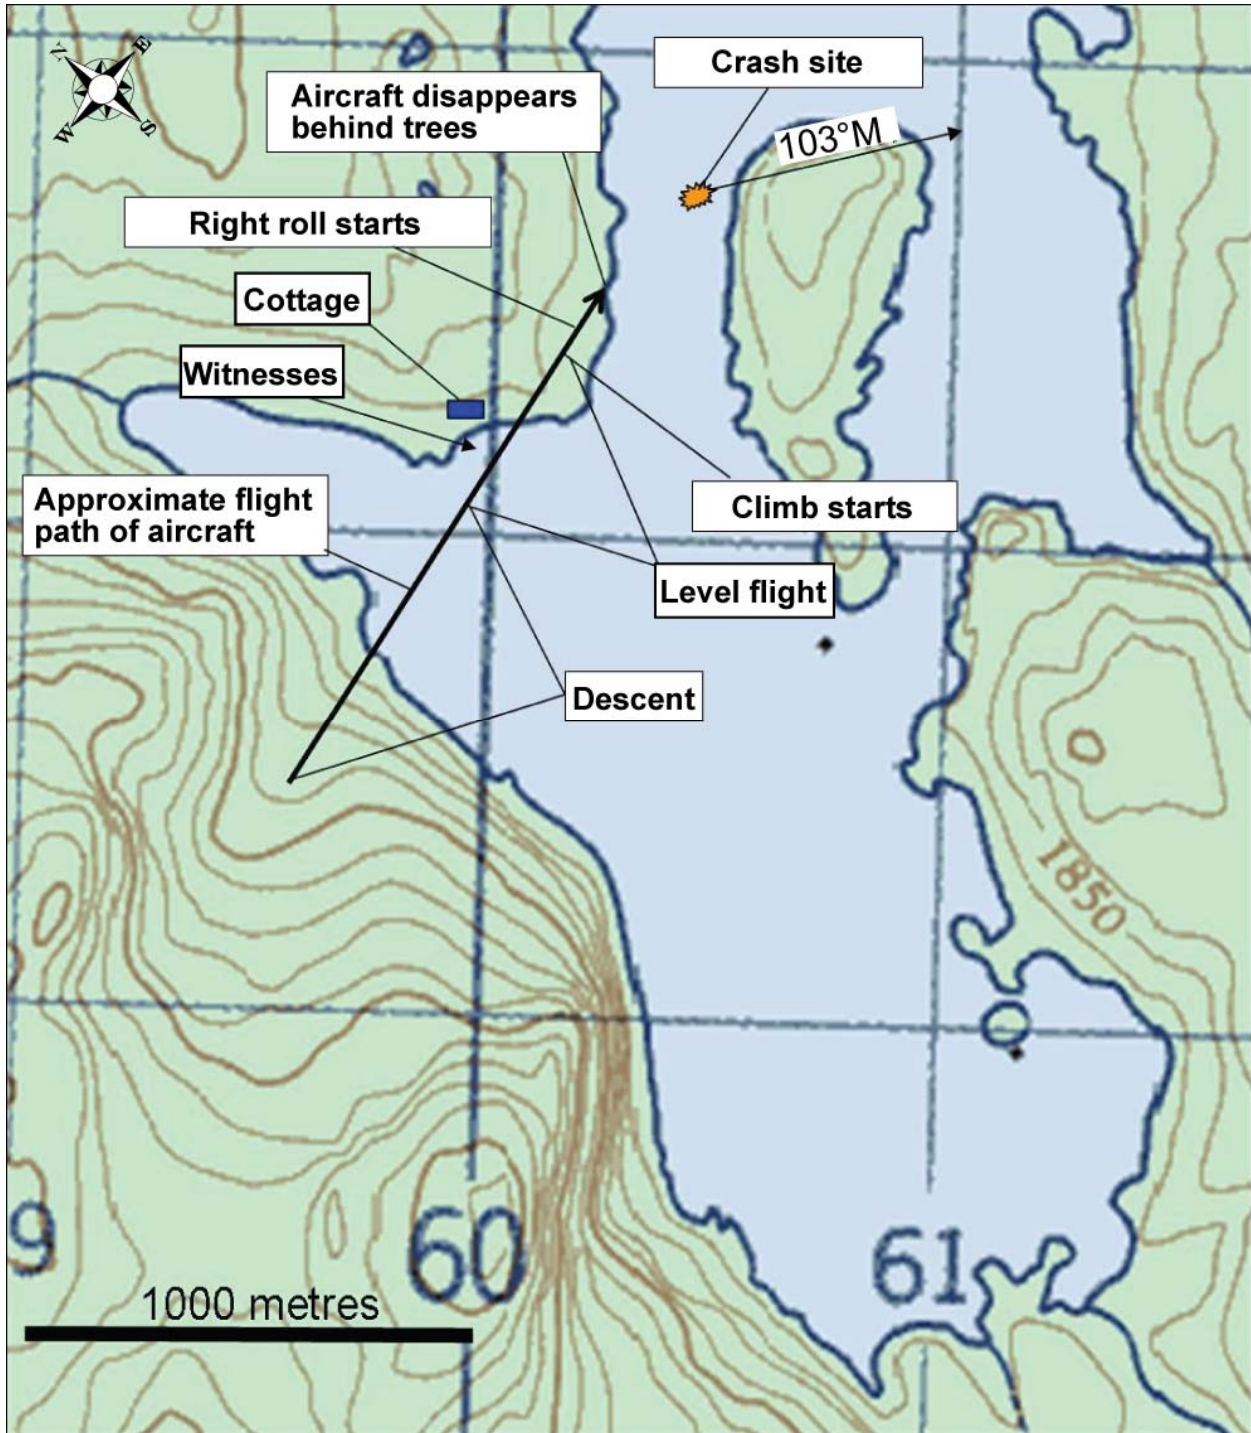
The flight path of C-FTIW could not be accurately determined. However, the information available reveals that the aircraft was heading northeast at an altitude between 100 and 300 feet before initiating a climb and a right turn. A few seconds later, the aircraft stalled and crashed after travelling approximately another 600 feet, in a slight nose-up attitude and banked slightly right.

The information gathered did not reveal the direction the aircraft banked before it crashed. However, analysis eliminated that ambiguity. If the aircraft had been banked steeply to the left, aerodynamic forces would have pushed it to the left of its flight path, that is, to the west of the lake, and it would have crashed in the trees. The attitude of the aircraft on impact and the marks on the ground indicate that the forces acting on the aircraft were directed toward the right. For that reason, it was concluded that the aircraft was banked right before it disappeared behind the trees. Therefore, it is reasonable to think that the pilot made a right turn after the low-altitude pass in order to continue on his route to Wabush.

Appendix A – Approximate Flight Path of Aircraft
