## AVIATION INVESTIGATION REPORT

A07W0186

### ENGINE FAILURE AND COLLISION WITH TERRAIN

PIPER MALIBU PA-46-310P, C-GTCS  
INVERMERE, BRITISH COLUMBIA, 11 nm E  
26 OCTOBER 2007

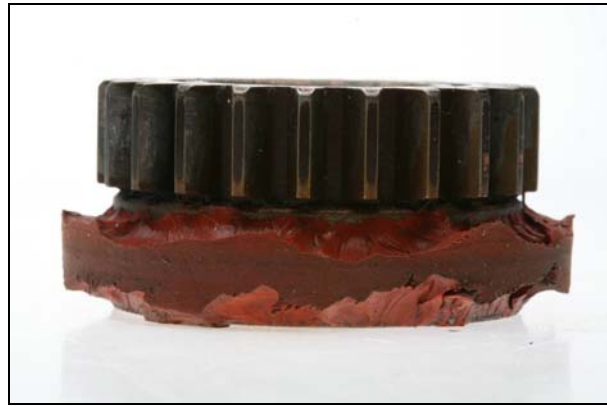
This washer was found to have forced the rubber ring further out of the cup and engage the gear teeth of the crankshaft alternator drive gear. This resulted in the destruction of the rubber portion of the coupling. Rubber particles of various sizes found their way into the engine sump (see Photo 1).

The rubber particles found in the engine sump matched those of the old coupling. In addition, several of the lifters contained rubber debris, indicating that the oil filter had been in a bypass state, allowing debris to flow into the system. The oil filter was also found to contain a large amount of rubber and metal debris. When the coupling was changed, the engine oil and filter were not changed, nor was the engine oil system flushed. The engine maintenance manual recommends checking the oil filter for metal debris during oil changes, but does not specify checking for other types of debris during other forms of maintenance. The engine manufacturer issued Service Bulletin M84-5 in 1984 that addressed gear-driven alternator malfunctions on all of its 520 series engines. It specifies that if any contamination is found upon removal of the alternator, the oil sump must be removed, the pick up cleaned or replaced, and, if anything further is found, a Teledyne Continental service representative should be contacted. This service bulletin does not apply to the 550 series engines even though they are equipped with gear-driven alternators. Standard industry practice is to check oil systems when contamination of any kind is found or known about, to flush the system, and to ascertain the source before releasing the aircraft for flight.

**Photo 1.** Gear damage to rubber material

An unapproved, shop-made washer that had been installed in the alternator drive coupling contributed to a quantity of rubber debris entering the engine. The presence of the washer in the coupling also caused the rubber disc to contact the alternator spur gear on the crankshaft, causing more debris to enter the sump. This debris then restricted oil flow in the failed area of the engine. The industry standard check of oil systems when contamination is found or known to exist was not carried out. The company performing the maintenance did not benefit from guidance developed in Service Bulletin M84-5 as the bulletin did not include this series of engine even though it had a gear-driven alternator.

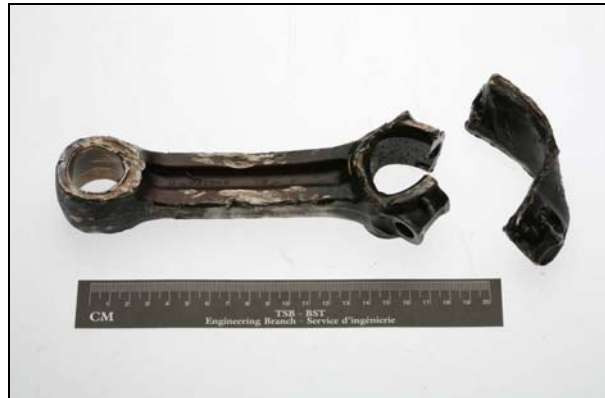
The top of the engine at centreline had a large hole over the number two connecting rod. The crankshaft and the number two connecting rod had indications of extreme heat, which was localized to this area (see Photos 2 and 3). The number two main bearing on one side was broken due to low-cycle pounding stresses. The number two piston had been making contact over time with its cylinder head and valves.

**Photo 2.** Heat and contact damage to connecting rod 2

It is highly probable that the engine failure was initiated by a partial blockage of oil flow, caused by debris in the oil, to the number two connecting rod journal and bearing. This resulted in a progressive loosening of the clearances at that location, which allowed a gradual increase in piston stroke and increasing contact between the piston and the cylinder/valves. This looseness caused repeated reaction forces on the number two main bearing, pounding it until fatigue cracking broke up the left bearing shell. The connecting rod journal continued to overheat and elongate the bearing area until the lower connecting rod end cap nut came apart. Total engine failure and seizure then occurred.

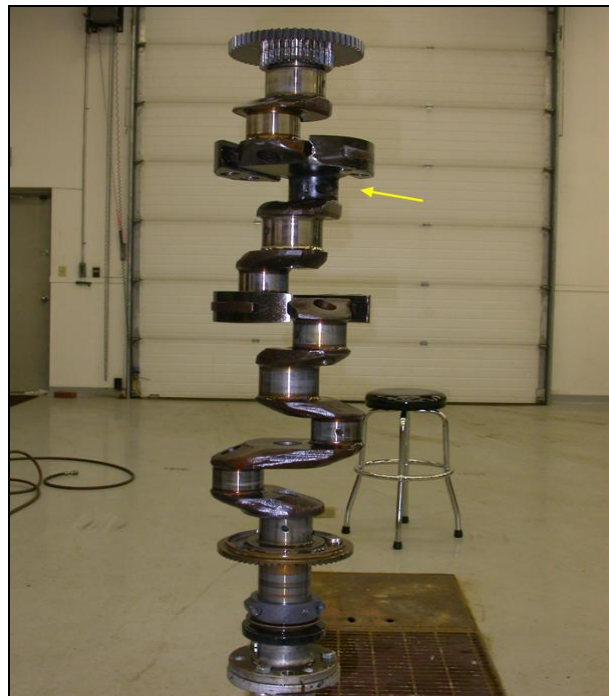
**Photo 3.** Crankshaft showing heated area
