**AVIATION INVESTIGATION REPORT
A08C0124**

FUEL STARVATION / FORCED LANDING

**MEADOW AIR LIMITED
CESSNA 337D, C-GYHW
BUFFALO NARROWS, SASKATCHEWAN, 14 nm NE
13 JUNE 2008**

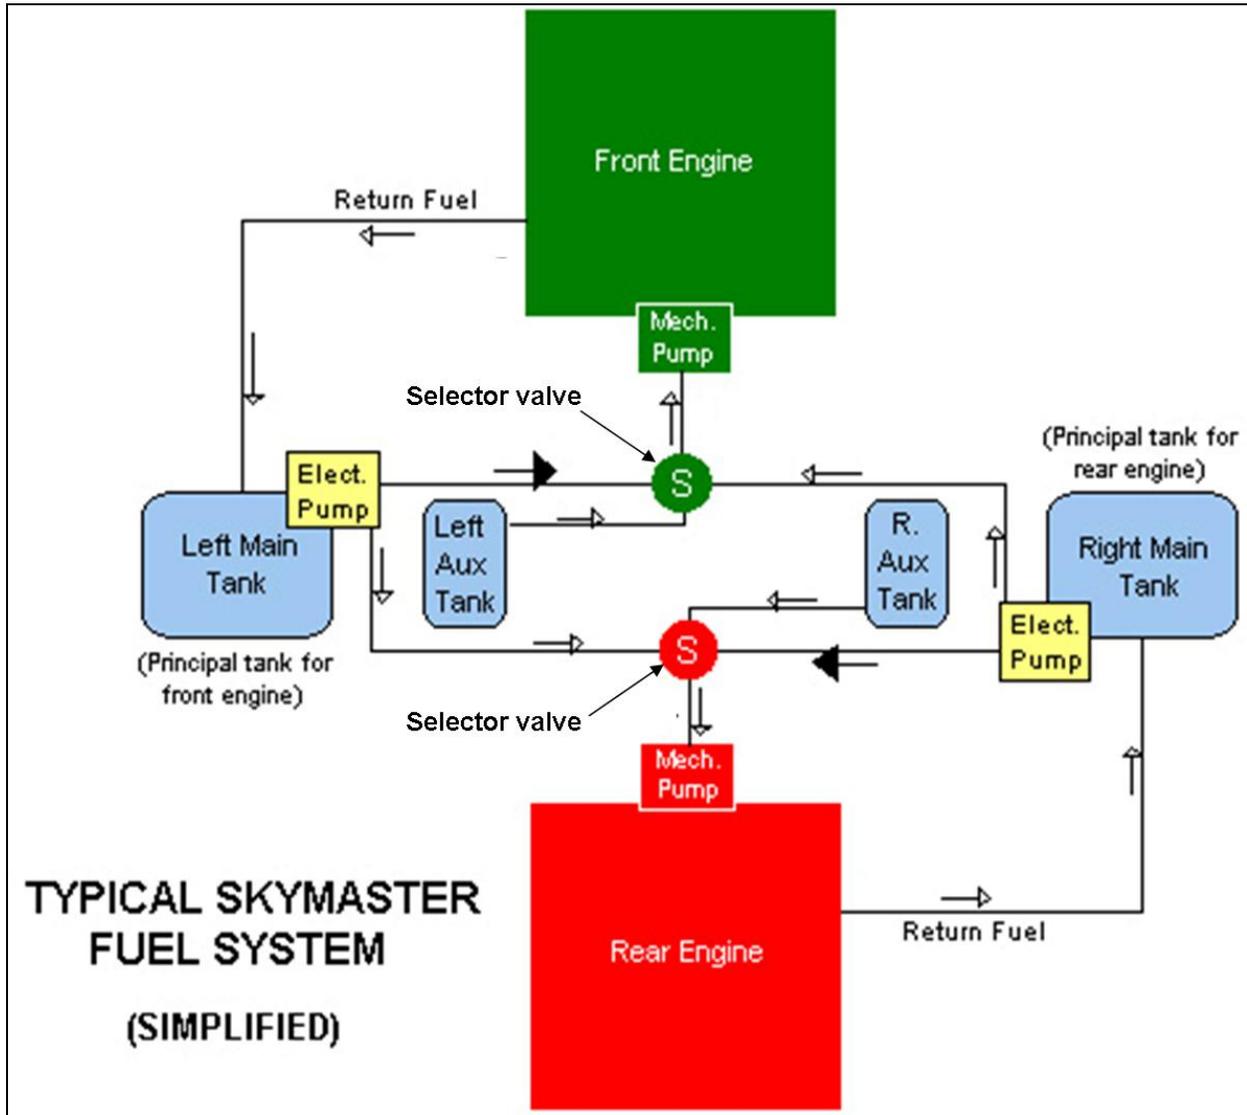
Appendix A – Fuel Schematic (simplified)

The C-337D fuel system is comprised of two outboard main-wing fuel tanks and two inboard auxiliary (aux) fuel tanks. There are two engine-driven fuel pumps which supply fuel to their respective engines during normal operations. There are also two auxiliary fuel pumps which supply fuel to the engine-driven pumps for starting and emergency operations. The design of the system is such that the auxiliary pumps can only pump fuel from the main tanks. In the event that fuel is depleted from the main tanks, operation of the auxiliary pumps will not draw fuel from the auxiliary tanks.

The fuel tank selector controls are mounted overhead in tandem on the cockpit ceiling. The forward mounted selector controls fuel for the front engine and is marked with positions Left Main (normal operation), Fuel Off Front Engine, Right Main (cross feed operation), and Left Aux. The rear-mounted selector controls fuel for the rear engine and is marked with positions Right Main (normal operation), Fuel Off Rear Engine, Left Main (cross feed operation), and Right Aux ³.

The fuel selectors are located overhead on the cockpit ceiling, which requires that the pilot divert his attention from monitoring primary flight information when changing fuel selections. In a high-workload situation such as dealing with a dual-engine power loss, this cockpit configuration could complicate the management of the fuel system. The overhead location and tandem layout of the fuel selectors, along with the nomenclature of the system, which includes "aux" pumps that do not pump fuel from the "aux" tanks, can make operation of the C-337's fuel system confusing to pilots who are not totally familiar with its operation.

1. The design and nomenclature of the C-337D fuel system complicates its operation during periods of high cockpit workload, thus increasing the risk of confusion.
