## AVIATION INVESTIGATION REPORT

A08Q0082

### IN-FLIGHT FUEL FEED FAILURE RESULTING IN ENGINE FUEL STARVATION

AIRBUS A330-343 C-GFAH

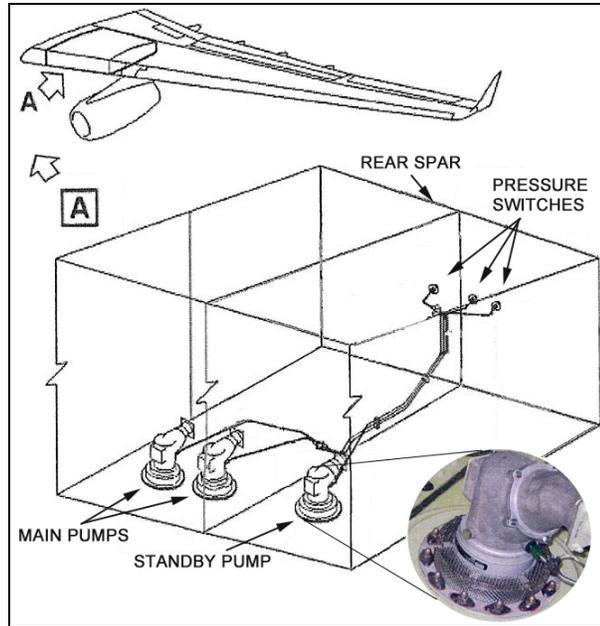
Figure 2. Fuel pumps and pressure switches

Three pressure switches (part number HTE69000-1) are co-located on the rear spar of each wing and sense the fuel pressure from each pump using separate sensing lines (see Figure 2). The switches trigger a low-pressure warning if the delivery pressure of the corresponding pump falls below 6 psi. The main fuel pumps operate continuously, while the standby pumps located outboard of the collector cell operate only when a main pump low-pressure is sensed. A non-return valve (NRV) is installed in each pump's outlet port to prevent reverse flow of fuel through the inoperative pump.

The fuel tanks had not been drained for 26 days contrary to prescribed water draining every 7 days. The suspended water particles or droplets found in the pressure switch sensing lines, if frozen, would have pushed on the internal side of the diaphragm, resulting in an erroneous normal pressure indication. However, moisture freezing and expanding in the vented area of the pressure switch could act upon the other side of the diaphragm, resulting in an erroneous low-pressure signal.

- A fleet manager information was issued to provide background information to the crews and highlight the results of the Airbus test flight, analysis and conclusions.
- All fuel pressure switches were replaced with the latest recommended model (FRH100002A).
- An aircraft technical bulletin was issued to revise the A330 minimum fuel over destination (FOD) to 3600 kg.
- The water removal procedure is now performed at every service check without options to defer.
- The anticipated low fuel ECAM (ALFE) procedure was rescinded for the A330.

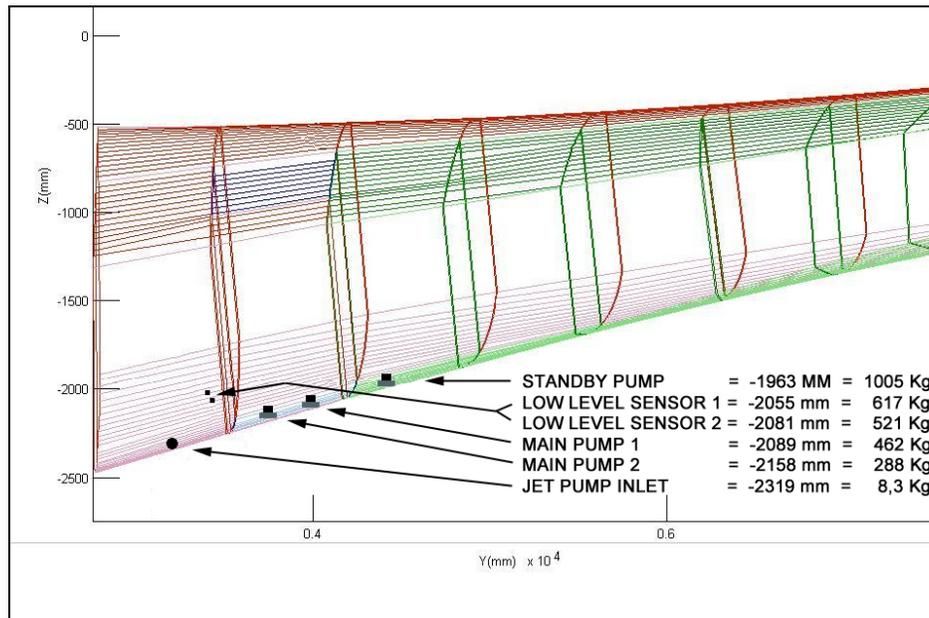
Figure 5. Inner fuel tank modeling (cross-section)

Given the wing dihedral angle, the fuel pumps are located on a different water line <sup>27</sup> or Z axis (see Figure 5). On the A330, the reference water line is located above the fuel tank; the references provided are negative. Two low-level sensors are located at tank heights of -2055 mm and -2081 mm. The highest low-level sensor is located 92 mm below the standby pump inlet port located at -1963 mm.

During gravity fuel feeding, fuel flows through each main and standby pump inlet ports to the engine-driven low-pressure and high-pressure fuel pumps. The inlet ports of the main pumps number one and number two are located respectively 126 mm and 195 mm below the standby pump inlet port. The suction created by the engine-driven pumps while gravity fuel feeding will eventually draw air into the fuel line when the fuel level approaches the standby pump inlet port.

The current A330 fuel system design with the standby pump inlet port located at the highest level allows air ingestion at fuel quantities up to 2750 kg when the main pumps are inoperative. With the 2 low fuel sensors located below the standby pump inlet port, the ECAM did not generate a fuel low-level warning on either the test flight or the occurrence flight. Therefore, the crew does not receive advance warning of imminent engine failure due to air ingestion into the fuel line when the main fuel pumps are not operating.

- An A330 temporary revision (No. 251-1) was issued in November 2008, whereby the gravity fuel feeding procedure now indicates that 2000 kg of fuel in the affected fuel tank cannot be used by gravity.
- Temporary revisions No. 01-28/010 and No. 02- 28/020, dated October 2009 and approved by the European Aviation Safety Agency (EASA) on 16 November 2009, updated the A330 master minimum equipment list (MEL). The conditions and operational procedures in the case of dispatch with one main inner tank fuel pump inoperative were changed to ensure that the crossfeed valve is operative, and that 2000 kg of additional fuel is loaded in the aircraft.
