AVIATION INVESTIGATION REPORT

A08Q0187

VISUAL FLIGHT RULES FLIGHT INTO ADVERSE WEATHER AND FORCED LANDING

DHC-2 MK1 C-FYNT
CLUB CÉSAR (1993) INC.
PARENT, QUEBEC, 27 nm SW
23 SEPTEMBER 2008

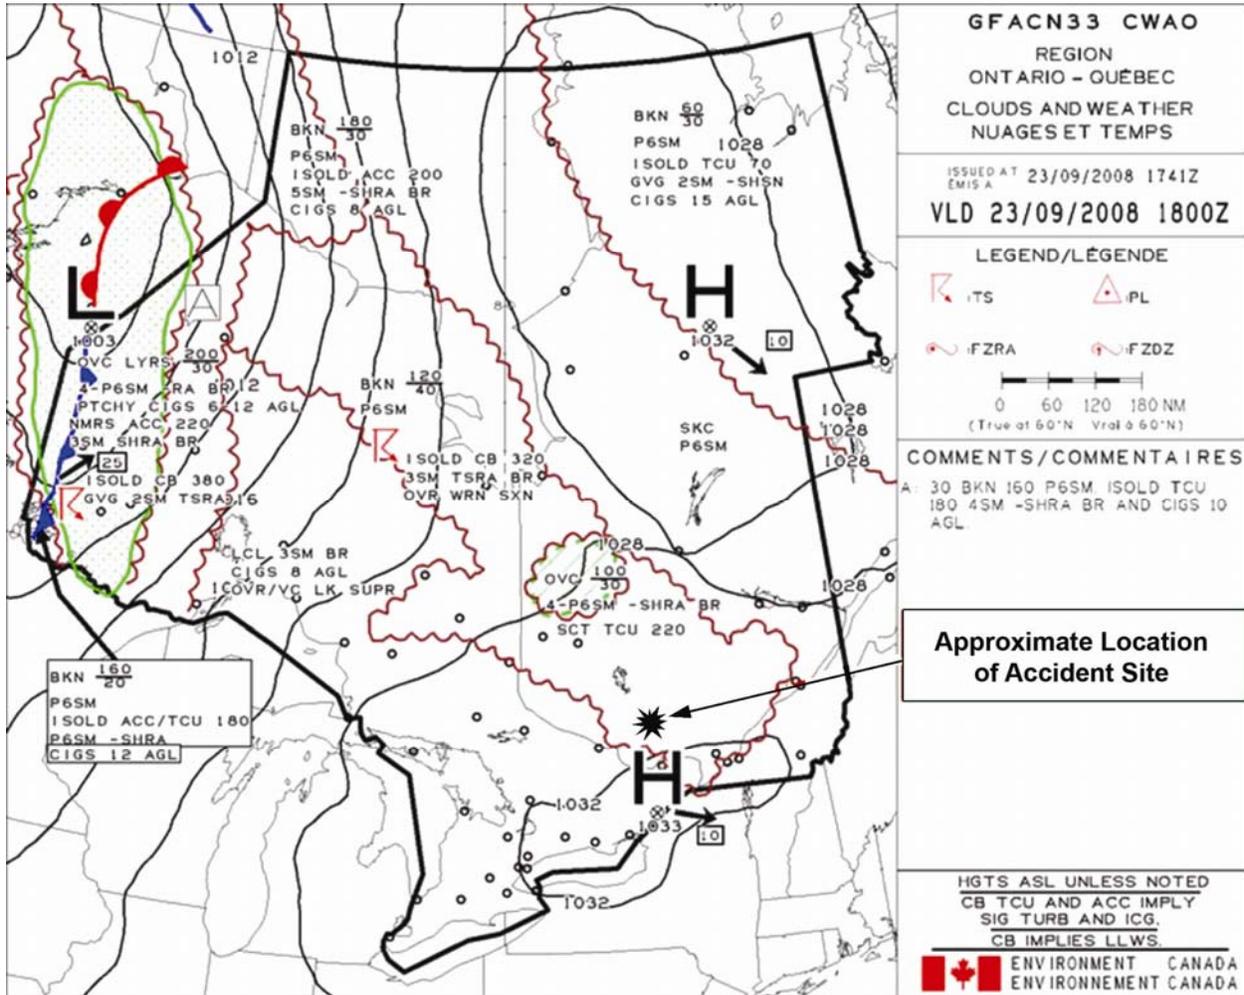
Appendix B – Graphic Area Forecast – GFACN33 CWAO

The graphic area forecast (see Appendix B – Graphic Area Forecast – GFACN33 CWAQ) for Ontario and Quebec (GFACN33 CWAQ) issued at 1741 Z³ on 23 September 2008, valid at 1800 Z (1400 EDT) was as follows:

An area of broken cloud based at 4000 feet with tops at 12 000 feet was over Parent, located 28 nm northeast of the outfitter base. Visibility was over 6 statute miles. Approximately 60 miles west of Parent and embedded in the previously mentioned area was an area of overcast cloud based at 3000 feet with tops at 10 000 feet, with visibility from 4 to over 6 statute miles in showers and mist. Scattered towering cumulus with tops to 22 000 feet were also forecast within this area of cloud. No turbulence or icing was forecast for the area near Parent on 23 September 2008. Although these conditions are suitable for VFR flight, the graphic area forecast (GFA) did indicate the possibility of showers and mist in the Parent area. No short-term weather advisories (AIRMET)⁴ or significant meteorological information (SIGMETs)⁵ were issued during this period.
