AVIATION INVESTIGATION REPORT

A09C0028

GEAR-UP LANDING

**PERIMETER AVIATION LIMITED
SWEARINGEN SA226-TC METRO II C-FSLZ
WINNIPEG, MANITOBA
03 MARCH 2009**

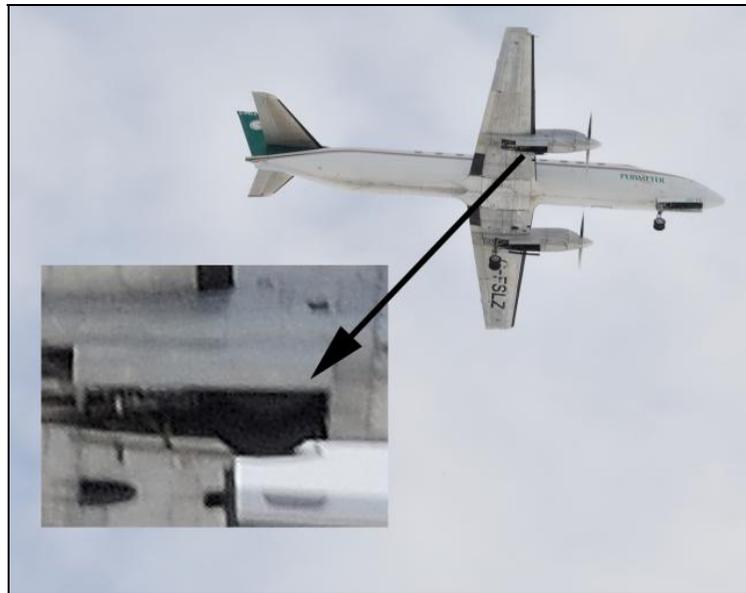
The gear was observed from the cabin area. The left main landing gear was checked to be fully down. The right main landing gear appeared to be hung up in the wheel well area with the gear doors partially open. The inboard tire was on top of the inboard gear door (see Photo 1).

Photo 1. Tire resting on inboard gear door (Source: Department of National Defence)

The inability of the right landing gear to fully extend from the wheel well resulted from interference between the number three tire and the inboard gear door. A combination of several factors likely came into play to cause the tire to interfere with the gear door.

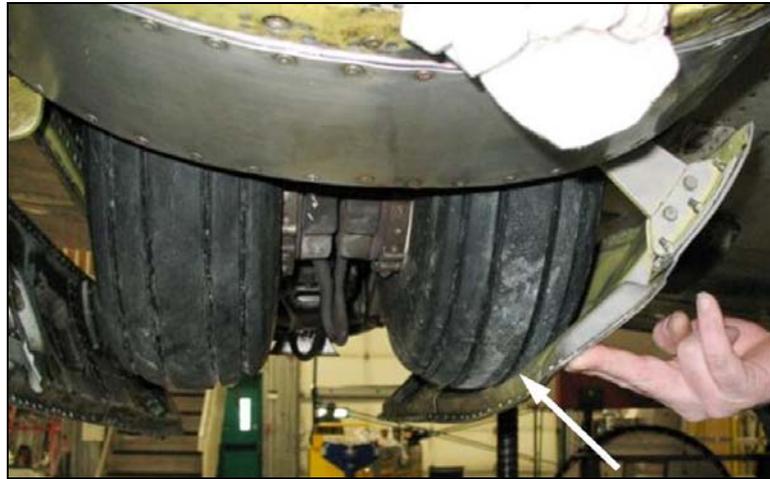
A gear swing was carried out and the gear swung freely with no hang-ups. The clearance between the number three tire and the inner gear door was tight, but the tire passed freely due to the pronounced bend in the gear door. The inner and outer door panels were straightened as a temporary repair to facilitate troubleshooting, but the original rigidity of the door could not be maintained. Subsequent gear swings were carried out and it was noticed that during gear extension the number three tire would catch momentarily on the raised inner skin panel, but the door would flex and the tire would slide by. A side load was placed on the gear door to account for anticipated air loads during flight. The number three tire caught and jammed on a ledge area of the raised inner skin panel (see Photo 2), stopping the gear extension and bending the gear door as observed after the occurrence (see Photo 3).

Photo 2. Area of tire-to-gear-door interference

The right inboard landing gear door was rigged too tightly in the retracted position. The right outboard gear door hinge was also observed to be rigged too tightly against the inner wheel well keelson in the open position. The work done to the inboard gear door during an inspection in September 2008 could have affected the geometry and fit of the door. A rigging check was required after this work, and there is no record that it was done, other than the visual inspection required by Form 31, which relies on the experience of the maintainer. The lack of a maintenance record does not mean that a rigging check was not carried out, but the rigging discrepancies noted on both right main gear doors should have been resolved. After the repair to the gear door during the Phase 8 inspection, the doors were visually inspected on three occasions, and there is no record to indicate that the gear doors were adjusted. Thus, the mis-rigging of the gear doors likely went unnoticed through four separate inspections.

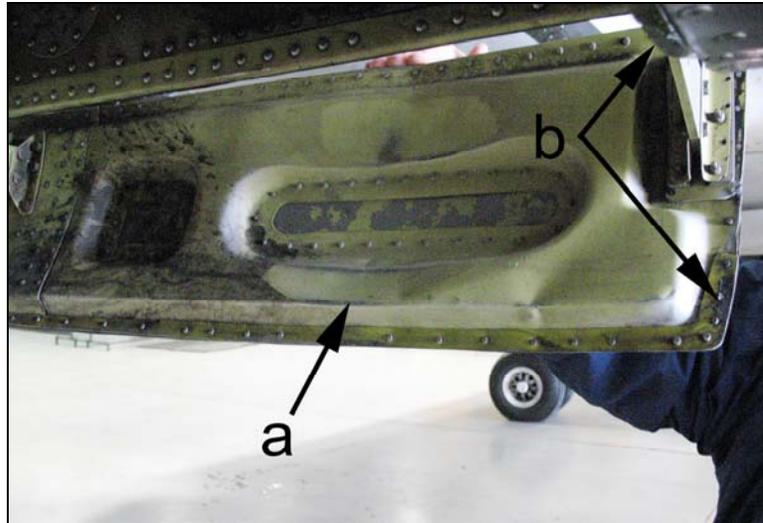
The aircraft was placed on jacks and inspected. The main landing gear doors, flaps, and aft belly area had abrasions and damage from scraping along the runway. The right inboard gear door had a pronounced bend on the outer skin panel and an indentation in the raised inner skin panel with rub marks from contact with the number three tire.² There was no indication that the door had been damaged prior to the flight. The leading edge of the gear door and the aft nacelle channel stop had fretting and wear marks from contact with each other (see Photo 3). Due to the damage to the door, the inboard gear door rigging could not be checked. The gear door actuator linkage rod (used to adjust the gear door) was observed to be approximately 1/8 to 3/16 inch shorter than the other three gear door link rods. Some free play was noticed in the gear door bushings/linkage arrangement, but the free play was not considered excessive. The right outboard gear door hinge was observed to be rigged tight against the inner wheel well keelson while in the open position. Section 32-30-00 of the *M7 Aerospace SA226 Series Maintenance Manual* specifies a minimum clearance of 0.063 inch (see Appendix A).

Photo 3. (a) Damage to the ledge area of the raised inner skin panel
(b) Wear marks from contact with aft nacelle channel stop

Some free play was noted in the gear door bushings/linkage arrangement, but it was not considered excessive. The bushings would have gradually worn in service during the 663 cycles since replacement, resulting in a small delay in the opening sequence of the gear doors due to the air loading. The combined effect of a mis-rigged gear door and the installation of a new re-capped tire with larger dimensions, coupled with growing free play in the gear door bushings/linkage arrangement and air loading on the gear door reduced clearances sufficiently that the right inboard tire caught on a ledge on the inboard door skin, preventing the right main gear from extending.

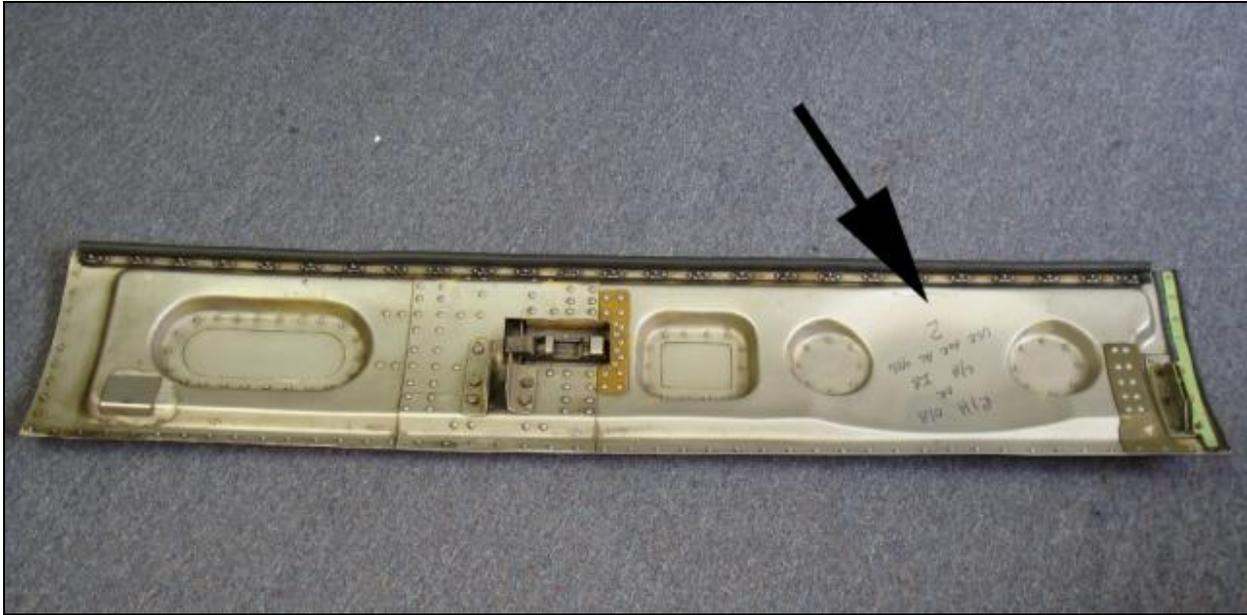
The gear door is designed with a raised inner panel to offer rigidity to the door, but the design has the undesirable effect of providing a ledge that could snag a tire. The gear doors on the later production Fairchild SA227 Metro III/23 aircraft were re-designed to remove the ledge shape (see Photo 4).

Photo 4. Later production Fairchild SA227 Metro III/23 re-designed gear door

1. In later production Fairchild SA227 Metro III/23 aircraft, the ledge area on the inner door skin was re-designed with a shallower profile area, which somewhat alleviates the tire clearance issue.
