AVIATION INVESTIGATION REPORT A09Q0181

FUEL STARVATION

PIPER PA-34-200T C-FANI
MIRABEL, QUEBEC
11 OCTOBER 2009

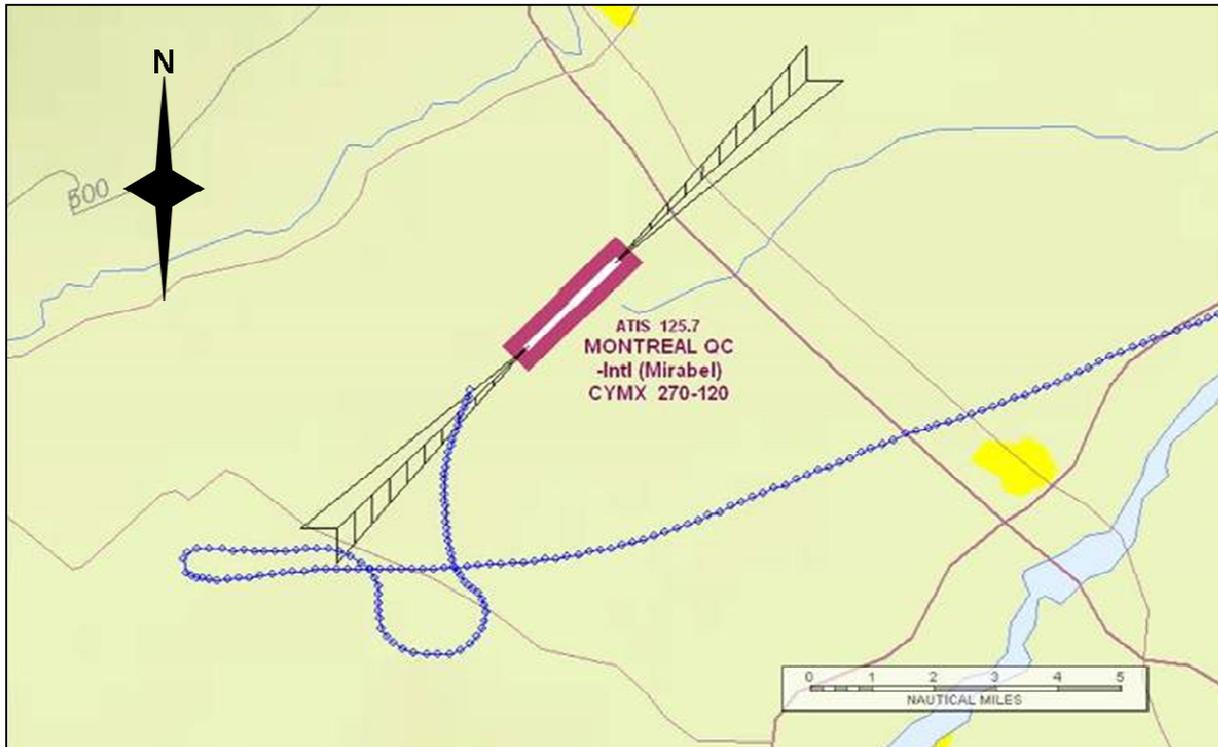
Figure 1. Trajectory of the aircraft

At 1726, 1 hour and 14 minutes into the flight, the aircraft was 7.4 nm southwest of Mirabel Airport when both engines lost power. The autopilot disengaged and the aircraft entered a right turn of approximately 180°. (See Figure 1.) After the turn was made, the aircraft was 1000 feet below its assigned altitude, and the pilot informed air traffic control (ATC) that he was having engine problems but did not declare an emergency. He said that the engines seemed frozen. He was assigned a heading of 080° magnetic to direct him toward Mirabel Airport. ATC asked whether he would need emergency equipment at Mirabel or whether he would like to declare an emergency. The pilot declined. He read back the heading of 080° but continued to turn south on a heading of approximately 180° magnetic before being assigned a new heading toward Mirabel. Once the pilot stated that he had visual contact with the runway, ATC cleared him for a visual approach to Runway 24, because the ground-level wind of 6 knots favoured landing on that runway. At approximately 4500 feet asl, the pilot reported that the engines were still running, even though the engines were not developing any power. During the descent, the pilot activated the booster pumps, but to no avail. The propellers were not feathered and continued to windmill. At 1600 feet asl, 2.2 nm west of the Runway 06 threshold, the pilot advised Mirabel Radio that he could not make it to Runway 24. The aircraft disappeared from the radar screen at approximately 400 feet asl (150 feet agl) and crashed at 1732 hours, 1.2 nm from the threshold of Mirabel Airport Runway 06.

When the engine failure occurred, the aircraft was 6.5 nm from the Runway 06 threshold and then continued to within 4.5 nm of the runway threshold before deviating south. The deviation increased the distance required to reach the threshold. The aircraft glided 10.7 nm before crashing.

When the engines stopped, the aircraft was at 10,000 feet asl and 6.5 nm from the Runway 06 threshold. Considering that the aircraft's deviation to the south increased the distance to be travelled by 4.2 nm and that the aircraft crashed 1.2 nm from the threshold, it is highly likely that the aircraft could have glided all the way to the Runway 06 threshold, even though the propellers had not been feathered.

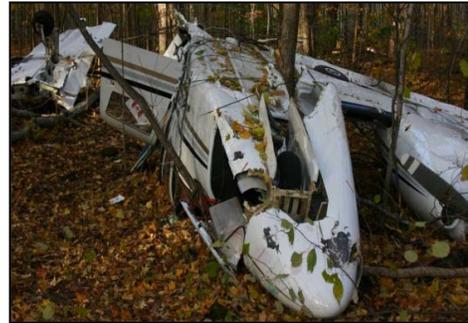
Figure 2. View of the aircraft

The right fuel tank was perforated in the impact, and the left fuel tank was completely gutted. The fuselage came to rest on its back against a tree measuring approximately 8 in. in diameter that penetrated the cabin on the passenger side (see Figure 2). A strong

odour of fuel was present at the crash site, confirming that there was fuel on board at the time of impact. The pilot was seriously injured. He managed to exit the cockpit and was found in the rear cabin.

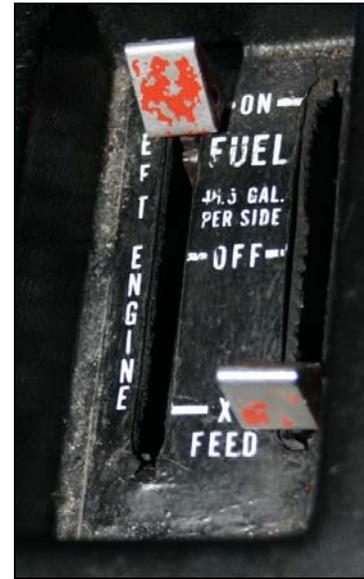
Figure 3. Fuel selector

The fuel system has two fuel selectors (see Figure 3), one for each engine, which are identified as LEFT ENGINE and RIGHT ENGINE. Each selector has three positions. The forward position (ON) enables each tank to fuel its respective engine. The central position (OFF) cuts off the fuel supply. The rear position (XFEED) is for crossfeeding, or fuelling an engine from the opposite tank. In other words, if the right fuel selector is on XFEED, the right engine will receive fuel from the left tank.

According to the pilot's checklist, the operation of the fuel selectors is checked while the aircraft is taxiing. In this occurrence, the operation was checked before the aircraft had started to taxi. To check the operation of the fuel selectors, the pilot sets one of the selectors to OFF. Once the corresponding engine starts cutting out, the selector is set to XFEED, and then the engine should resume operating normally. Then the selector is set to ON. The selector for the other engine is checked in the same manner. The checklist then provides four other opportunities to ensure that the two fuel selectors are set to ON: on run-up, during pre-takeoff checks, when the aircraft is lining up on the runway, and once the aircraft is established at cruising altitude. When the aircraft was examined at the crash site, the left selector was set to ON and the right to XFEED.

The most plausible hypothesis is that the right fuel selector was left on XFEED after being checked prior to the aircraft's departure from Saint-Georges.

1. The right fuel selector was left in the XFEED position, probably because the pilot was distracted and/or failed to follow the checklist. As a result, both engines were being fuelled by the left tank until it was completely empty, causing both engines to fail simultaneously.
2. The pilot relied on a fuel quantity indicator system that was based on the engine's fuel consumption and not on the quantity of fuel remaining indicated by the gauges.
3. The pilot did not recognize the loss of power as being an engine failure. The emergency checklist for engine failure was not followed.

Because the propellers were not feathered, they were windmilling, which gave the pilot the impression that the engines were still running, albeit slowly. This could explain why the pilot told ATC that the engines were still running as he descended through 4500 feet. Setting the left selector to XFEED and the right selector to ON would have restored the fuel supply to both engines.
