AVIATION INVESTIGATION REPORT

A09Q0210

DECREASE IN ROTOR SPEED FOLLOWED BY COLLISION WITH TERRAIN

**ROBINSON R44 II (HELICOPTER) C-GDSF
MONTRÉAL, QUEBEC
16 DECEMBER 2009**

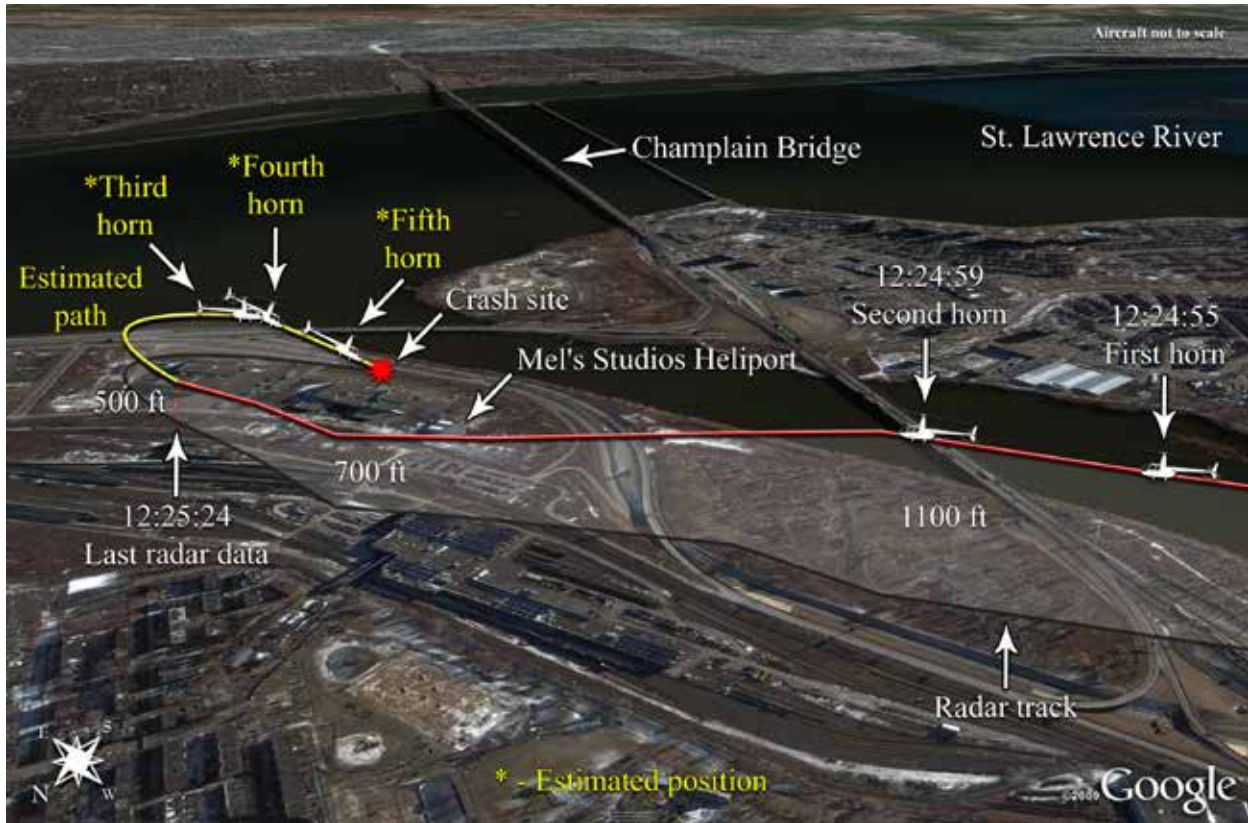
Figure 1. Helicopter's path (Times in UTC)

At 0724:55, just east of the Champlain Bridge, the first of 5 low rotor speed warning horns sounded and the engine began to overspeed. At 0725:17, while at an altitude of approximately 650 feet asl, the pilot informed the controller that he was making an emergency landing at Mel's Studios ⁴. The aircraft was then somewhat north of the heliport at Mel's Studios. At approximately 500 feet asl, the pilot executed a 180° turn to the right. During the final moments of the flight, control of the aircraft's pitch and roll ⁵ response was sluggish and almost non-existent. The helicopter crashed in a ditch located between Mel's Studios and the Bonaventure Expressway (see Figure 1).

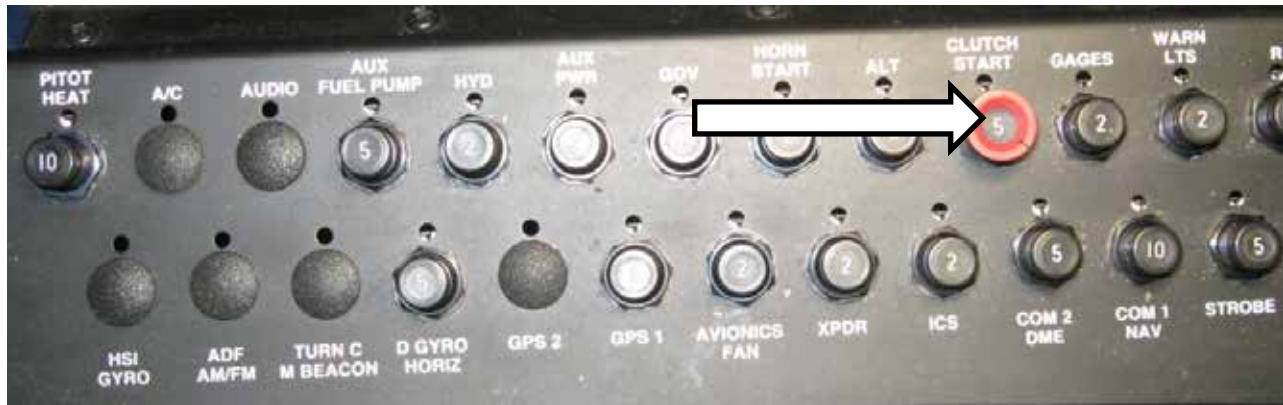
Photo 3. CLUTCH circuit breaker

It is normal for the warning light to come on during flight. However, if it remains on for more than 7 or 8 seconds, the POH recommends pulling the CLUTCH circuit breaker (see Photo 3), reducing power and landing immediately. The breaker is marked with a red ring to facilitate identification and manual activation. As well, the pilot is warned to be prepared to enter autorotation and inspect the drive system (see Figure 4).

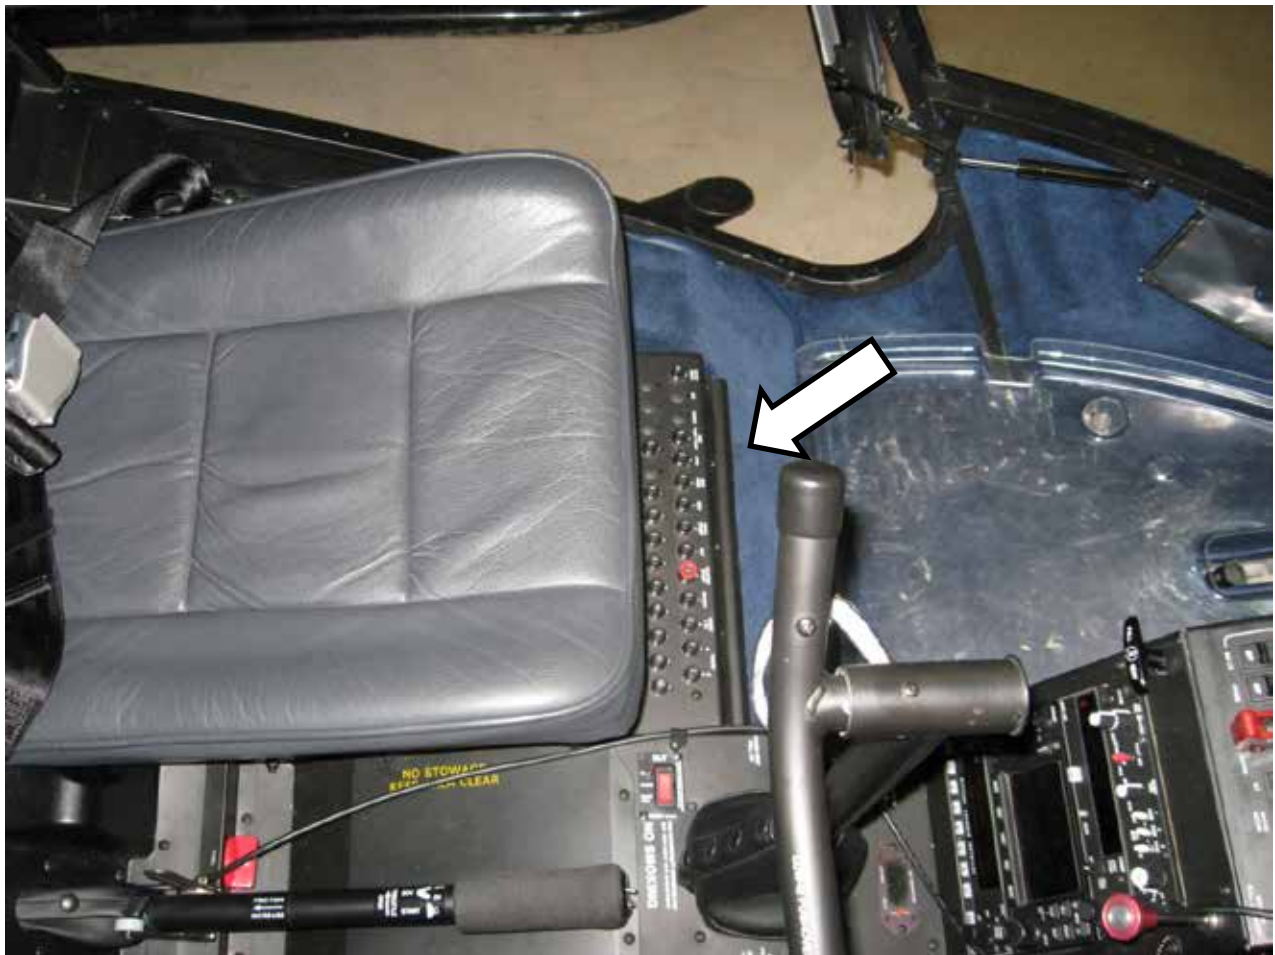
Photo 4. Left breaker panel

At the accident site, the Clutch/Start breaker, which is located on the left panel, was found in the open position. The breaker feeds the belt-tension actuator via the actuator switch. The CLUTCH warning light doesn't illuminate if power to the actuator is cut. When the breaker is opened, the actuator and the warning light stop working. An examination of the Clutch/Start breaker did not reveal any anomalies.

The Clutch/Start breaker is not exclusive to the actuator; it also powers the electrical circuits for the helicopter's main blade brakes and a lock-out signal to the starter system. CARs Section 527.1357 ¹¹ (Circuit Protective Devices) states that "a protective device for a circuit essential to flight safety may not be used to protect any other circuit".
