AVIATION INVESTIGATION REPORT
A09W0026

RUNWAY INCURSION / RISK OF COLLISION

NAV CANADA
FORT MCMURRAY AIRPORT
FORT MCMURRAY, ALBERTA
09 FEBRUARY 2009

Report Number A09W0026

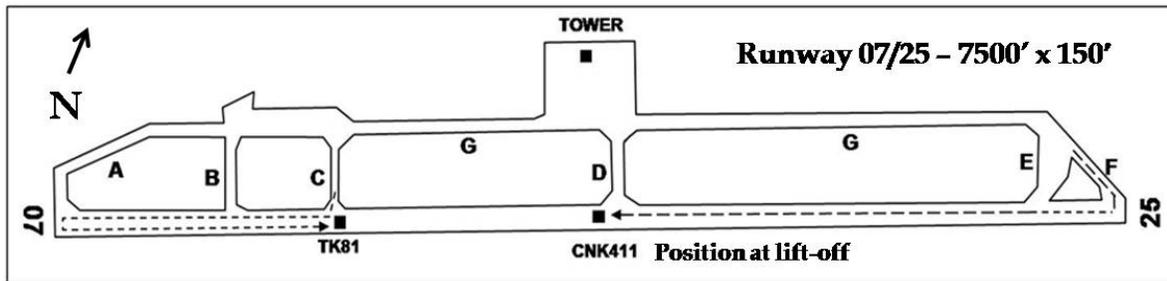
Figure 1. Fort McMurray Airport diagram

On the take-off roll, the captain of CNK411 was the pilot flying (PF) and was concentrating on tracking the runway centreline using the runway edge lights. Section 602.100 of the *Canadian Aviation Regulations* (CARs) requires the pilot-in-command to ascertain by radio communication and by visual observation that there is no likelihood of collision with another aircraft or a vehicle during take-off. On this occasion, the PF's forward vision was restricted by light snow blowing across the runway from right to left and from the glare from the aircraft's landing lights on the falling snow. The first officer was the pilot not flying (PNF) and was monitoring the instruments and power levers. Visibility was reported to be about 5/8 of a mile (3300 feet). When the PF initially saw TK81's headlights, the aircraft was in the vicinity of Taxiway D, which is 3500 feet from the threshold of Runway 25. TK81 was in the vicinity of Taxiway C, which is approximately 5400 feet from the threshold of Runway 25 (see Figure 1). The crew did not see the rotating beacon on the snowplow until they were directly overhead.
