**AVIATION INVESTIGATION REPORT
A10O0018**

IN-FLIGHT SEPARATION AND IMPACT WITH TERRAIN

**VANS RV-7A C-GNDY
MADOC, ONTARIO
23 JANUARY 2010**

Report Number A10O0018

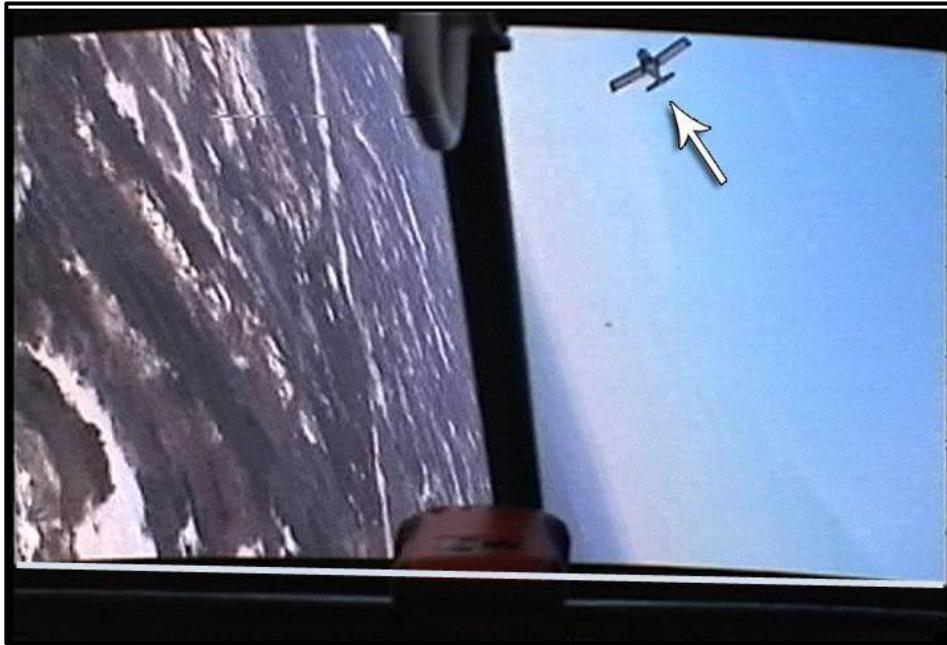
During a pull-out from a rapid descent, there was a sudden onset of an airframe vibration (shuddering around the longitudinal axis), which was followed by a yawing motion, a roll and ground impact.

Photo 1. Video still image of the lead aircraft manoeuvring

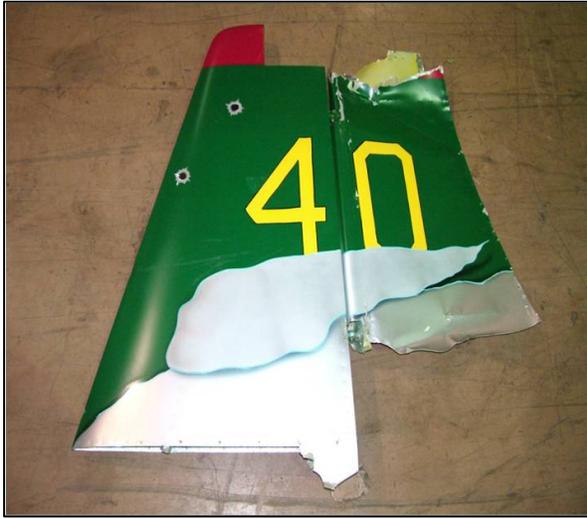
The rudder had experienced severe structural damage and had fractured approximately in half. The bottom half of the rudder remained attached to the aft fuselage, linked only by the rudder cables and electrical wiring. The rudder was badly bent along its length, twisted chord wise, and the riveted joint at the trailing edge was split open. The top half of the rudder was still securely fastened to the vertical stabilizer by its top and centre hinges. The skin fracture surfaces were consistent with overstress. There were no indications of progressive failure.

The rudder was still attached to the vertical stabilizer at the top and centre hinges and had fractured in half just below the centre hinge. The rudder balance weight was missing. The vertical stabilizer was undamaged, but the rudder was badly torn and deformed.

Photo 2. Left side of rudder

The bottom rudder hinge had fractured, consistent with failure by overstress. The fracture surface did not exhibit any indications of progressive failure. The rudder stops impact marks tended to be concentrated at only one location on each stop. There were no indications of pounding marks at multiple locations to suggest the rudder was experiencing stop-to-stop vibrations. Furthermore, no evidence was found to suggest the counter weight had been progressively working its way loose.

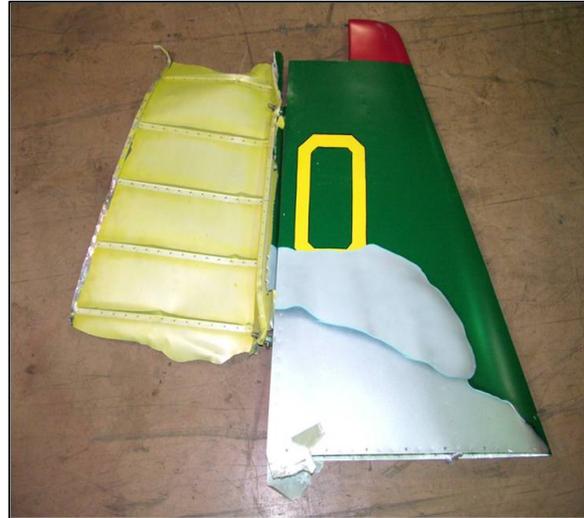
Photo 3. Right side of rudder
