AVIATION INVESTIGATION REPORT

A10Q0162

BIRD STRIKE ON TAKE-OFF AND COLLISION WITH TERRAIN

**MAX AVIATION INC.
BEEHCRAFT B100, C-FISK
MONTMAGNY AIRPORT, QUEBEC
22 SEPTEMBER 2010**

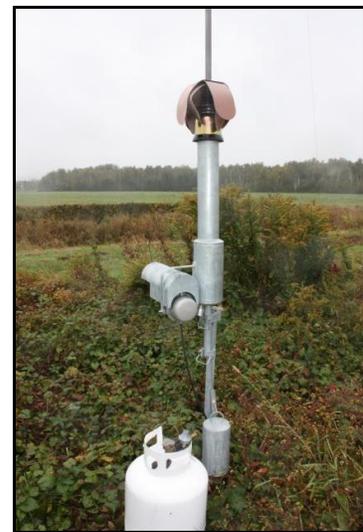
Photo 1. Propane-powered cannon

Several measures were put in place to mitigate the risk, including selective killing and the use of a propane-powered cannon near the runway edge (see Photo 1). The cannon was installed at Montmagny Airport in June 2010. Malfunctions were reported from 27 to 31 August 2010. Although the supplier was contacted for repair action and the cannon was put back in operation, it was not working on the day of the accident.

This propane cannon produces both visual and auditory stimulus to scare birds. The cannon produces thrust to propel a mechanism that causes a fringed rubber disk to slide up a pole mounted on a tripod. The mechanism drops back rapidly, but the disk descends more slowly, somewhat like a parachute. This decoy is designed to imitate a falcon hunting a bird. The cannon is reported effective within a 150-metre radius.

To reduce the risks associated with bird activity, a wildlife management program was in place. Although only one bird strike was reported at Montmagny Airport in the last 5 years, the bird hazard risk assessment by the Quebec Department of Transport found that gulls and geese pose a high risk at this airport. For that reason, bird control measures were in place, including selective killing and the use of a flare gun and a propane cannon. Since no bird congregations were seen prior to the take-off, selective killing and the flare gun were not used. The only bird control measure remaining was the propane cannon. However, the cannon was out of order on the day of the occurrence.

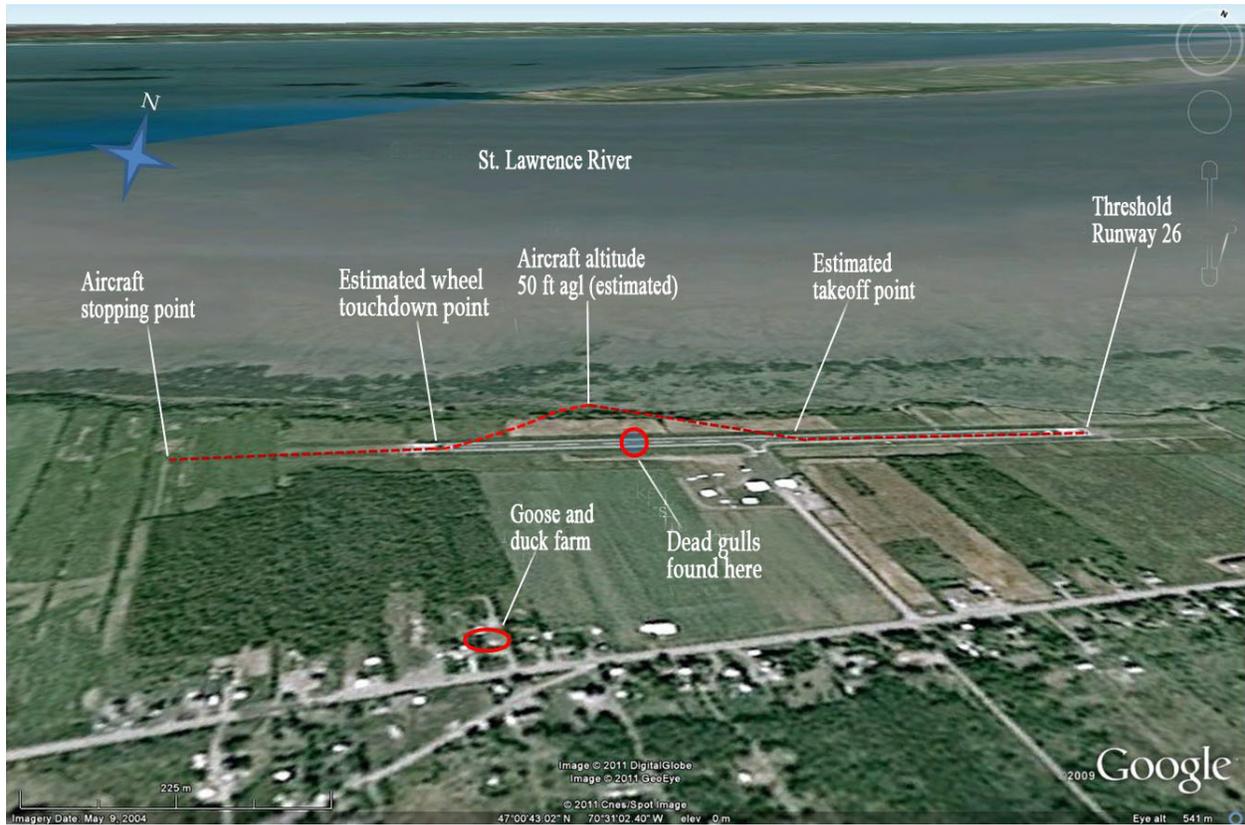
Appendix A – Estimated take-off profile

diagrams were used to estimate the take-off profile on the day of the occurrence (see Appendix A).

Given the no-flaps climb gradient and the location where the birds were found, the bird strike would have occurred at a height of 40 feet. A take-off with 30% flaps would have placed the aircraft 10 feet higher at the same point.

As for the accelerate-stop distance for a no-flaps take-off, the performance diagrams show that 3300 feet of runway is required to bring the aircraft to a halt if one engine fails at the rotation speed (V_r). For a take-off with 30% flaps, the accelerate-stop distance is reduced to 3200 feet. Although these diagrams are provided in the AFM as a reference, 703 operators are not required to ensure that the usable accelerate-stop distance is equal to or greater than the accelerate-stop distance indicated in the performance diagrams. For 704¹⁵ and 705¹⁶ operators, take-off is not permitted if the required accelerate-stop distance exceeds the usable accelerate-stop distance.
