**AVIATION INVESTIGATION REPORT
A11C0047**

DOUBLE ENGINE POWER LOSS AND FORCED LANDING

**FUGRO AVIATION CANADA LIMITED
CASA C-212-CC40, C-FDKM
SASKATOON, SASKATCHEWAN
01 APRIL 2011**

Report Number A11C0047

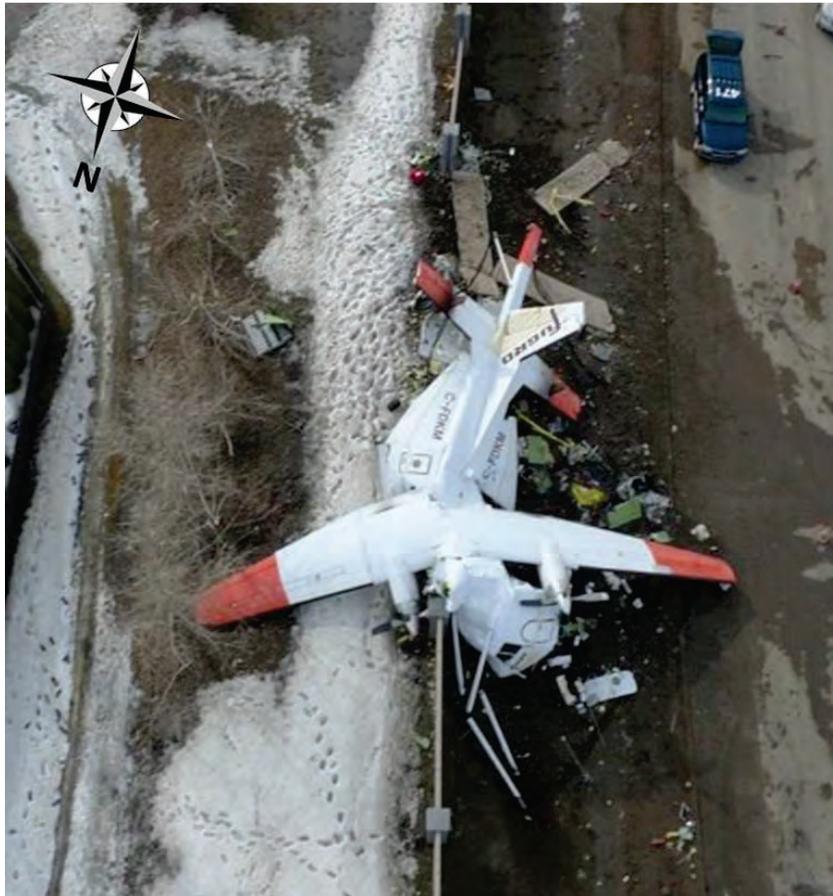
Photo 3. Crash site overview (Source: Saskatoon Police Service, used with permission)

Property damage was limited to the noise abatement wall and landscaping in the vicinity of the wall, with minor environmental damage from hydraulic and battery fluid spillage.

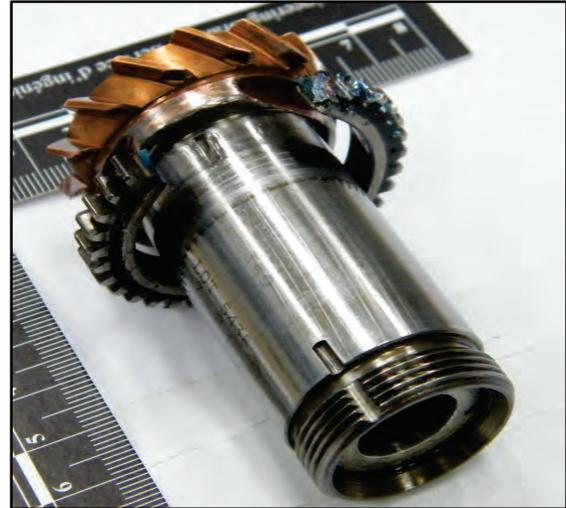
Removal of the reduction gear housing from the engine revealed that the intermediate spur gear (part number 896884-1) had failed and was no longer keyed to the torque sensor shaft (Photo 4). The intermediate spur gear transmits power, via the torque sensor shaft, from the high speed main shaft to a gear train which drives the high pressure fuel pump, fuel control unit, and oil pressure and scavenge pumps.

Photo 4. Failed gear on the torque sensor shaft

The torque sensor had accumulated approximately 6470 hours since overhaul in 1997. The torque sensor assembly does not have a designated overhaul period and is normally overhauled with the engine. The torque sensor was removed and visually examined by the manufacturer under the supervision of TSB investigators. The TSB Laboratory conducted a detailed examination of the torque sensor, as well as gear fragments, metal shavings and chips recovered from the reduction gear housing. See TSB Laboratory report LP 055/2011 – Metallurgical Examination of Torque Sensor.

TSB Laboratory analysis indicated that the case hardening of the gear tooth flanks and roots of 2 spur gears in the torque sensor gear train was below the manufacturer's specification requirements and likely led to the wear of the loaded faces and flanks of the gear teeth. The combined wear of the 2 gears likely caused an abnormal vibration that produced excessive cyclic loading and eventual fatigue cracking in the tooth roots of the intermediate gear. The intermediate spur gear subsequently separated into several fragments and caused the loss of power transmission to the high-pressure engine-driven fuel pump. The immediate result would have been fuel starvation of the engine, flameout and the loss of power.

The shudder felt was almost certainly associated with the gear failure. The engine-driven fuel pump was no longer operating so any attempt to restart the engine would have been unsuccessful.

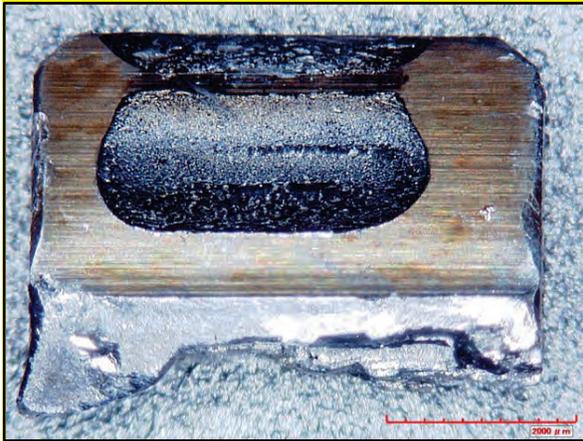
The laboratory analysis of the failed intermediate spur gear revealed fatigue cracks in the roots of most of the gear teeth. The gear had separated into several fragments as a result of fatigue cracking followed by overstress fractures. The woodruff key (part number MS35756-1) that indexed the gear to the torque sensor shaft had fractured in a fatigue mode followed by overstress fracture. The case hardening of the intermediate spur gear and one other spur gear (part number 3103589-1) in the gear train was slightly below the specified level on the tooth flanks and significantly lower in the tooth root areas. Both gears exhibited significant wear on the loaded faces and flanks of the gear teeth (Photo 5 and Photo 6).

Photo 5. Tooth from gear 896884-1 showing wear on the loaded face and flank

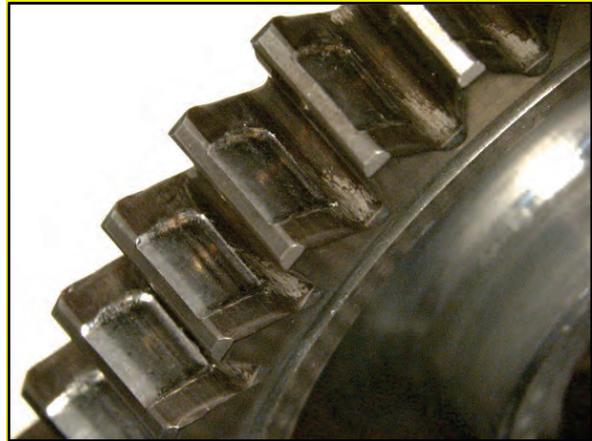
Photo 6. Gear 3103589-1 tooth wear on the loaded face and flank

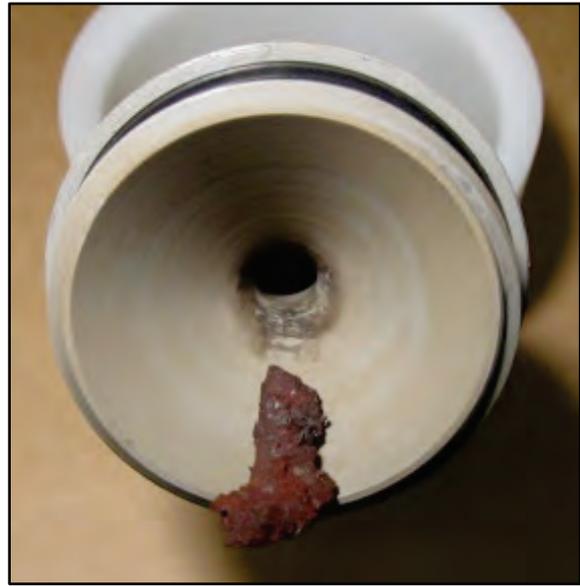
During the in-situ examination of the No. 2 ejector pump, a piece of flexible foreign object debris (FOD) fell out of the pump intake port. The piece of L-shaped FOD was approximately 2 mm thick, 4 mm wide and 13 mm long. Disassembly and examination of the No. 2 ejector pump nozzle revealed a stain approximately 4 mm wide (Photo 7).

Analysis of the FOD by the TSB Laboratory revealed that it was composed largely of a structure of polymeric materials. For comparison purposes, samples of sealant were removed from various locations in the fuel tank. Unlike the FOD, these samples were determined to be homogenous, particulate-filled polysulphide compounds.

Photo 7. No. 2 ejector nozzle and foreign object debris

Analysis of the FOD material revealed that it was dissimilar to the type of sealant material utilized in the construction, repair or maintenance of the fuel tank, but it could not be determined how or when the FOD was introduced into the fuel tank. The staining of the No. 2 ejector pump nozzle indicates that it had been present for some time prior to the accident flight.

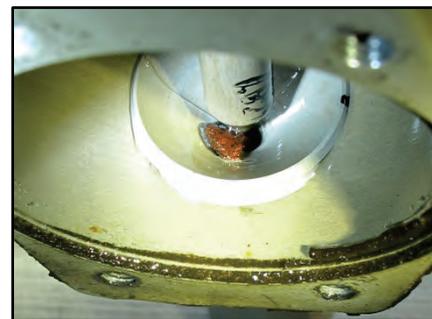
Photo 8. Foreign object debris as ingested into No. 2 ejector pump during bench testing

substantially as a result of the FOD lodging deep in the ejector nozzle (Photo 8). The pump was reinstalled in the wing in this condition (Appendix H) and 4 additional test runs were conducted.
