**AVIATION INVESTIGATION REPORT
A11W0070**

LOSS OF CONTROL - COLLISION WITH WATER

**CAMPBELL HELICOPTERS LTD.
BELL 212 C-FJUR
SLAVE LAKE, ALBERTA, 12 NM W
20 MAY 2011**

Report Number A11W0070

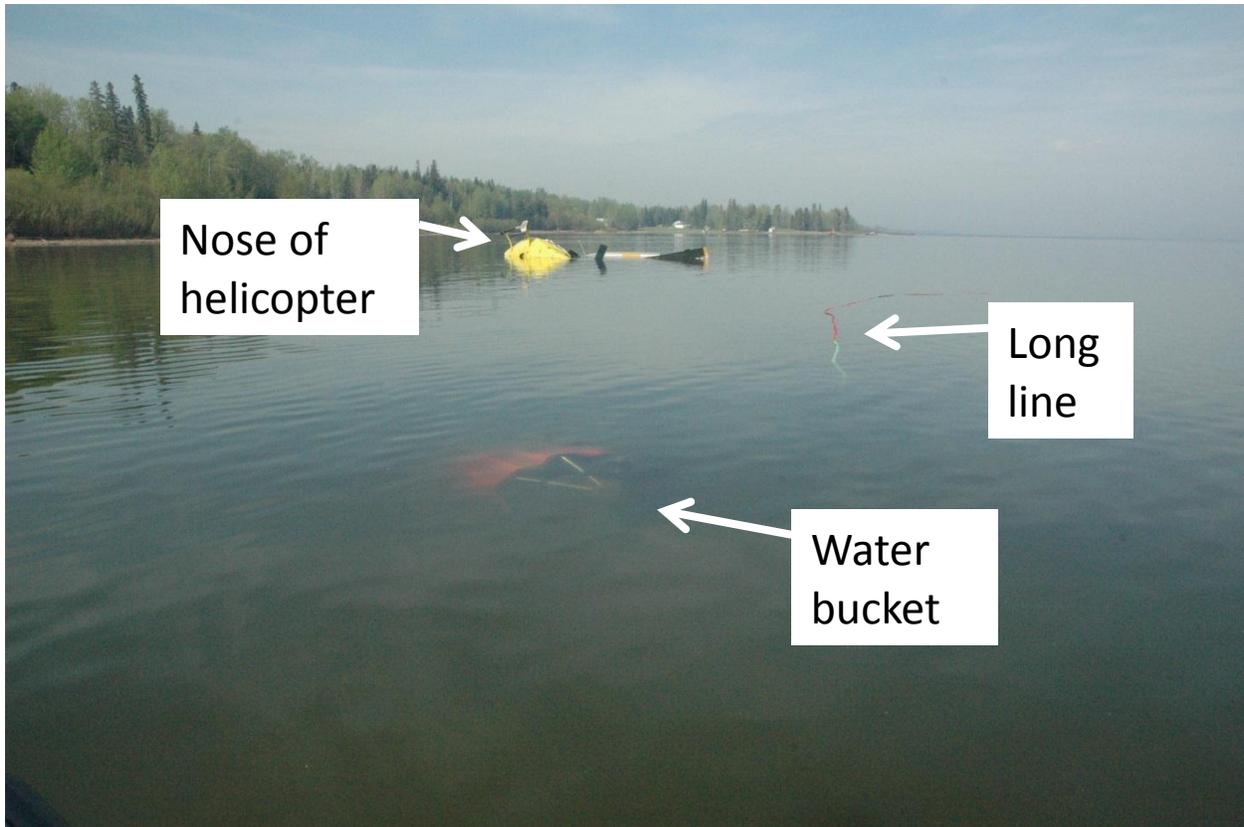
The helicopter was found on its right-hand side in Lesser Slave Lake at 55°22.154' N and 115°03.319' W. The helicopter was approximately 290 feet from the southern edge of the lake and oriented parallel to the shore, facing west (see Photo 1).

Photo 1. Helicopter Crash Location

The helicopter experienced extensive hydroforming of the right-hand sub-floor panels as well as the right-side roof and sliding door. In addition, the 2 left attachment points on the tail boom failed due to overload toward the right side of the helicopter. This is consistent with the helicopter landing with a high downward velocity on its right side at impact.
