**AVIATION INVESTIGATION REPORT
A11W0144**

LOSS OF CONTROL AND COLLISION WITH BUILDING

**ARCTIC SUNWEST CHARTERS
DE HAVILLAND DHC-6-300 TWIN OTTER, C-GARW
YELLOWKNIFE, NORTHWEST TERRITORIES
22 SEPTEMBER 2011**

Report Number A11W0144

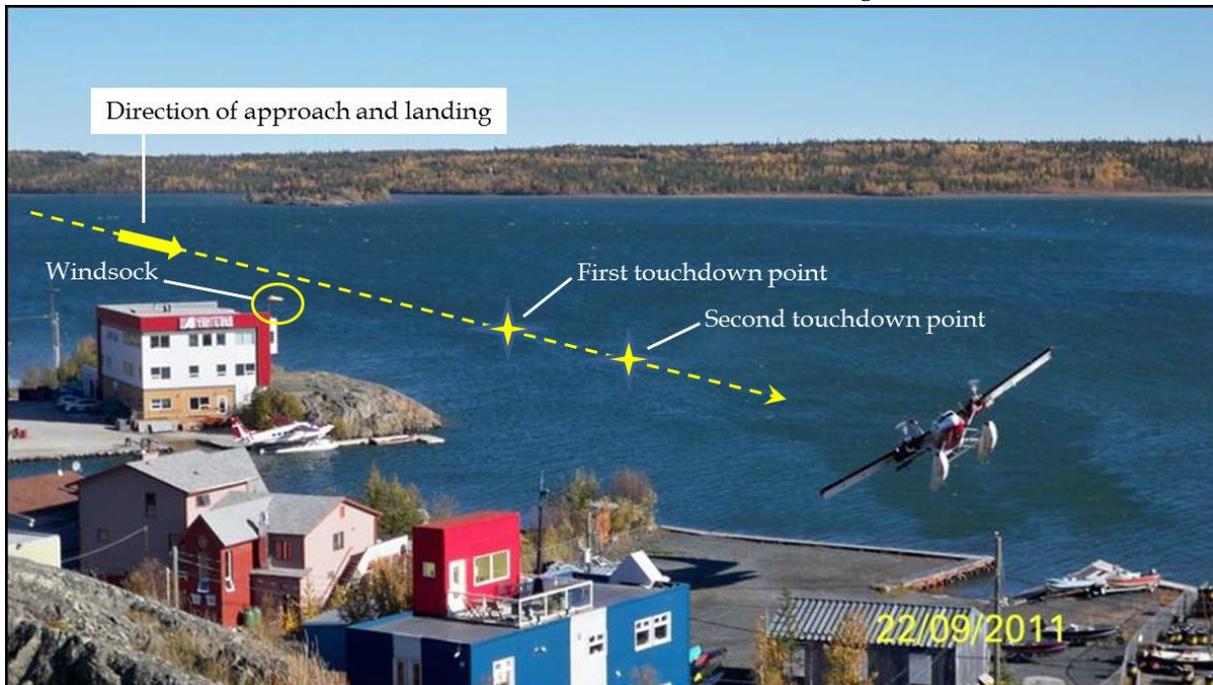
Southwest of the landing zone and the accident site in Old Town is a rock outcrop known as The Rock, rising about 70 feet above the lake level and about 60 feet above the street. Located on top of The Rock is a public viewpoint, a private weather station, and the Pilot's Monument. The aircraft was photographed from the public viewpoint throughout the approach, landing, overshoot (Photo 1), and impact with the building. Also visible in the photos taken before and after Photo 1 was a windsock on a building beside the touchdown area displaying the changes in wind speed and direction throughout the landing sequence. At initial touchdown, the wind was a crosswind from the west. The wind then changed to a southwest headwind at the start of the overshoot, and shifted back to west for the remainder of the flight.

Photo 1. C-GARW over docks during overshoot (photo used with owner's permission)

The approximate track of C-GARW through the approach and landing was 195°M. Wind direction was variable, but was from approximately 273°M at 24 knots, gusting to 31 knots at touchdown, resulting in a crosswind component of 20 to 30 knots. The wind direction at the time of landing can be verified by the deflection of the windsock (Photo 1).
